BRIDGE GROUP

Bridge Inspection Photographs

Structure Number :	08194	Structure Name :	Pinal Creek RCB	Inspected by :	ADOT-Zapata/Kazmi
Route :	0	Road Name :	Sixshooter Cyn Rd	Inspection Type:	Routine
MP :	0	Agency :	Gila Co	Inspection Date :	Wednesday, May 6, 2020
ADOT District:	Southeast			Next Insp. Due By :	05/06/2024

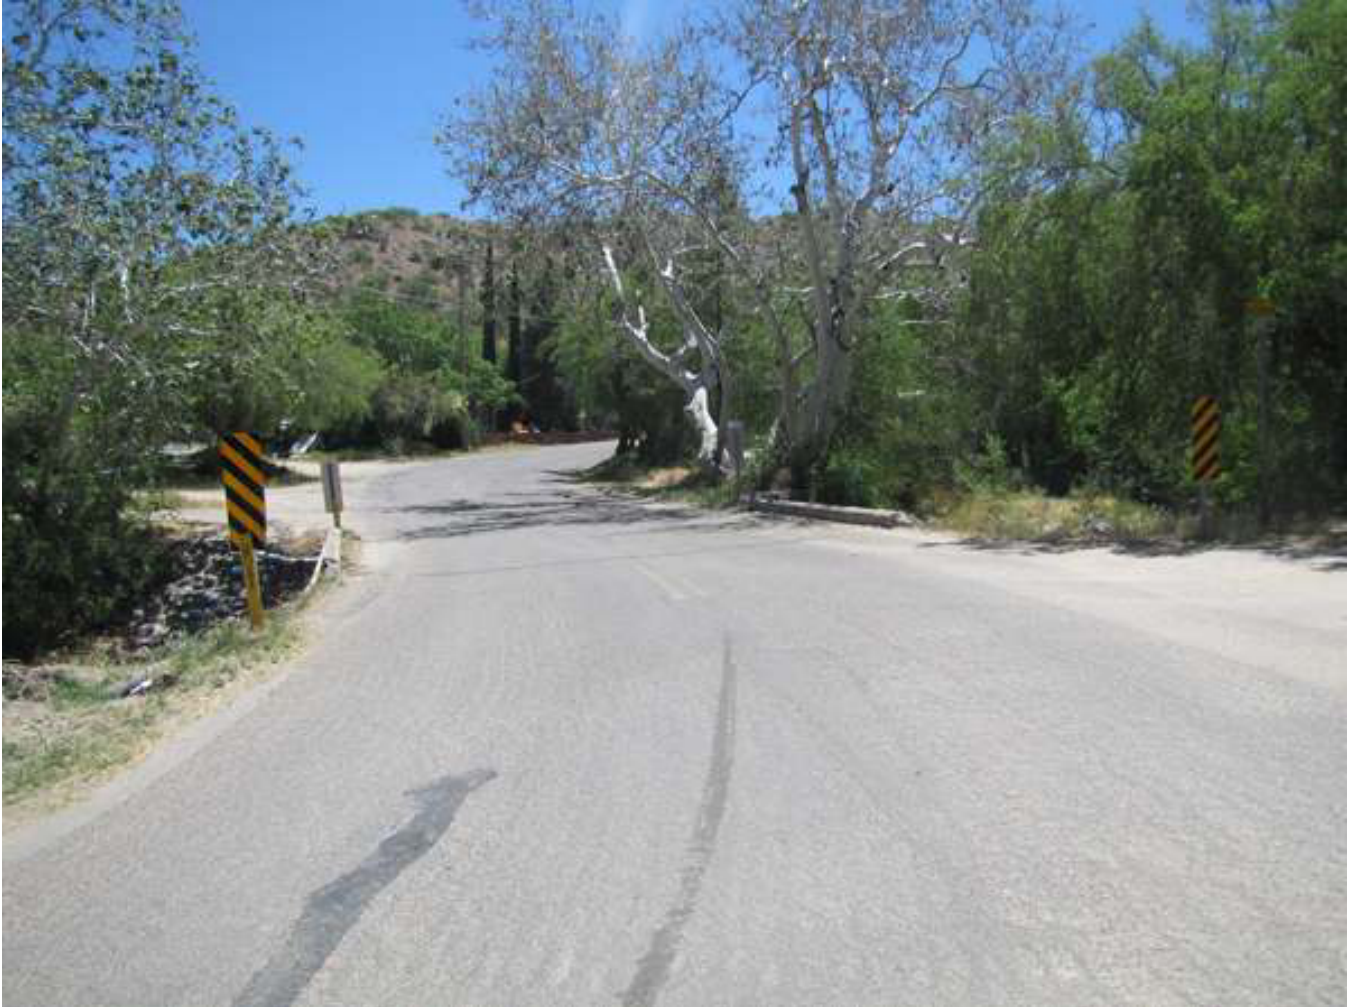
File Name : 08194-2020-05-06-Photo-1.jpg

Description : Roadway ID looking west

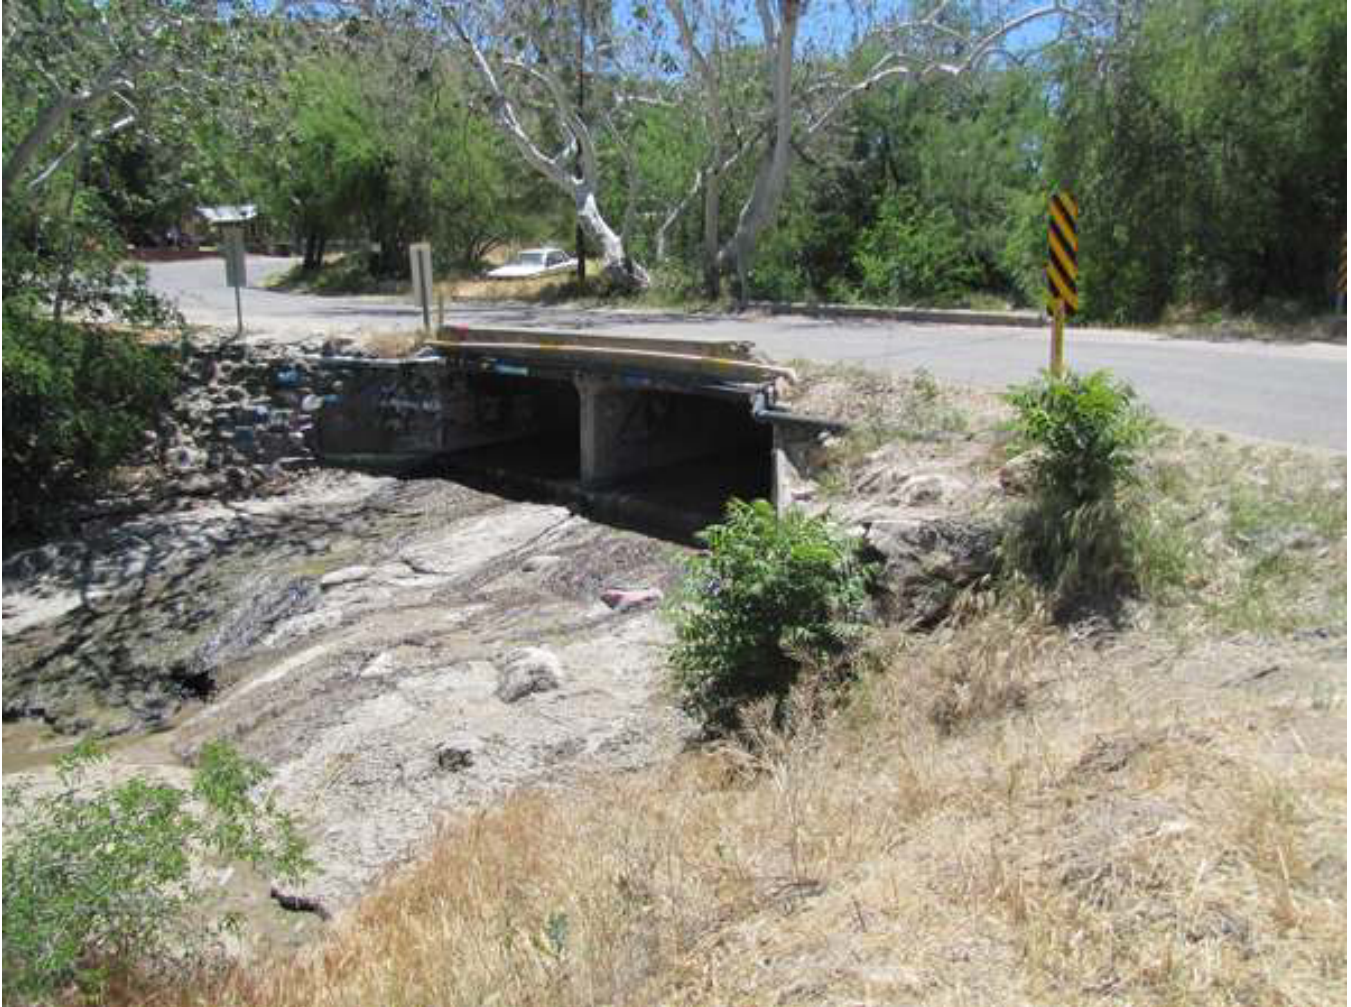
File Name : 08194-2020-05-06-Photo-2.jpg

Description : Elevation ID looking Upstream (S)

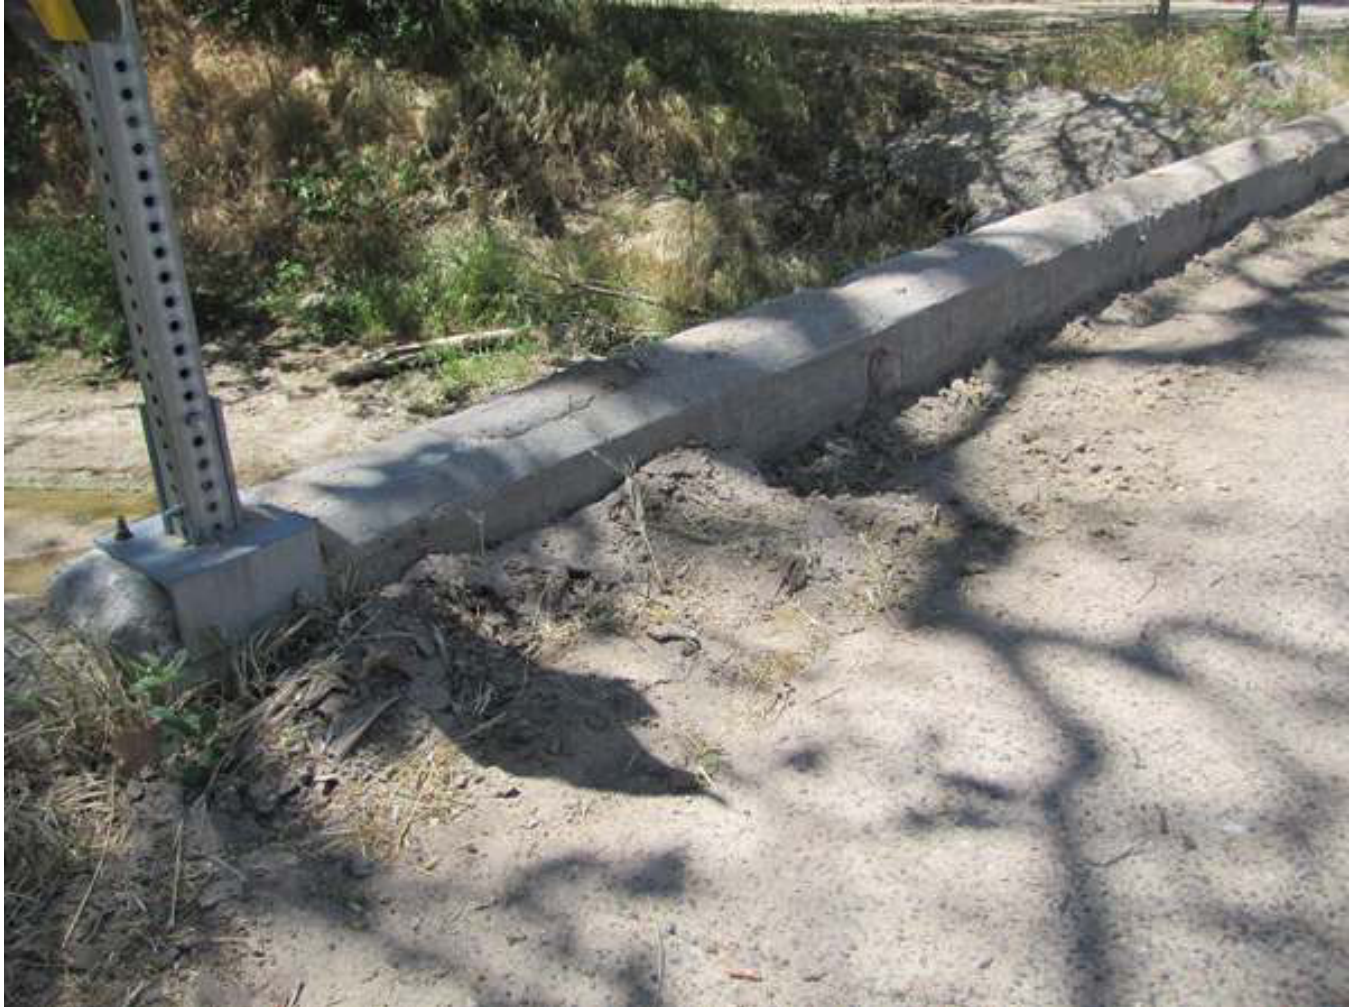
File Name : 08194-2020-05-06-Photo-3.jpg

Description : Deck Top with AC overlay and rebar exposed on north curb

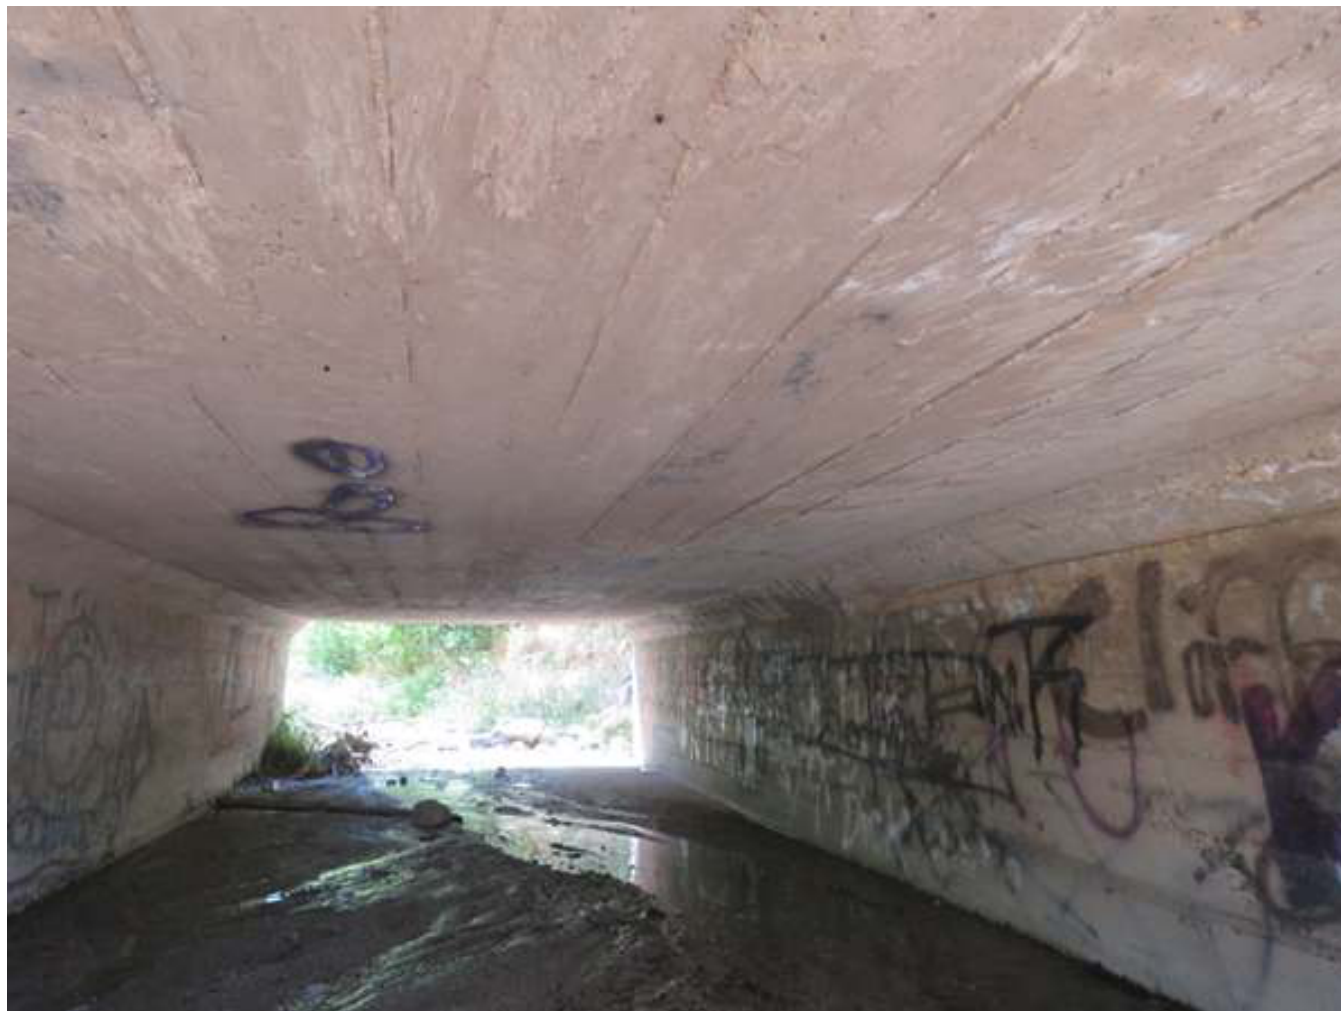
File Name : 08194-2020-05-06-Photo-4.jpg

Description : Barrel view

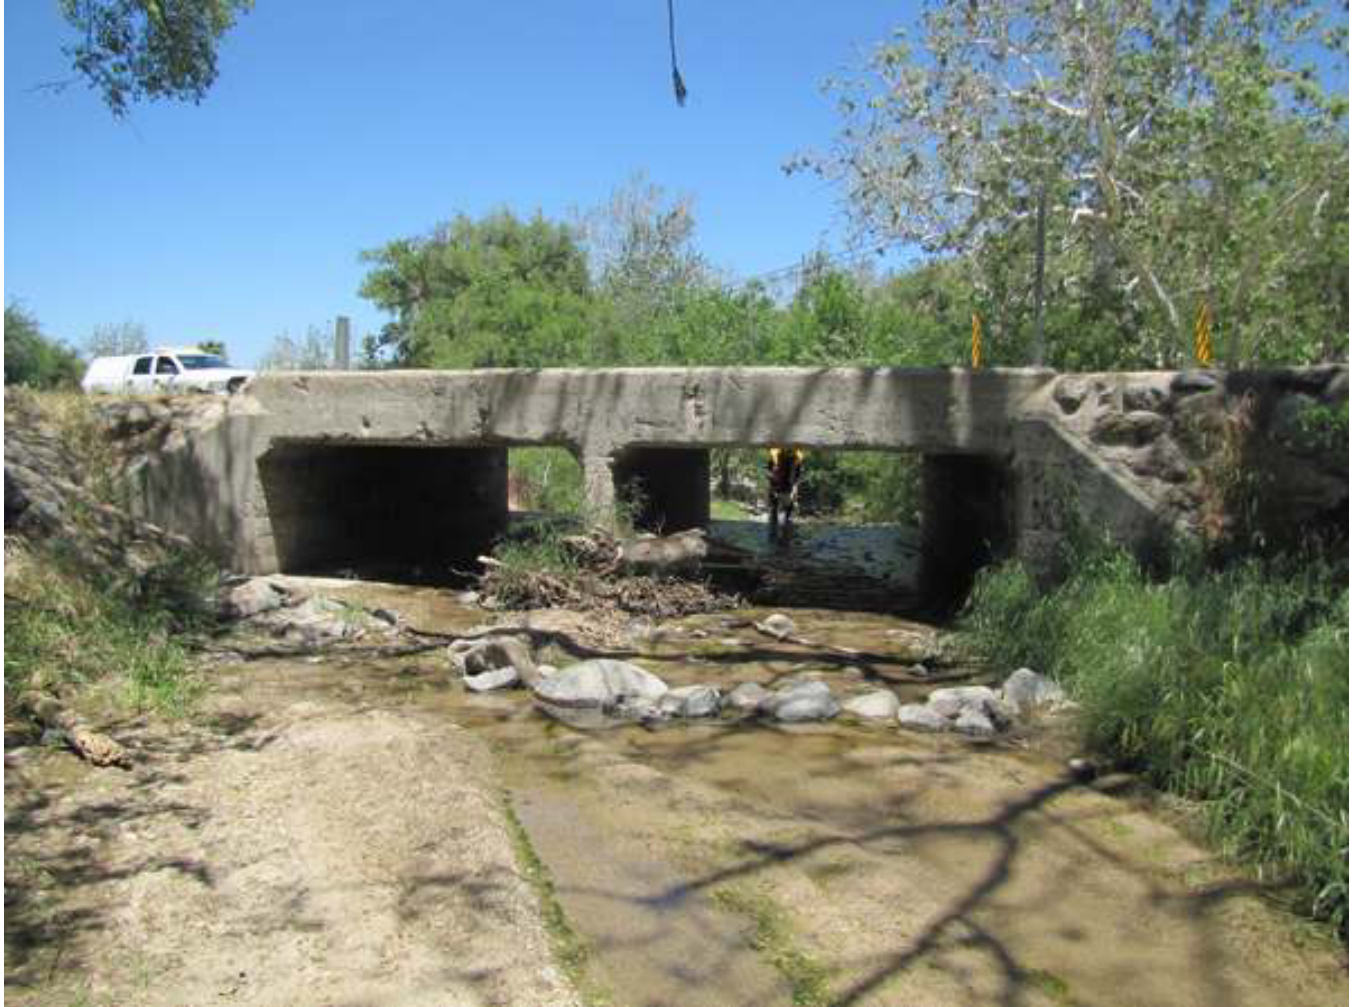
File Name : 08194-2020-05-06-Photo-5.jpg

Description : Elevation ID looking downstream (N)

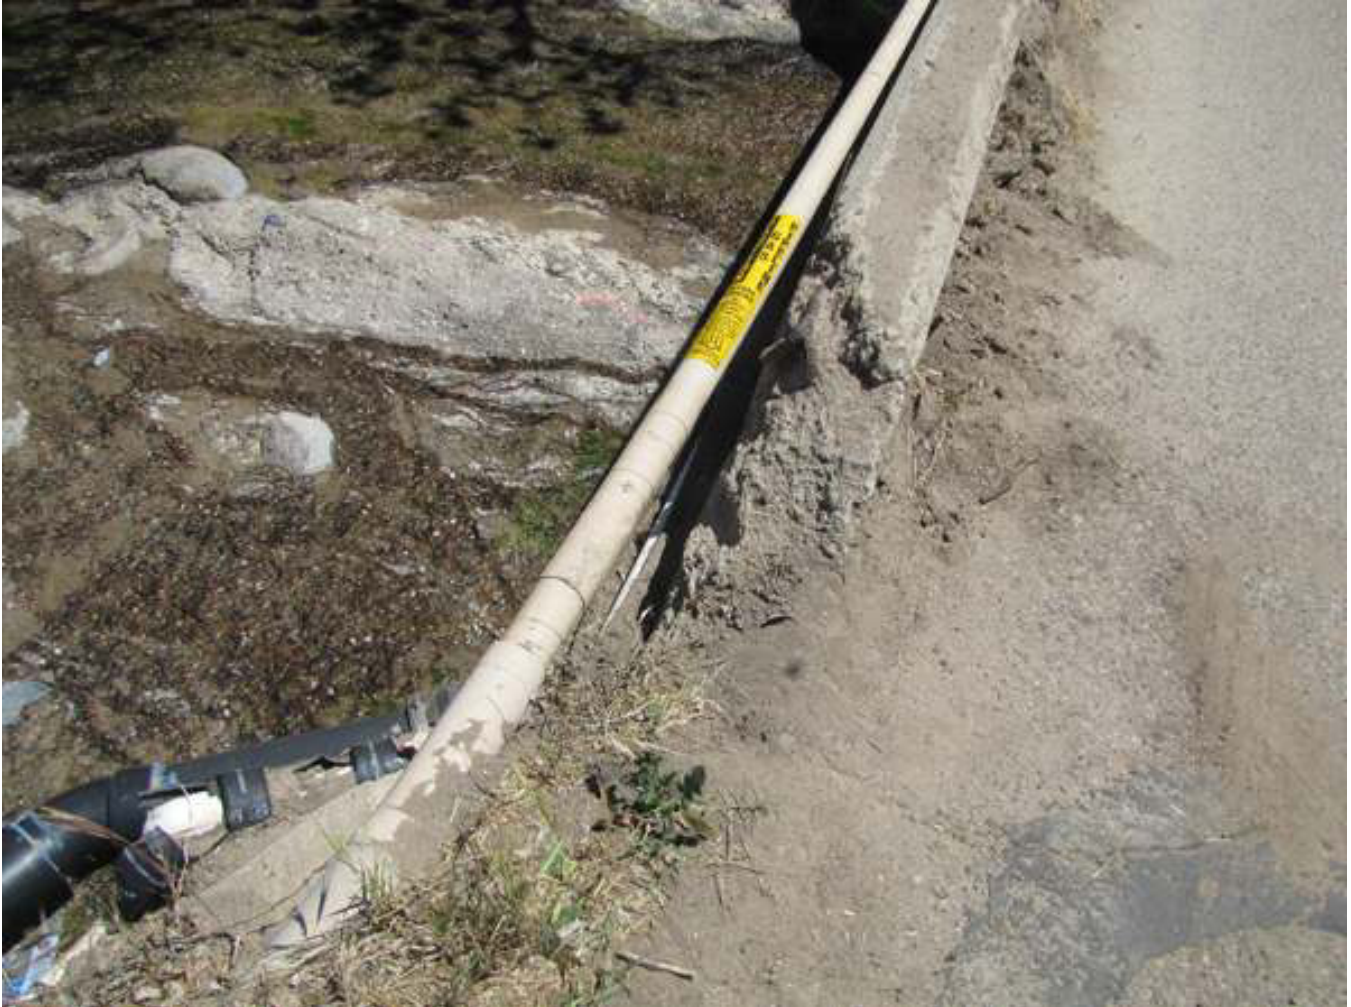
File Name : 08194-2020-05-06-Photo-6.jpg

Description : Exposed rebars on north curb

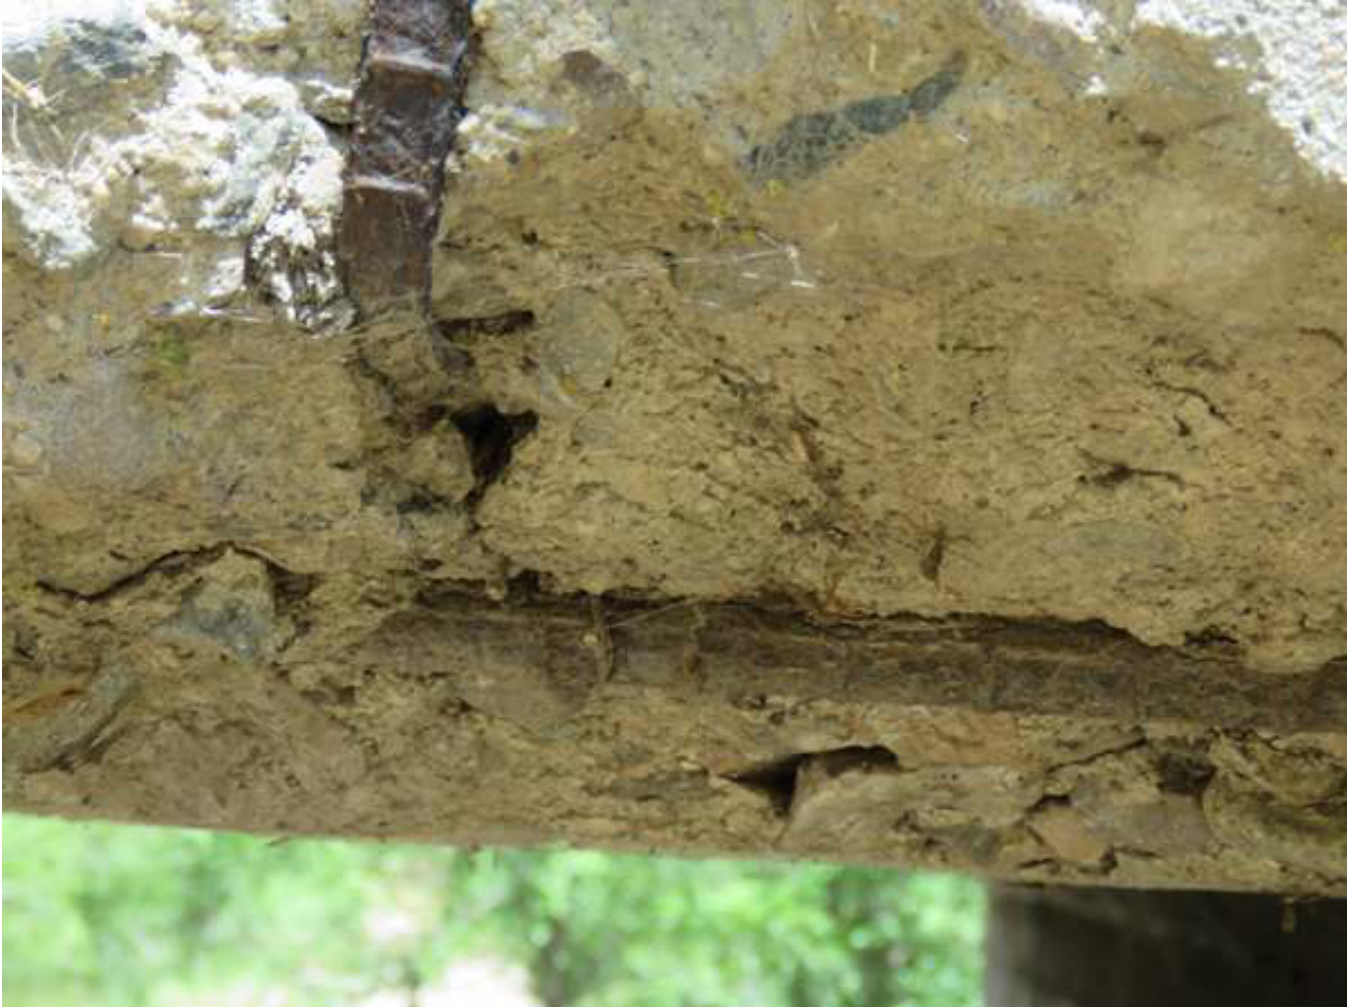
File Name : 08194-2020-05-06-Photo-7.jpg

Description : Exposed rebars on soffit next to south fascia

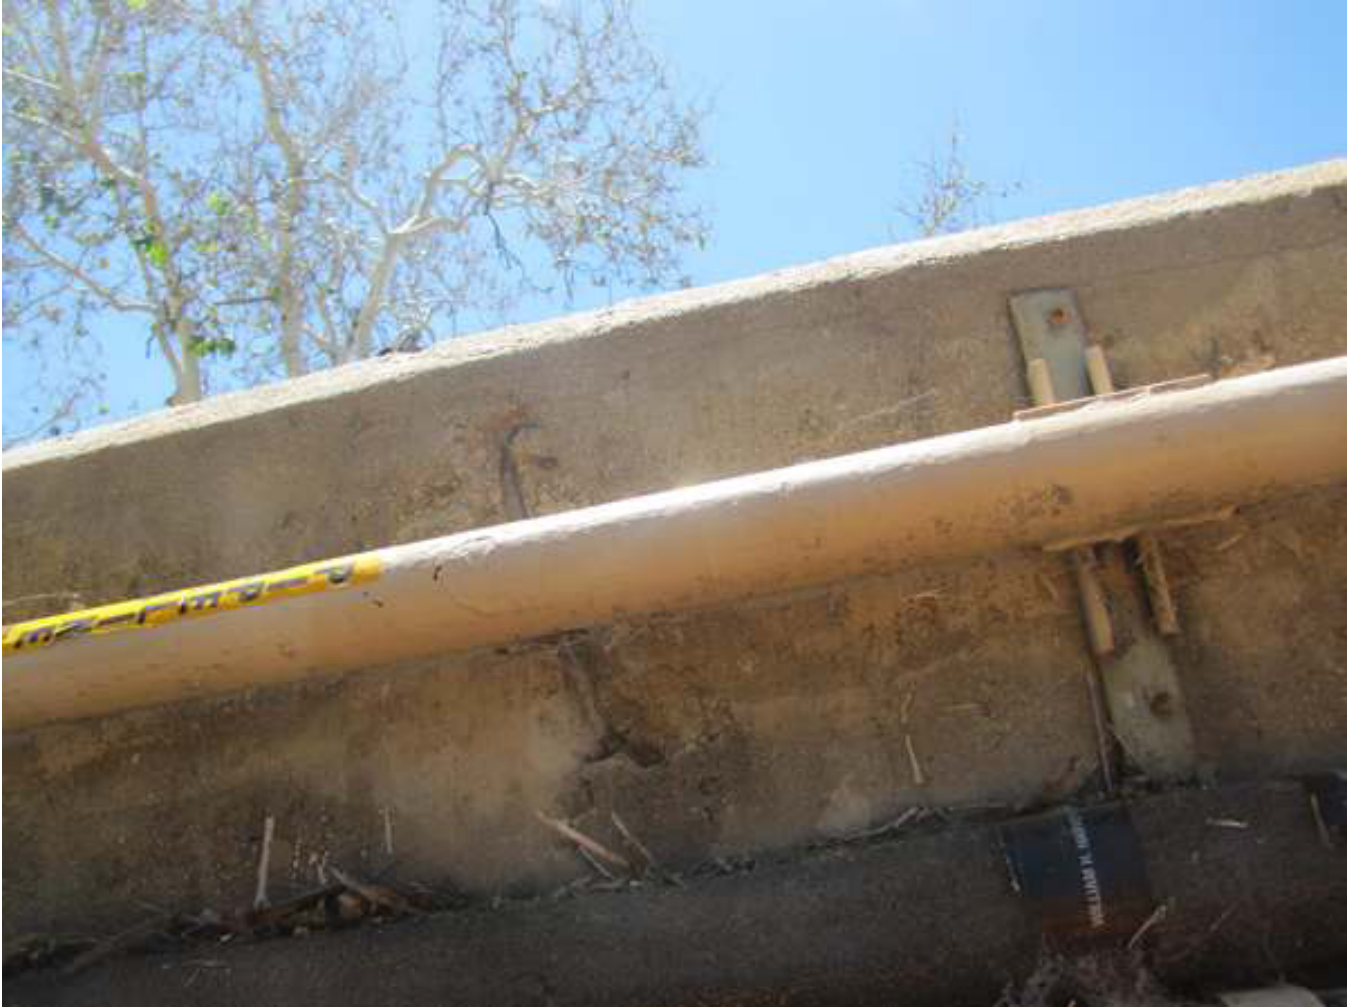
File Name : 08194-2020-05-06-Photo-8.jpg

Description : Exposed rebar on outlet headwall
