Bridge Inspection Photographs

Structure Number :	08605	Structure Name :	Pinal Creek RCB	Inspected by :	ADOT-Zapata/Kazmi
Route :	0	Road Name :	Bixby Road	Inspection Type:	Routine
MP :	0	Agency :	Gila Co	Inspection Date :	Wednesday, May 6, 2020
ADOT District:	Southeast			Next Insp. Due By :	05/06/2024

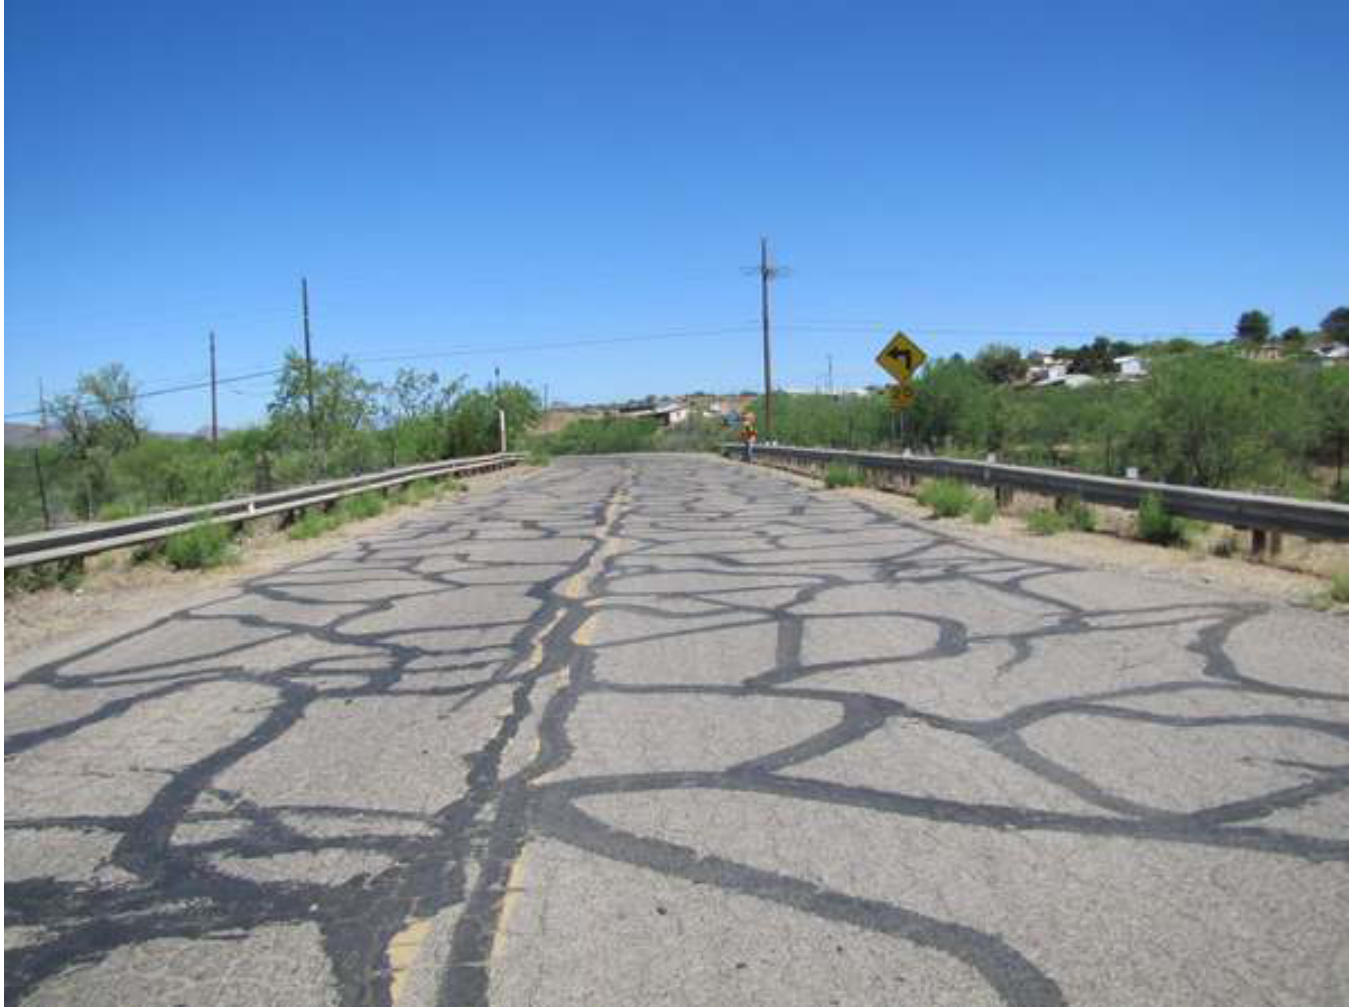
File Name : 08605-2020-05-06-Photo-1.jpg

Description : Roadway ID looking North

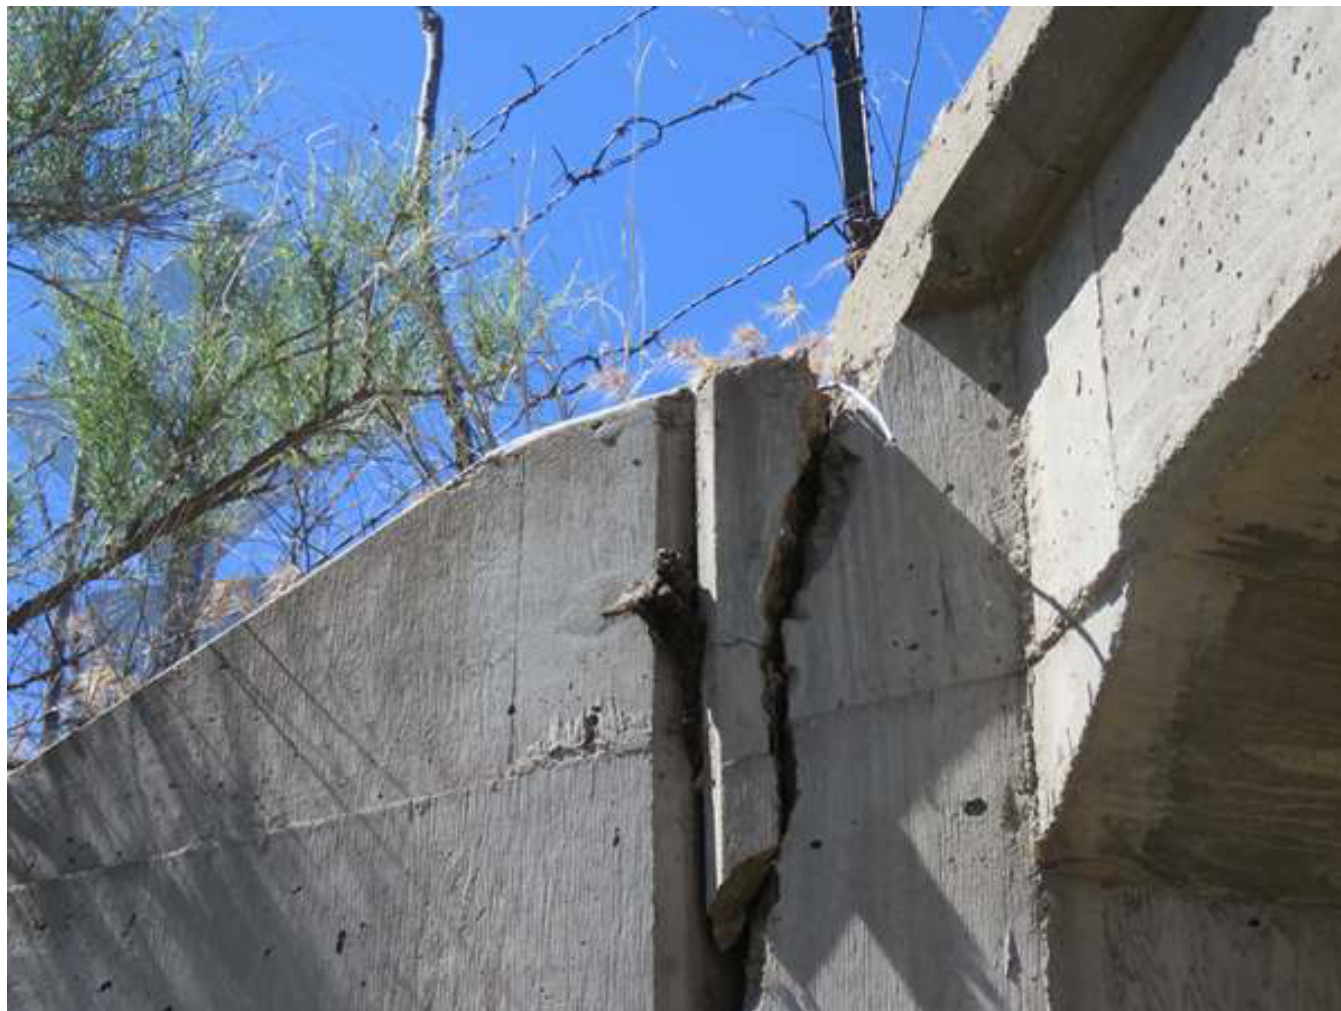
File Name : 08605-2020-05-06-Photo-10.jpg

Description : Broken off section on southeast corner junction of wingwall and RCB

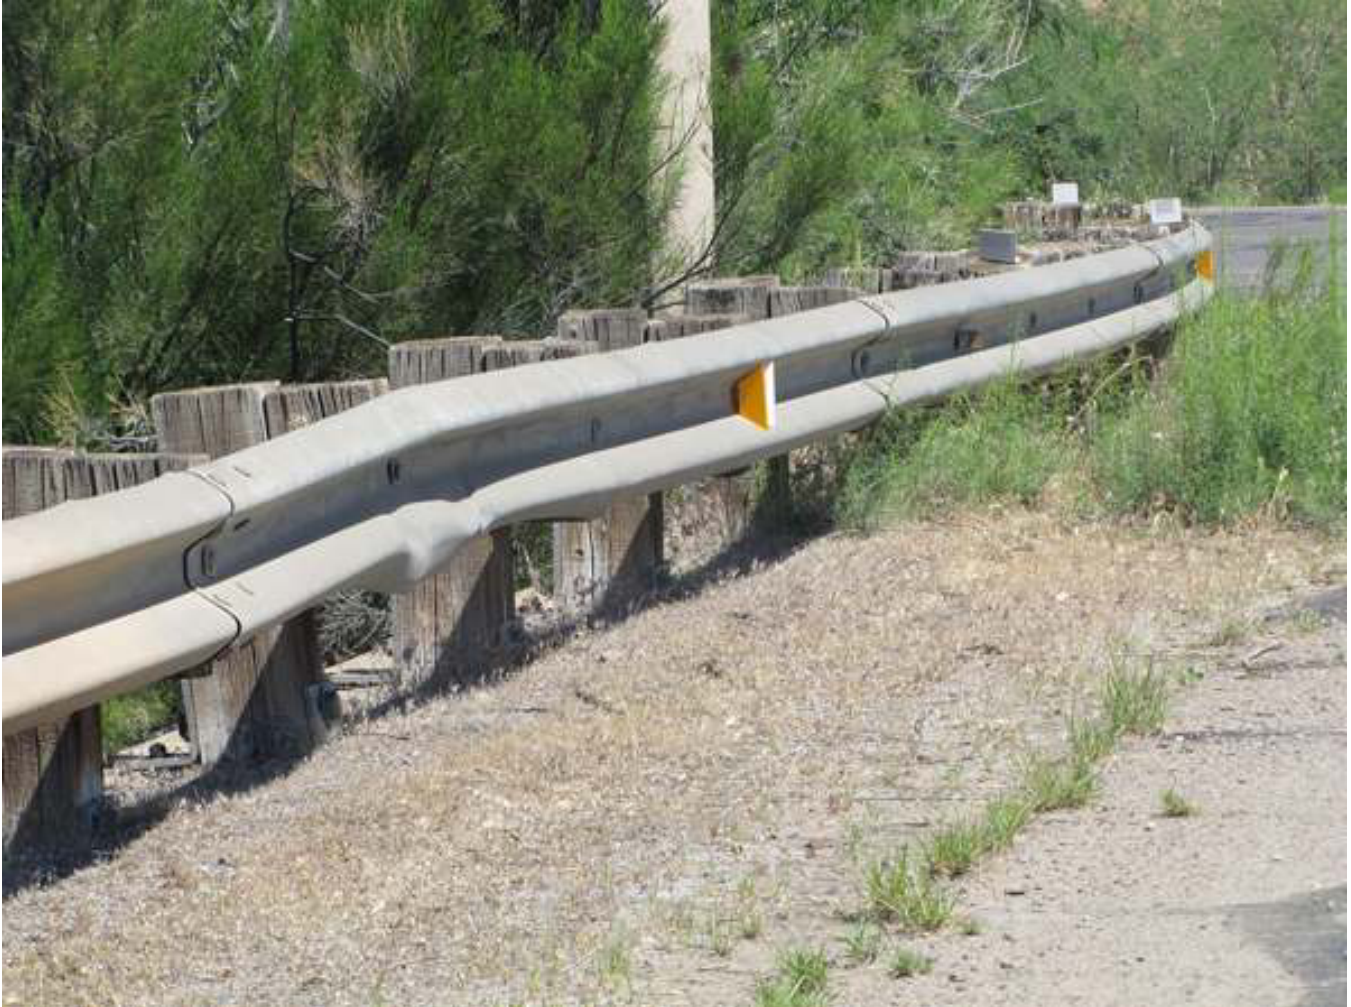
File Name : 08605-2020-05-06-Photo-11.jpg

Description : West side guardrail Damaged

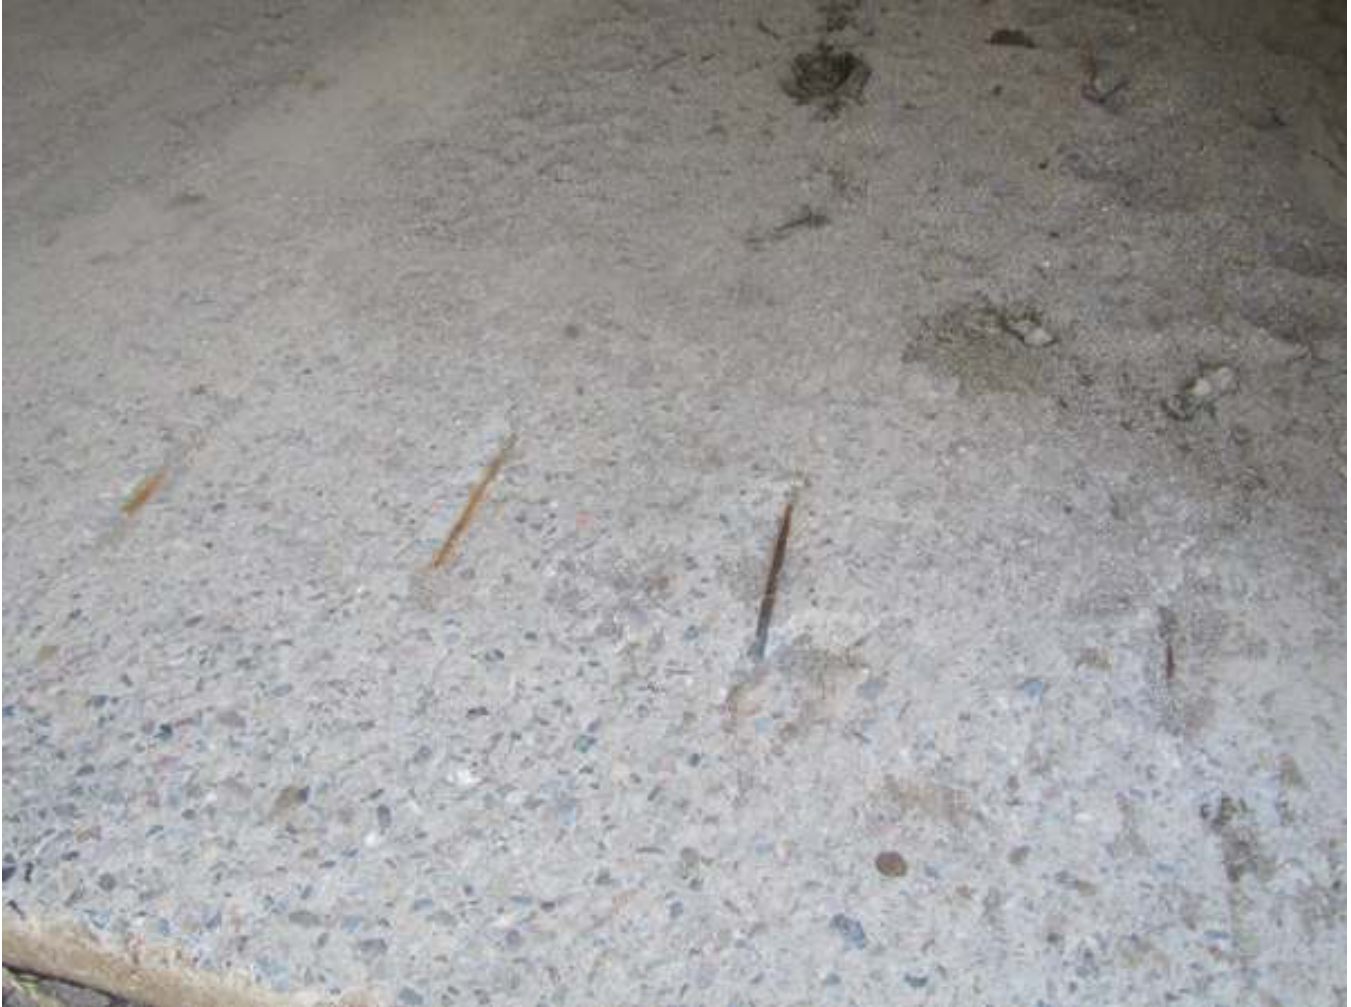
File Name : 08605-2020-05-06-Photo-12.jpg

Description : Rebar exposed on floor near outlet.

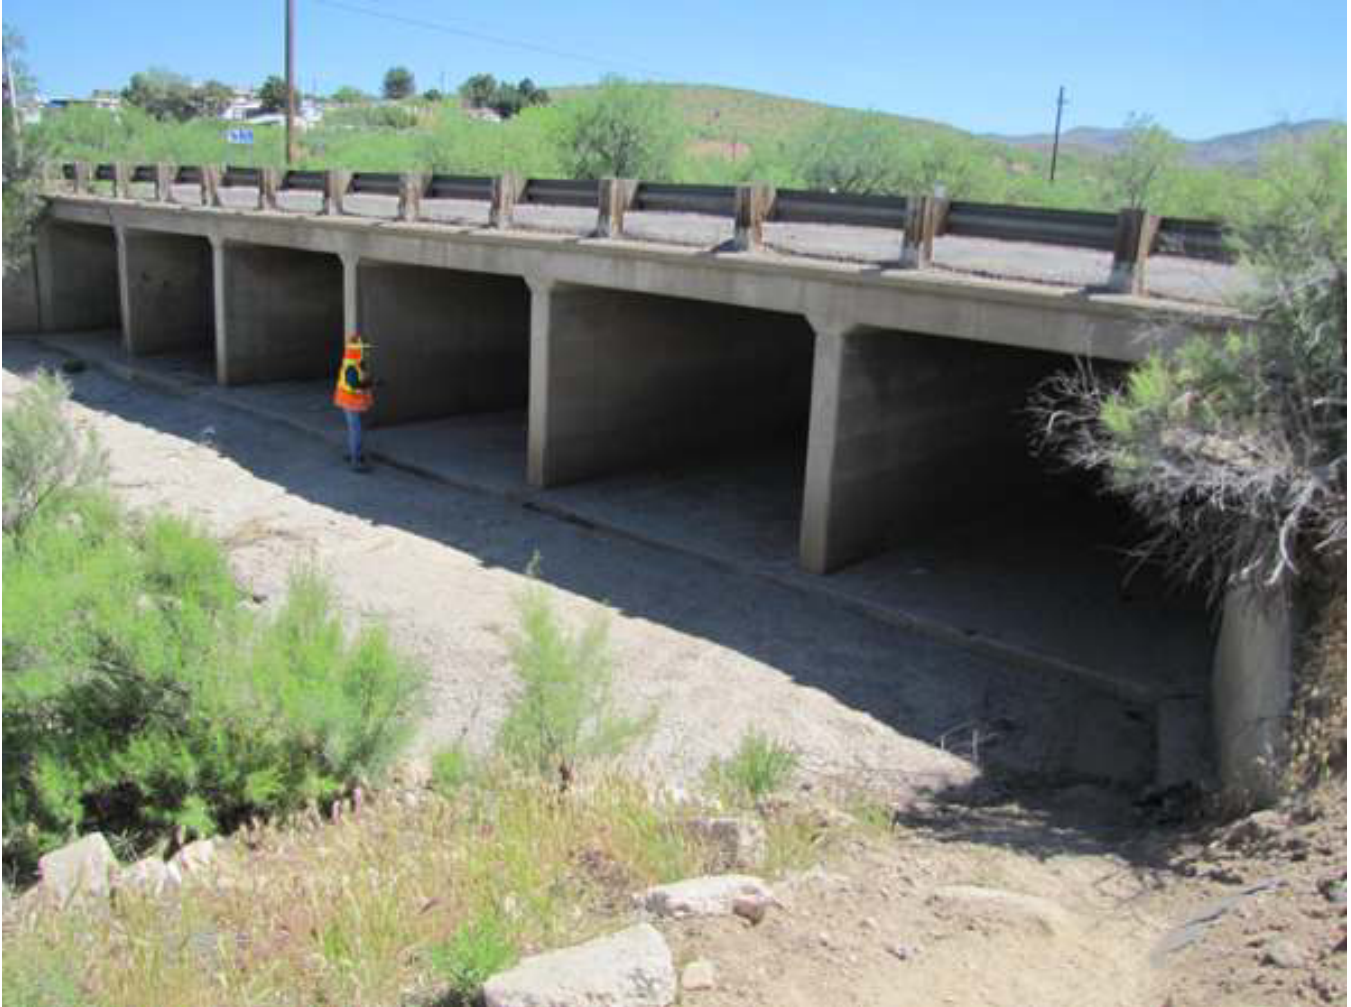
File Name : 08605-2020-05-06-Photo-2.jpg

Description : Elevation ID looking U/S (E)

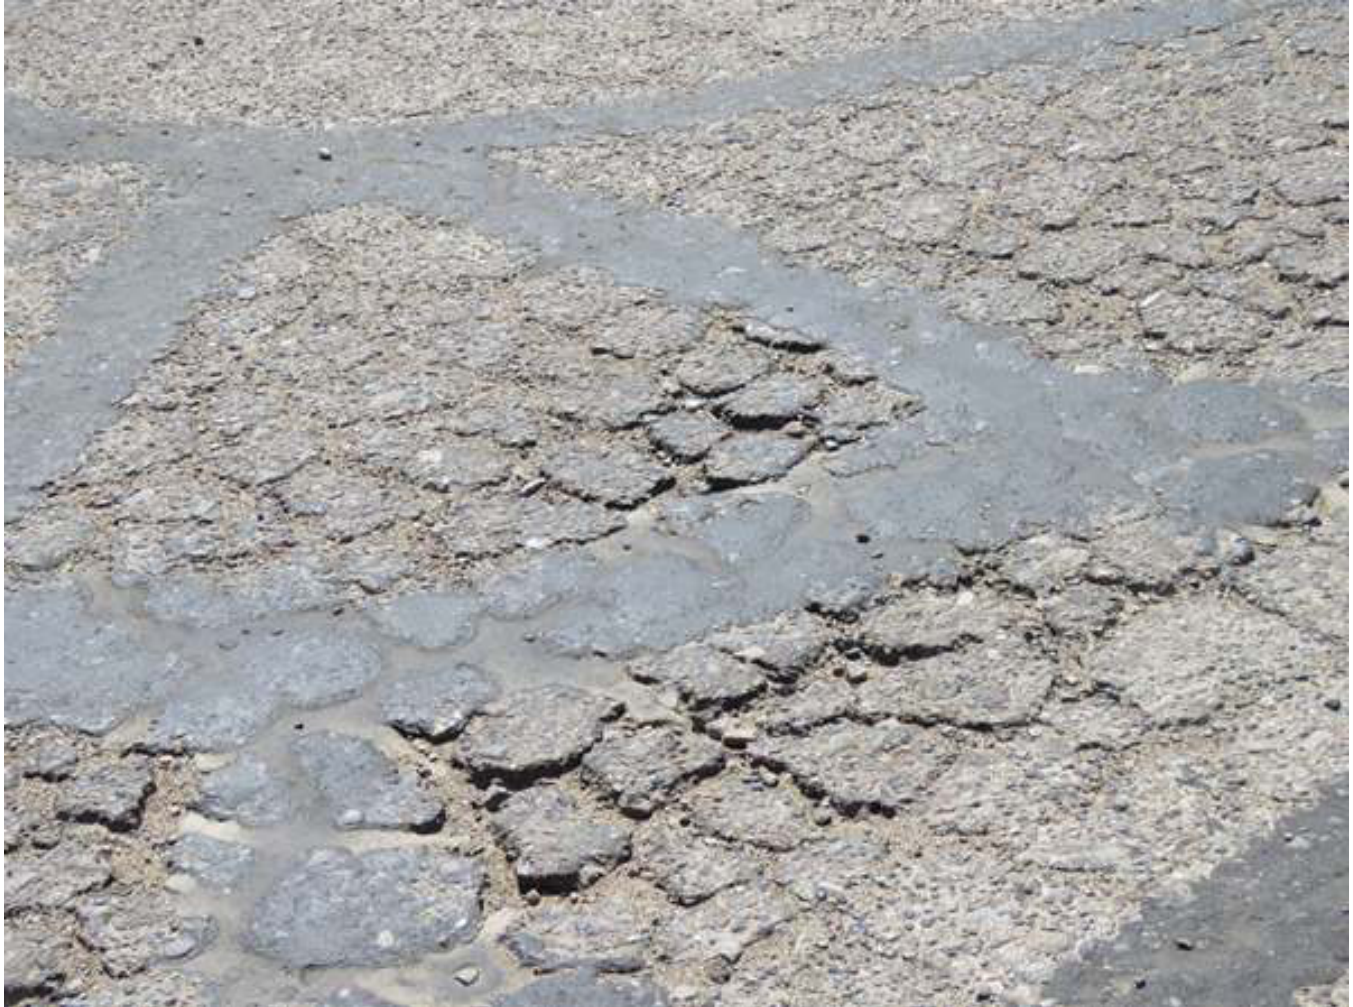
File Name : 08605-2020-05-06-Photo-3.jpg

Description : Deck Top

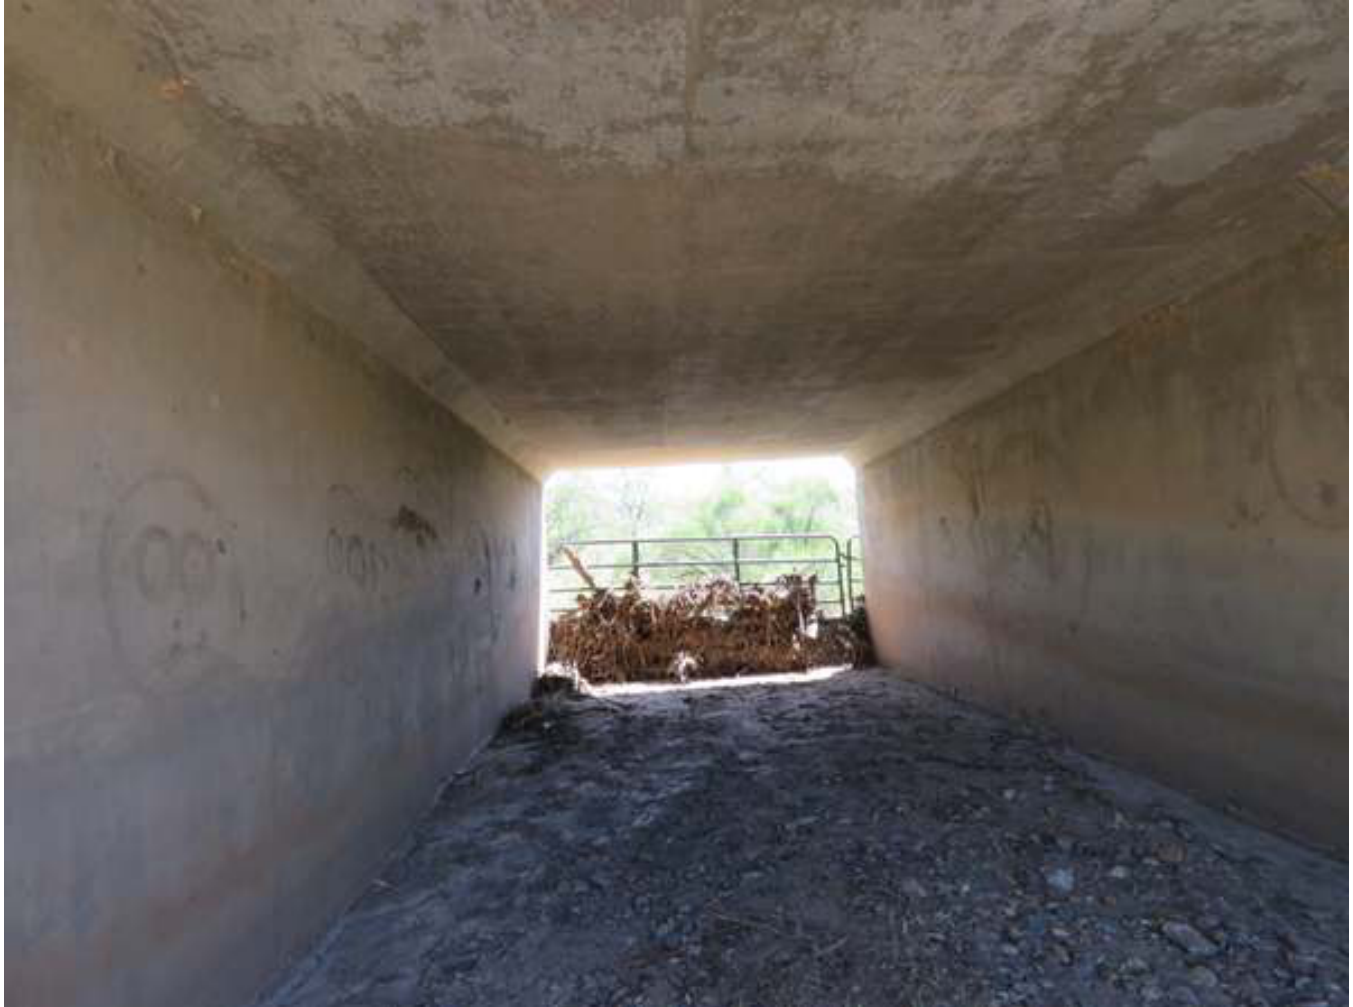
File Name : 08605-2020-05-06-Photo-4.jpg

Description : Barrel View

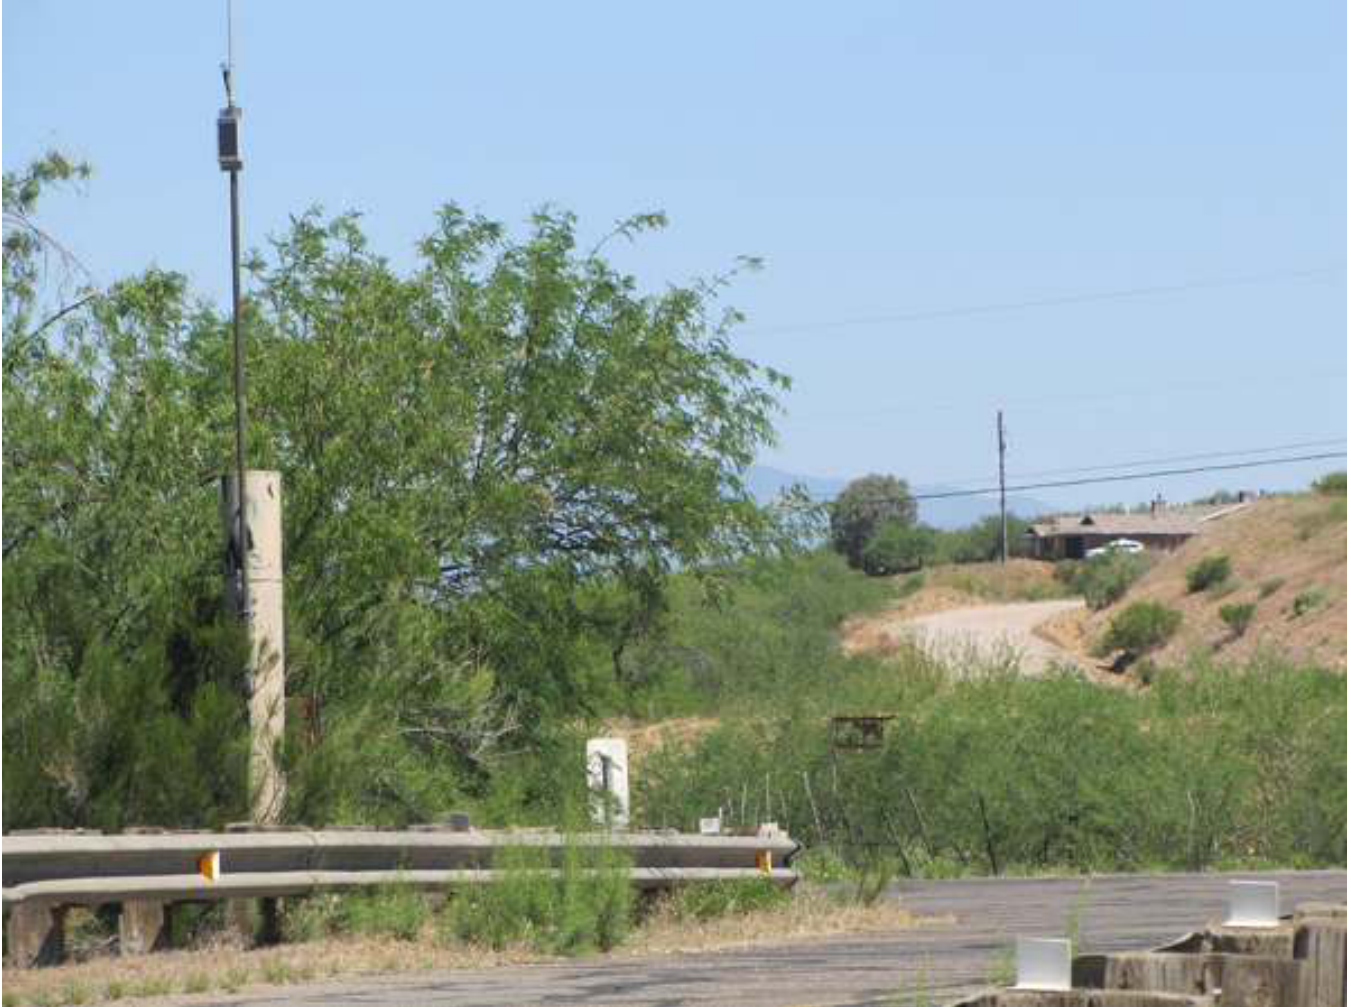
File Name : 08605-2020-05-06-Photo-5.jpg

Description : Bushes encroaching roadway

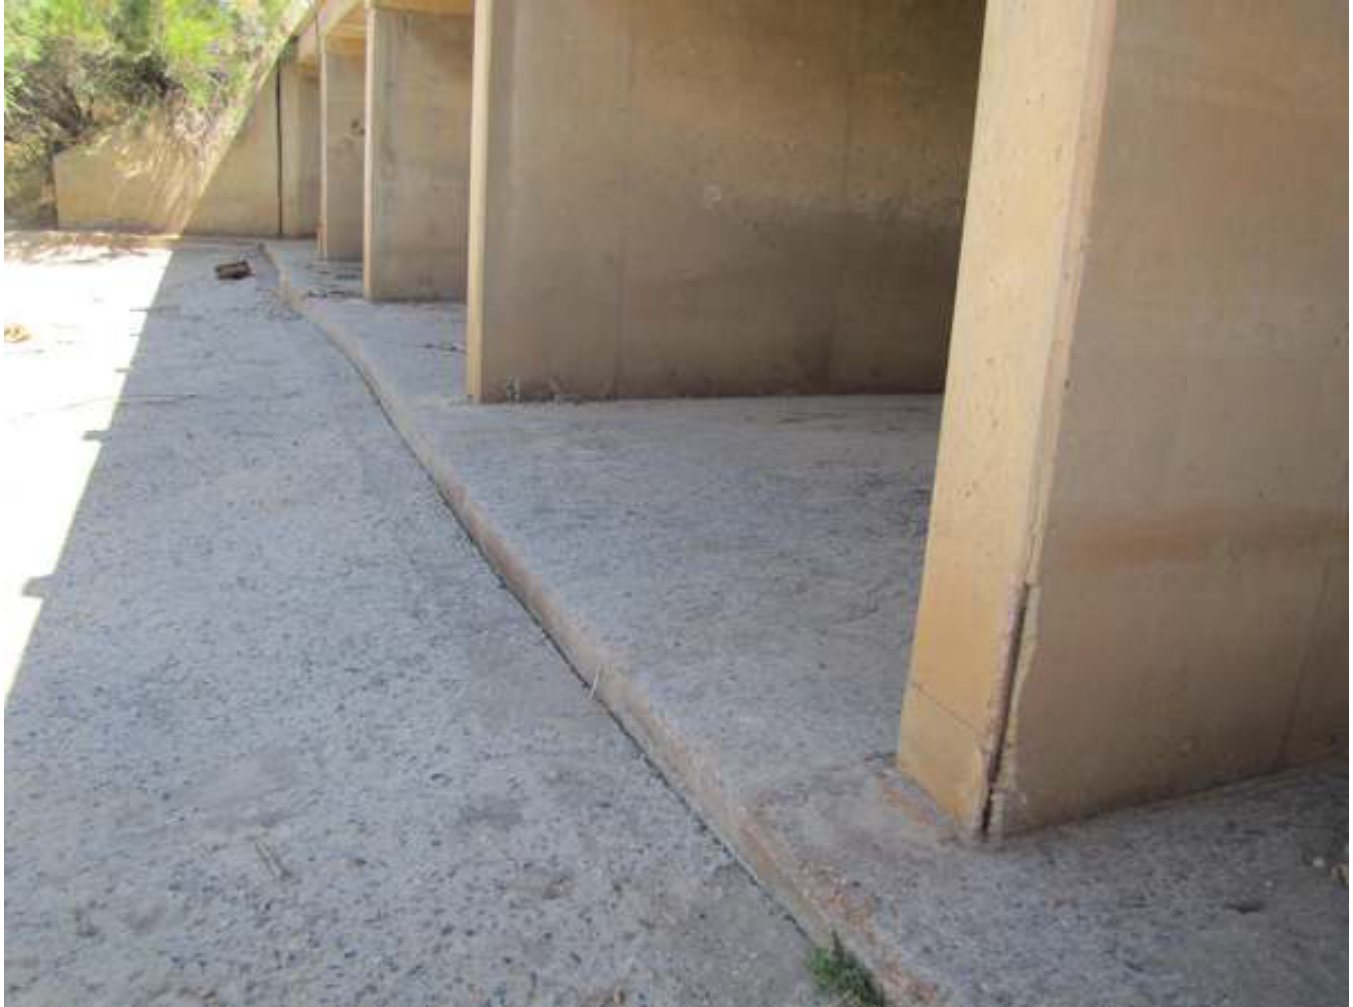
File Name : 08605-2020-05-06-Photo-6.jpg

Description : Rebar exposed at 4th wall from north, at downstream end.

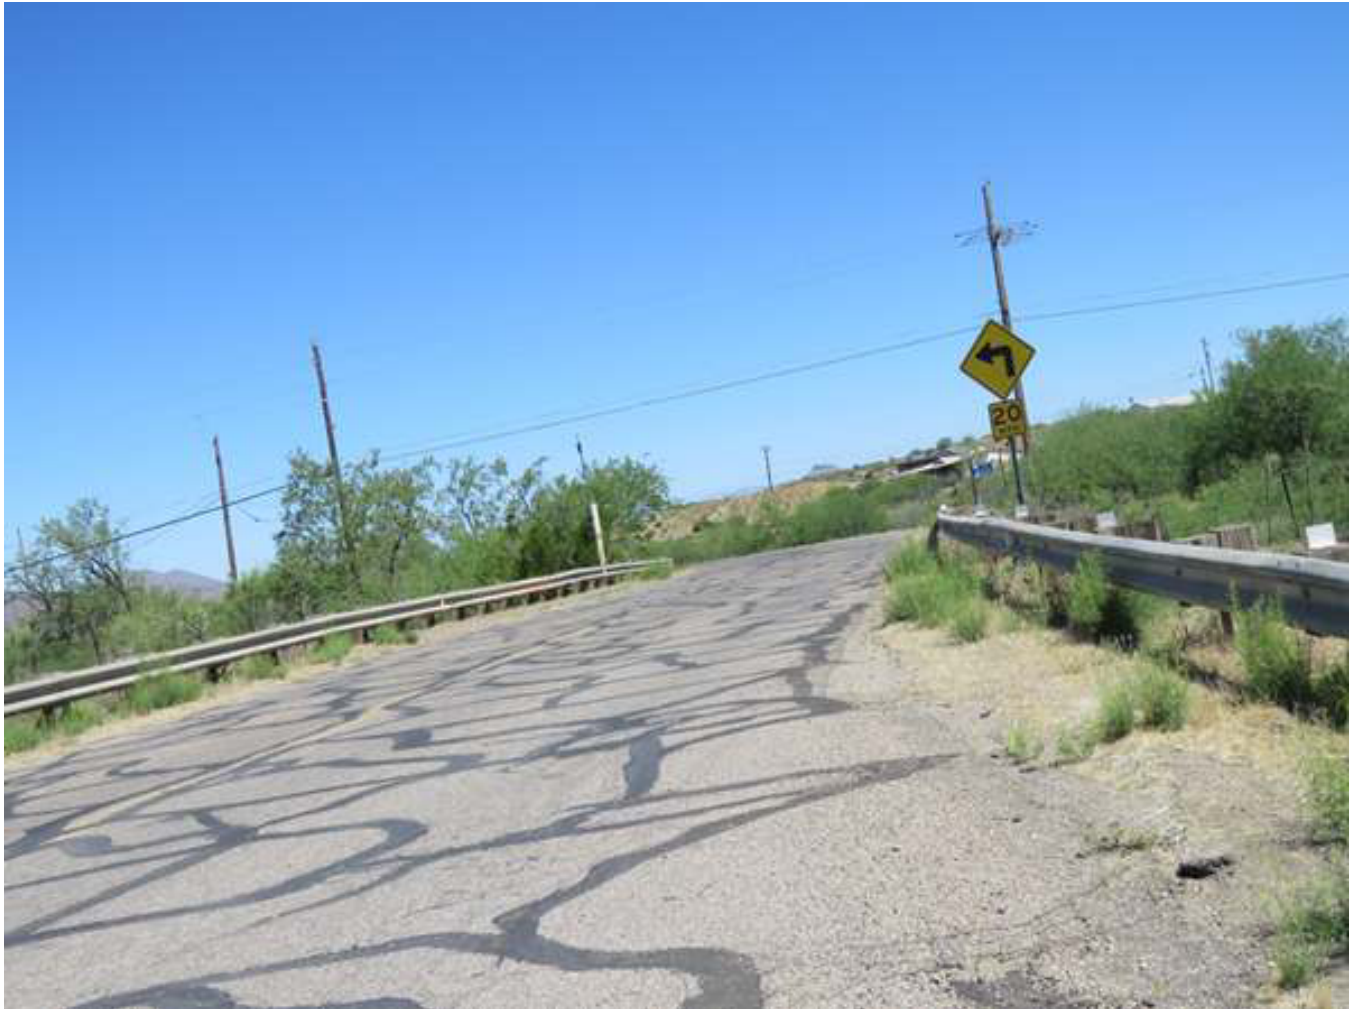
File Name : 08605-2020-05-06-Photo-7.jpg

Description : Missing B/Y marker at northeast corner

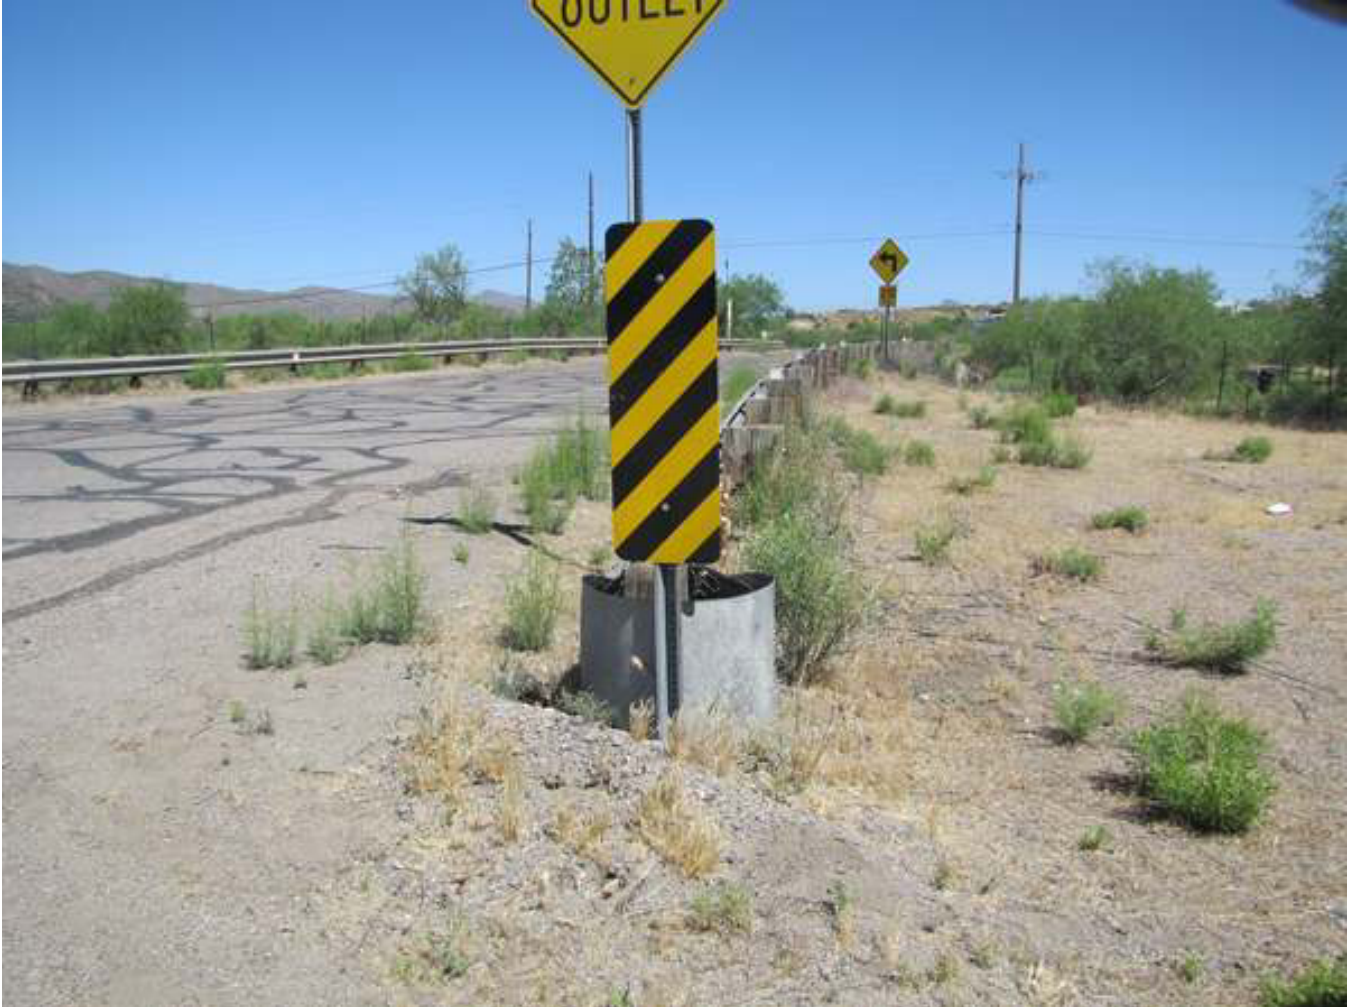
File Name : 08605-2020-05-06-Photo-8.jpg

Description : Guardrail height very low to the ground

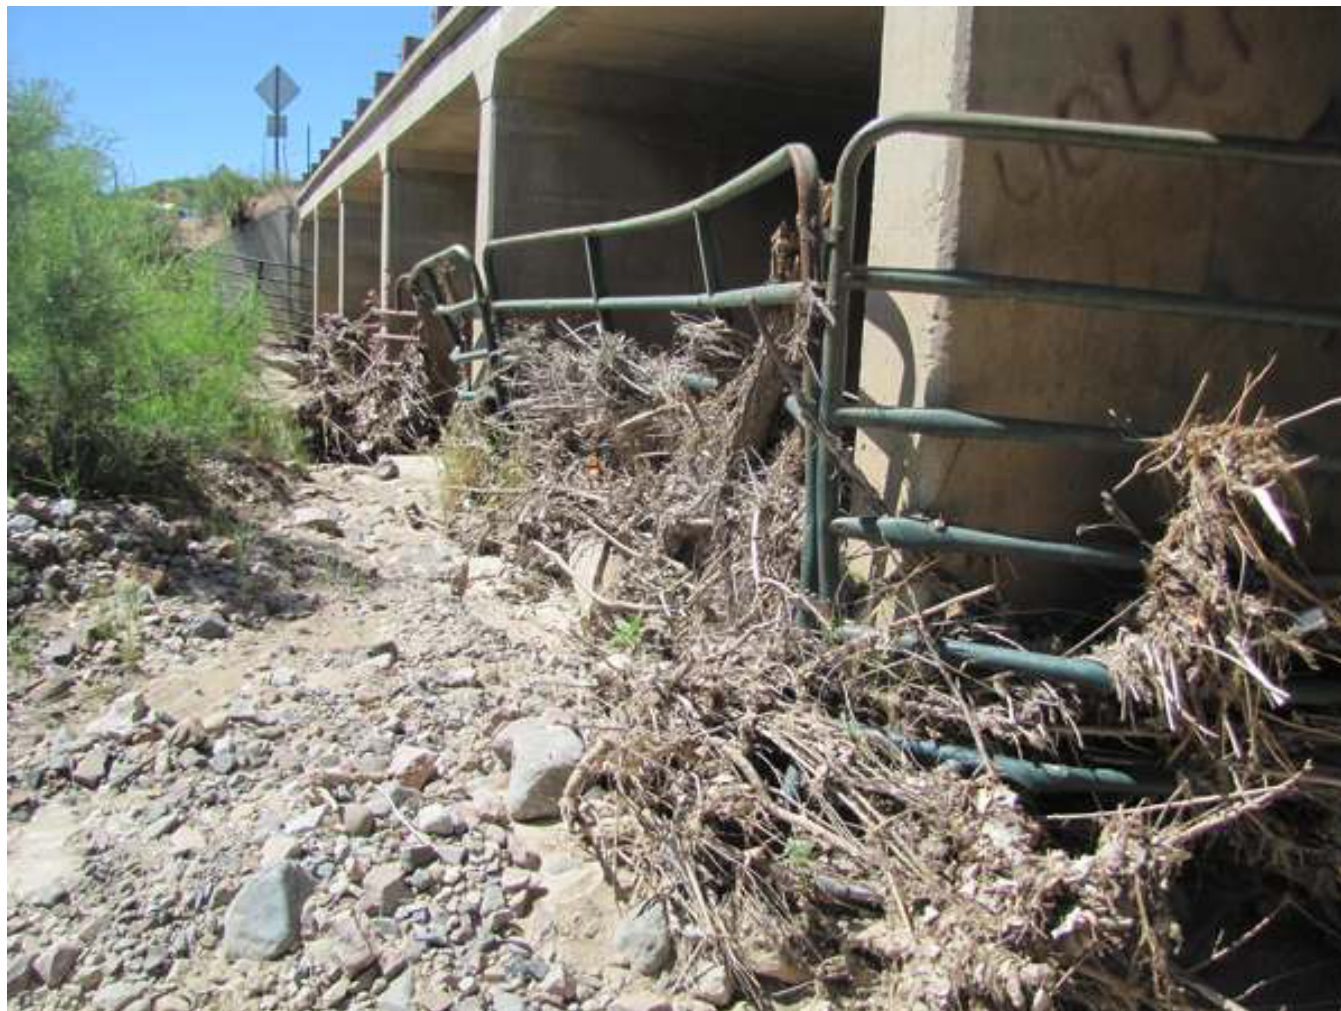
File Name : 08605-2020-05-06-Photo-9.jpg

Description : Inlet gate damaged and debris piled up against inlet gate
