Bridge Inspection Photographs

Structure Number :	08914	Structure Name :	Icehouse Canyon Br # 3	Inspected by :	ADOT-Zapata/Kazmi
Route :	0	Road Name :	Alamo Way	Inspection Type:	Routine
MP :	0	Agency :	Gila Co	Inspection Date :	Monday, May 4, 2020
ADOT District:	Southeast			Next Insp. Due By :	05/04/2022

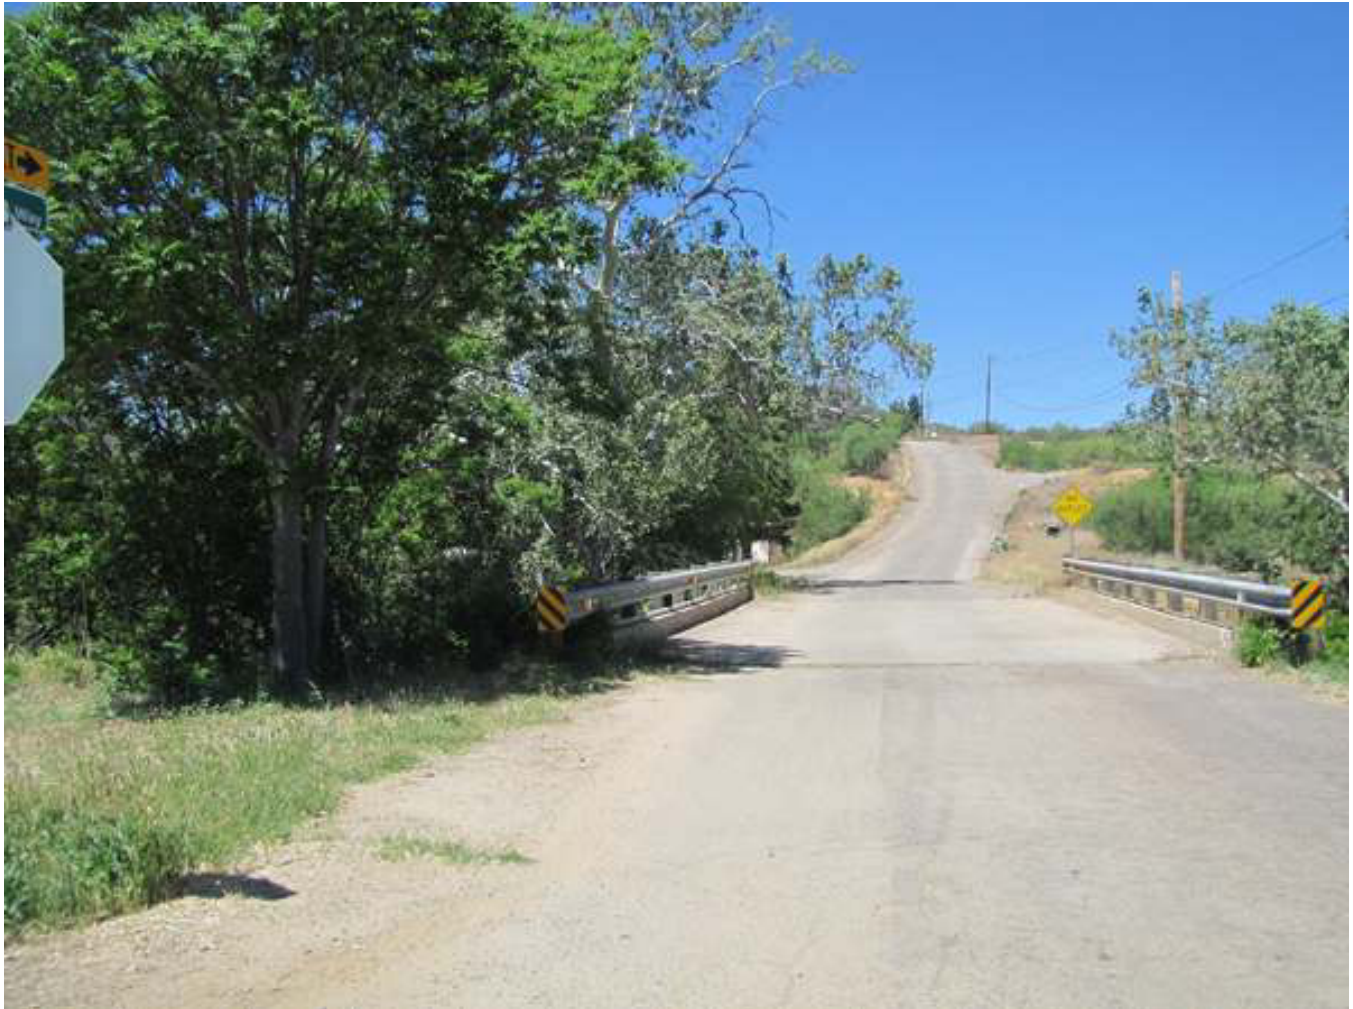
File Name : 08914-2020-05-06-Photo-1.jpg

Description : Roadway ID looking West

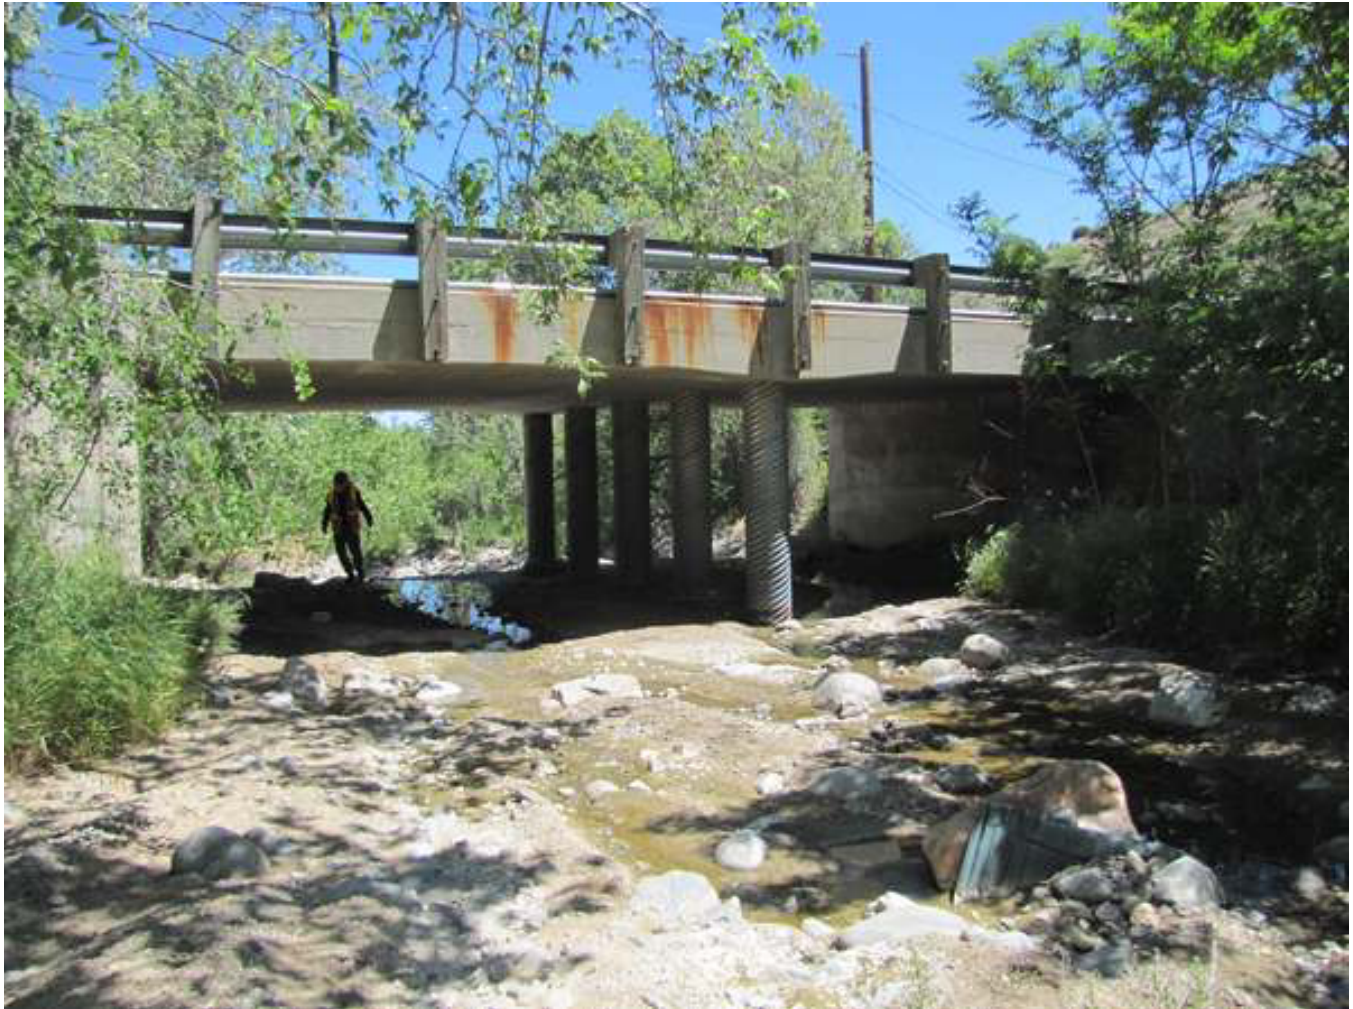
File Name : 08914-2020-05-06-Photo-2.jpg

Description : Elevation ID looking Downstream (N)

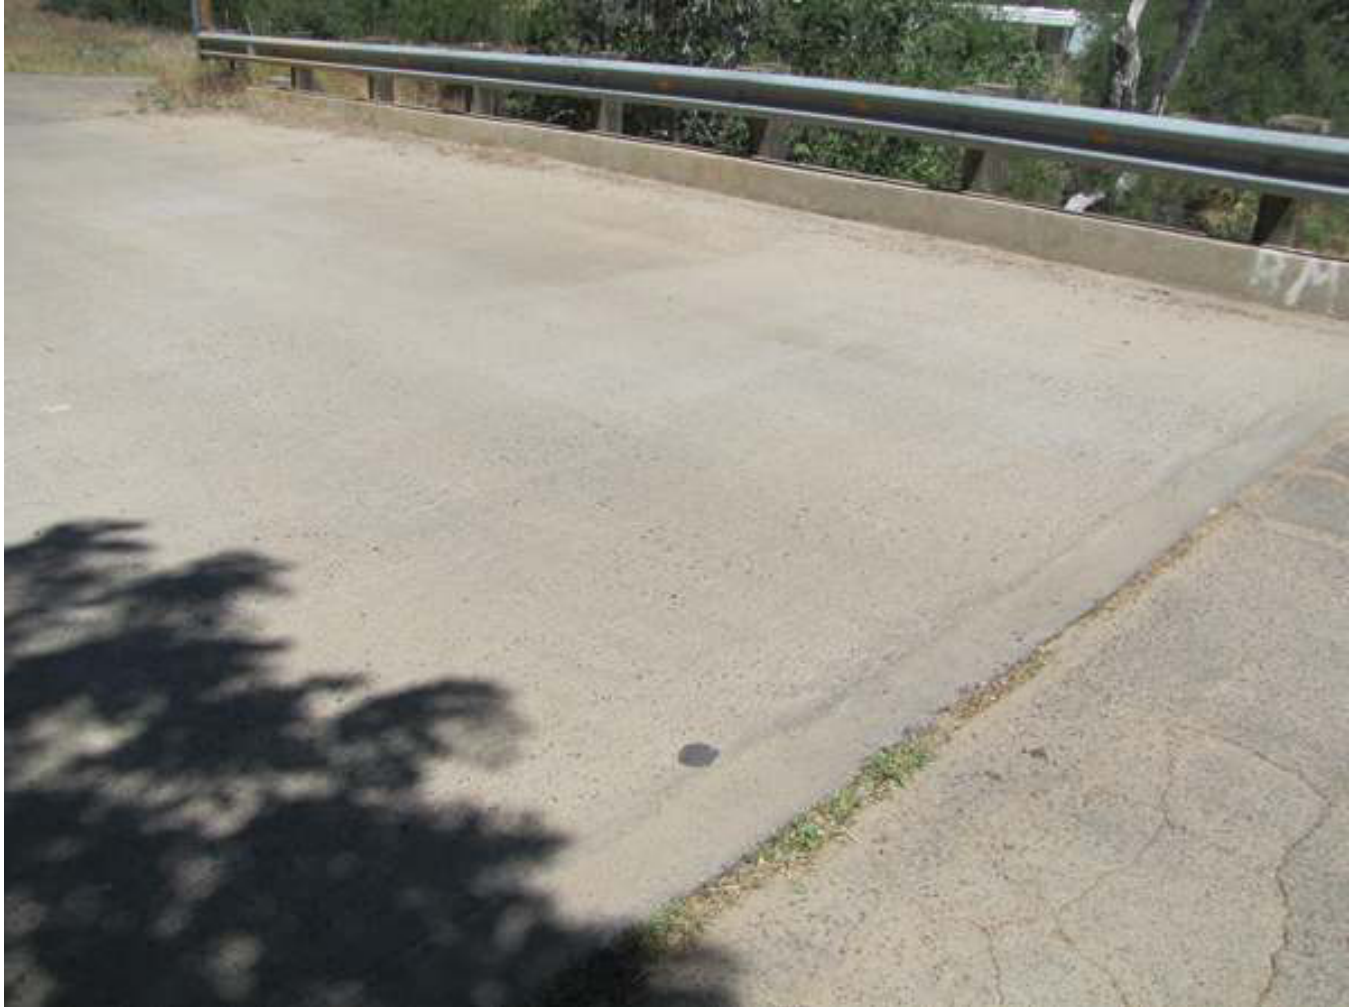
File Name : 08914-2020-05-06-Photo-3.jpg

Description : Deck Top

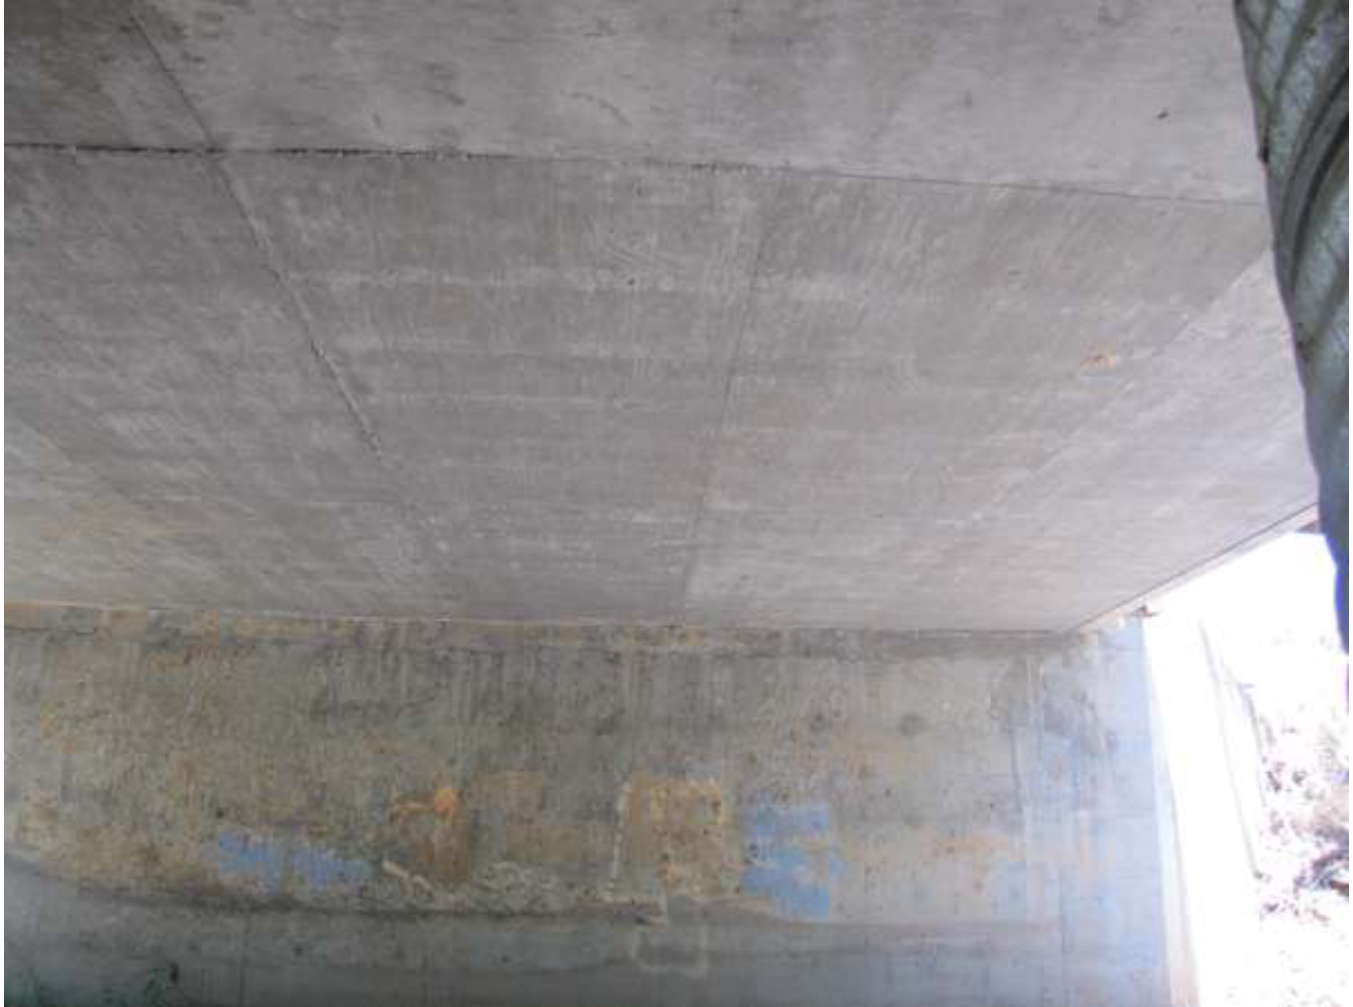
File Name : 08914-2020-05-06-Photo-4.jpg

Description : Soffit

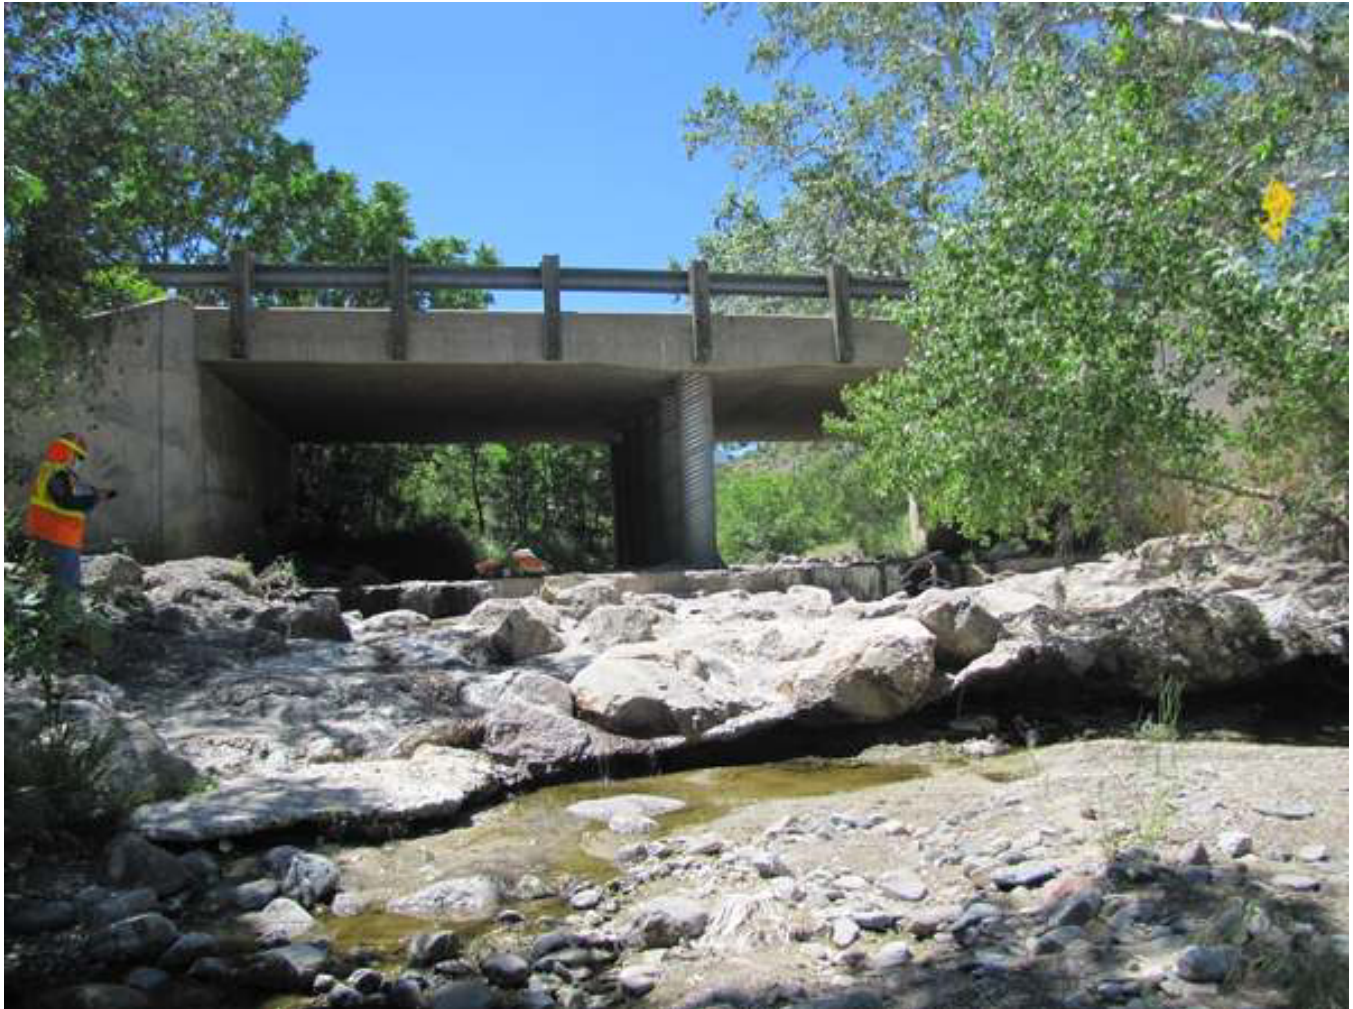
File Name : 08914-2020-05-06-Photo-5.jpg

Description : Elevation ID looking upstream (s)
