Structure Inventory and Appraisal

Structure Number : 10839    Structure Name : Bloody Tanks Wash Bridge    Feature Under : Bloody Tanks Wash  
 Route :    MP :    Road Name : Schulze Ranch Rd    Agency: Gila Co    Location : 150 ft S Jct US 60

## Inspection Report

Structure No. : 10839    Structure Name : Bloody Tanks Wash Bridge    Inspected by : Stantec-Cressman/Woodburn  
 Route :                    Road Name : Schultze Ranch Rd                    Inspection Type: In-Depth  
 MP :                        Agency : Gila Co                                    Inspection Date : Friday, May 29, 2020  
 ADOT District: Southeast                                    Next Insp. Due By : May 2022

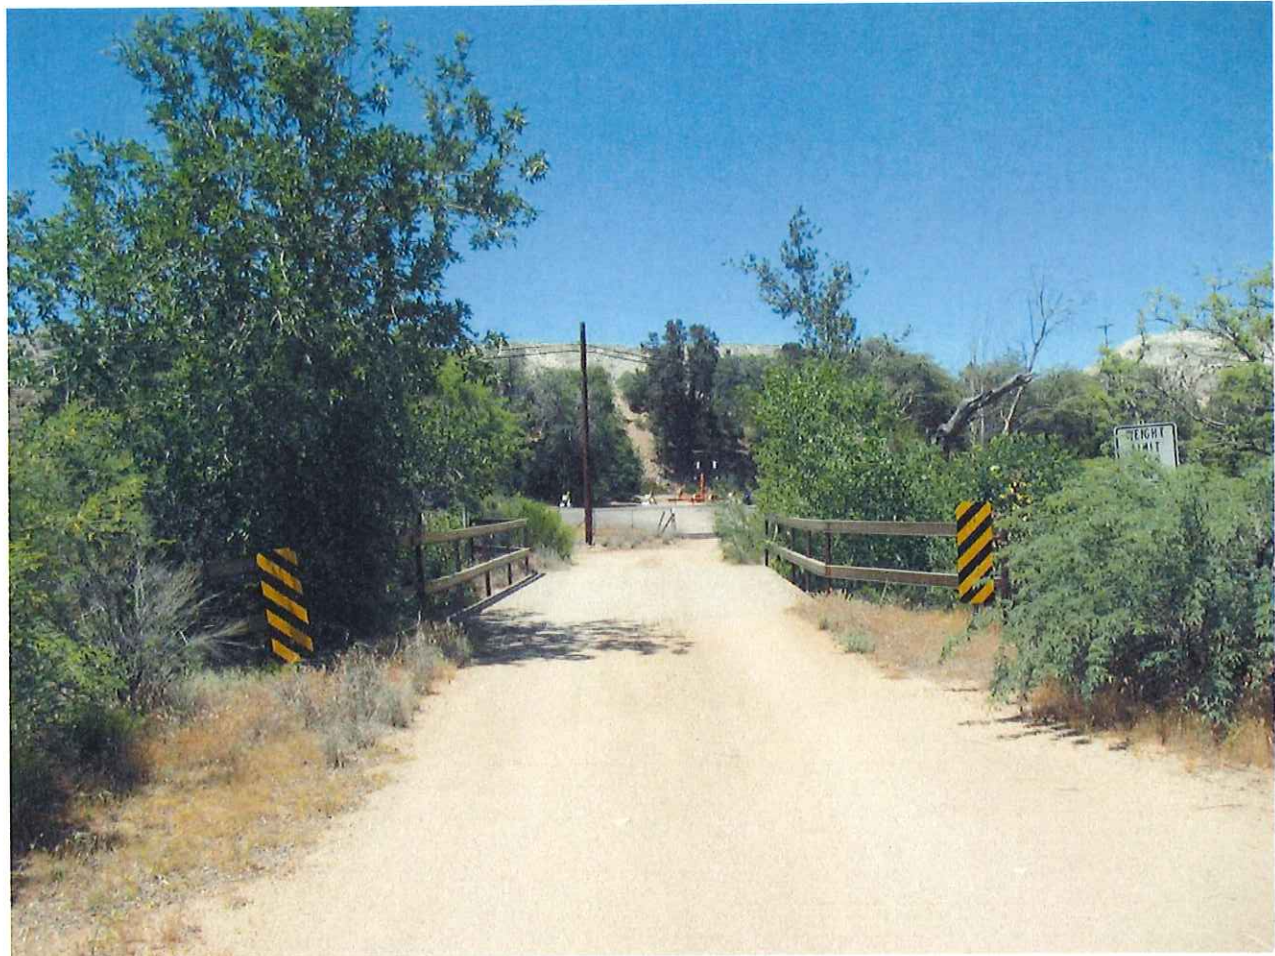
File Name : 10839-2020-05-29-Photo-a.JPG

Description : Roadway ID looking north

<b>Work Candidate ID:</b> 508C6CE-2037-052318-DDDBD97DEA	<b>A216 - Actual Completion Cost</b>	\$ <input type="text"/>
<b>Action:</b> 1056 Misc-Remove Vegetation	<b>A215 - Completion Date:</b>	<input type="text"/>
<b>Estimated Quantity:</b>		
<b>Estimated Cost:</b> \$0.00		
<b>A212 - Repair Priority:</b> 3-Can be scheduled		
Remove vegetation growing over bridge and covering object markers and load posting signs (Photos A, E, and F).

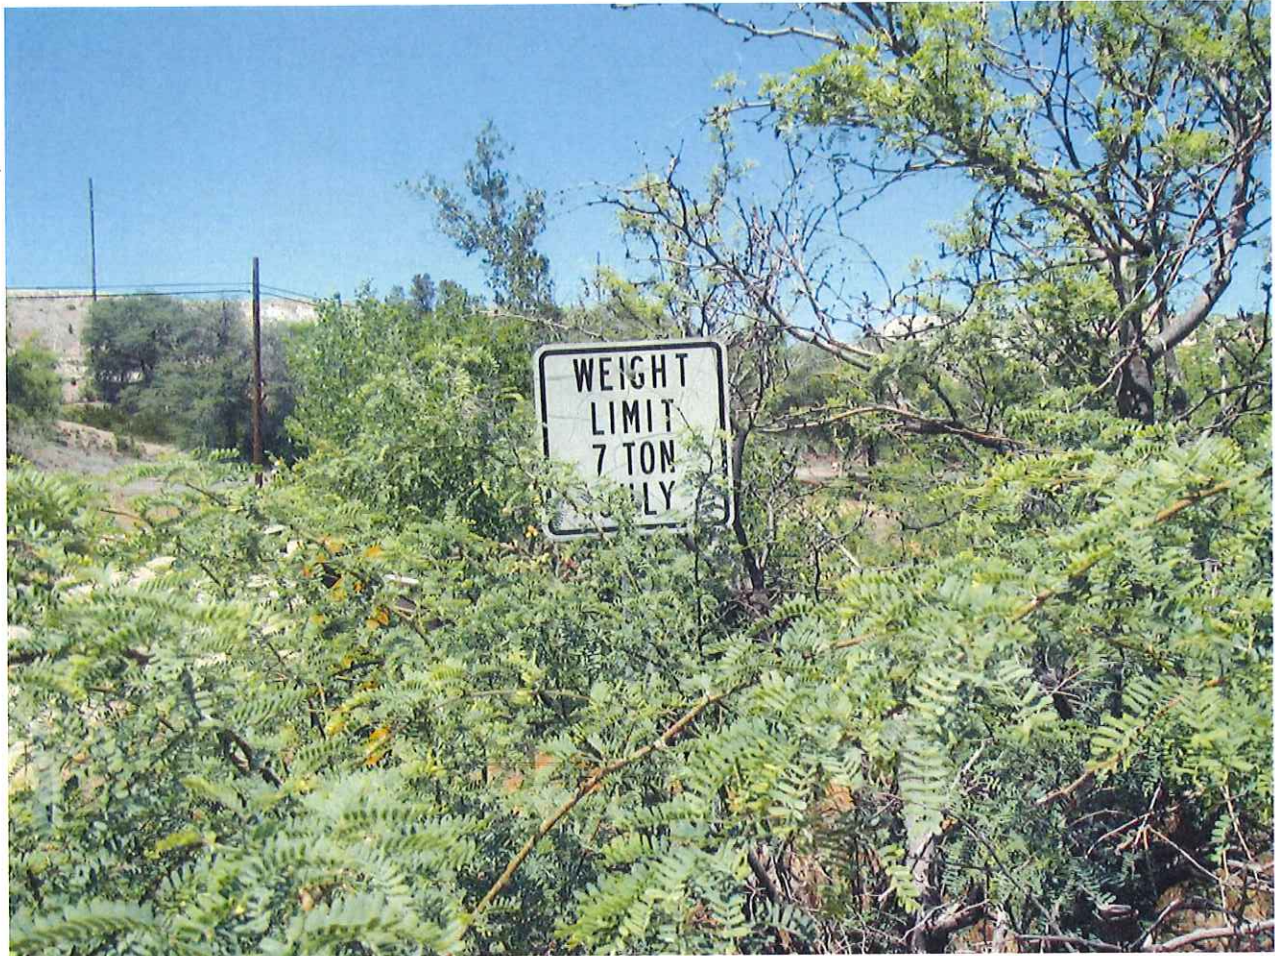
File Name : 10839-2020-05-29-Photo-e.JPG

Description : Load posting sign at south approach

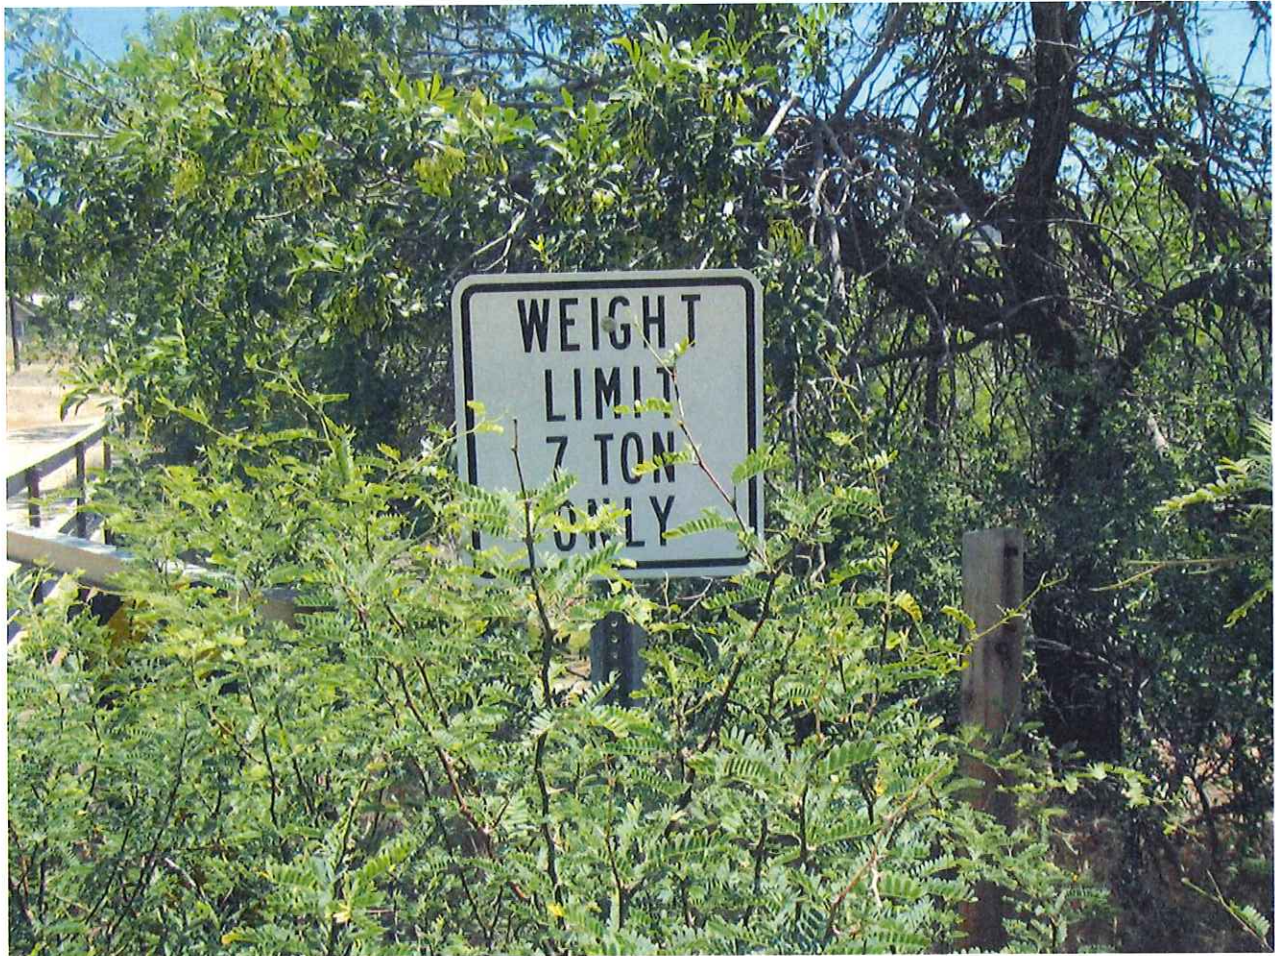
File Name : 10839-2020-05-29-Photo-f.JPG  
Description : Load posting sign at north approach

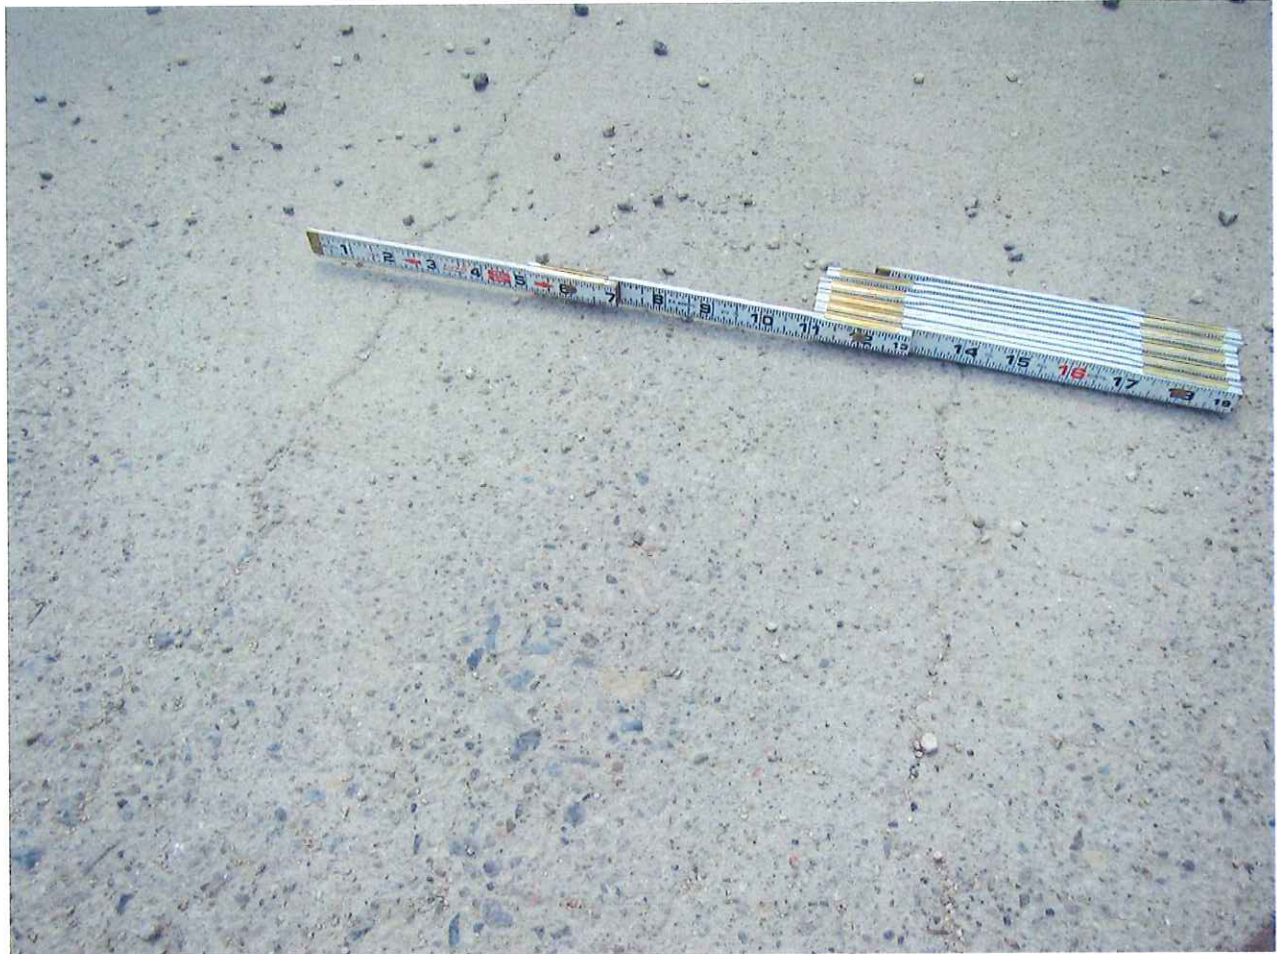
File Name : 10839-2020-05-29-Photo-g.JPG

1. North and south top edges of the deck exhibit small corner spalls.								
1130	Cracking (RC and Other)	40.00	sq.ft	2.00	0	40	0	0
1. Top of deck and soffit exhibit hairline to moderate sized transverse, longitudinal, and random cracks (Photo G).								
1190	Abrasion(PSC/RC)	136.00	sq.ft	2.00	0	136	0	0

Description : Transverse cracks in deck

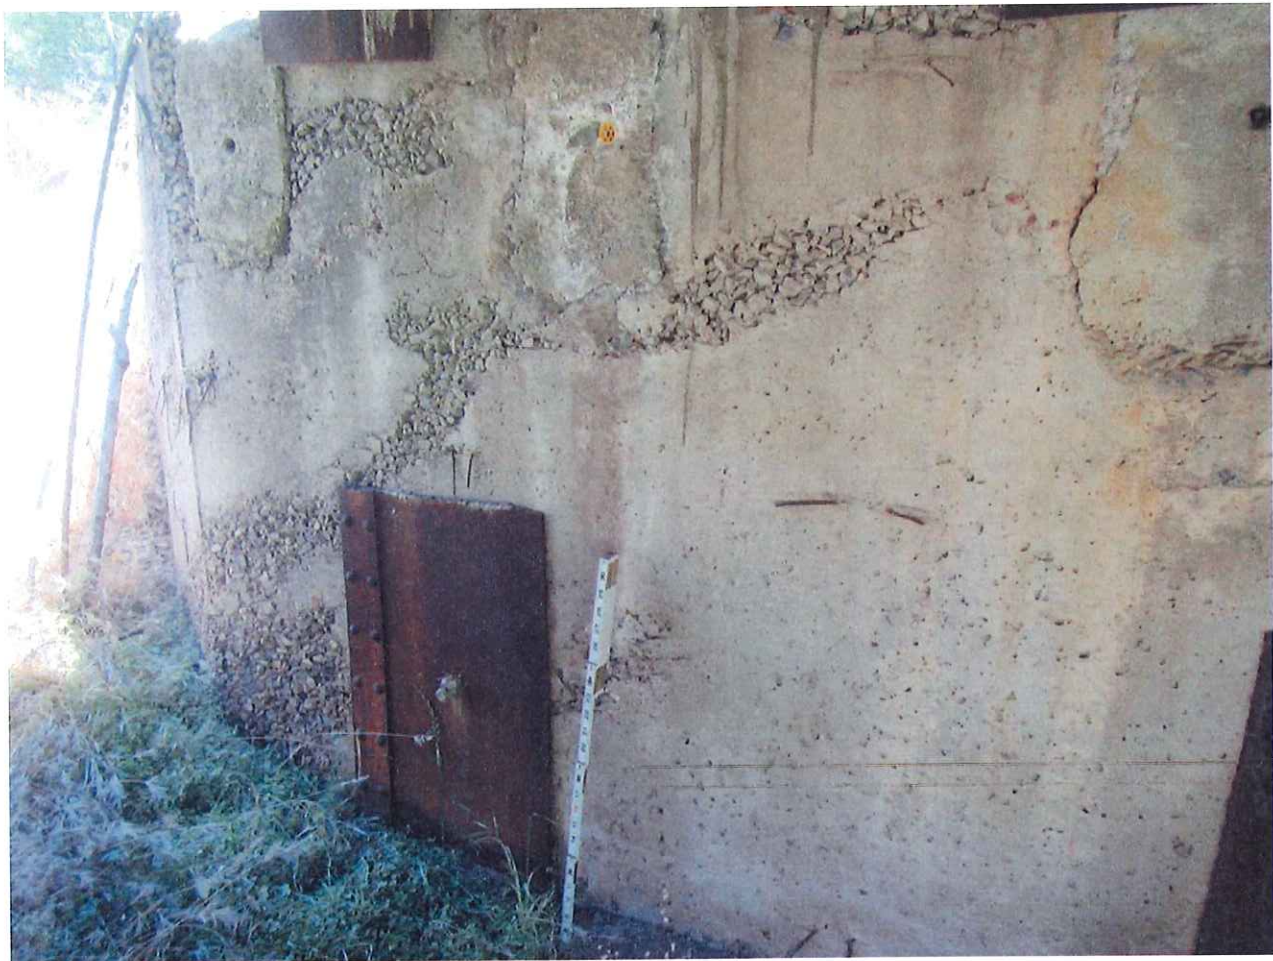
File Name : 10839-2020-05-29-Photo-h.JPG

1. Both abutments exhibit honeycombing throughout (Photo H).								
(Full quantity of CS2=72 not represented in condition states to eliminate double counting).								
1190	Abrasion(PSC/RC)	18.00	ft	2.00	0	18	0	0

Description : Honeycombing in Abutment 1

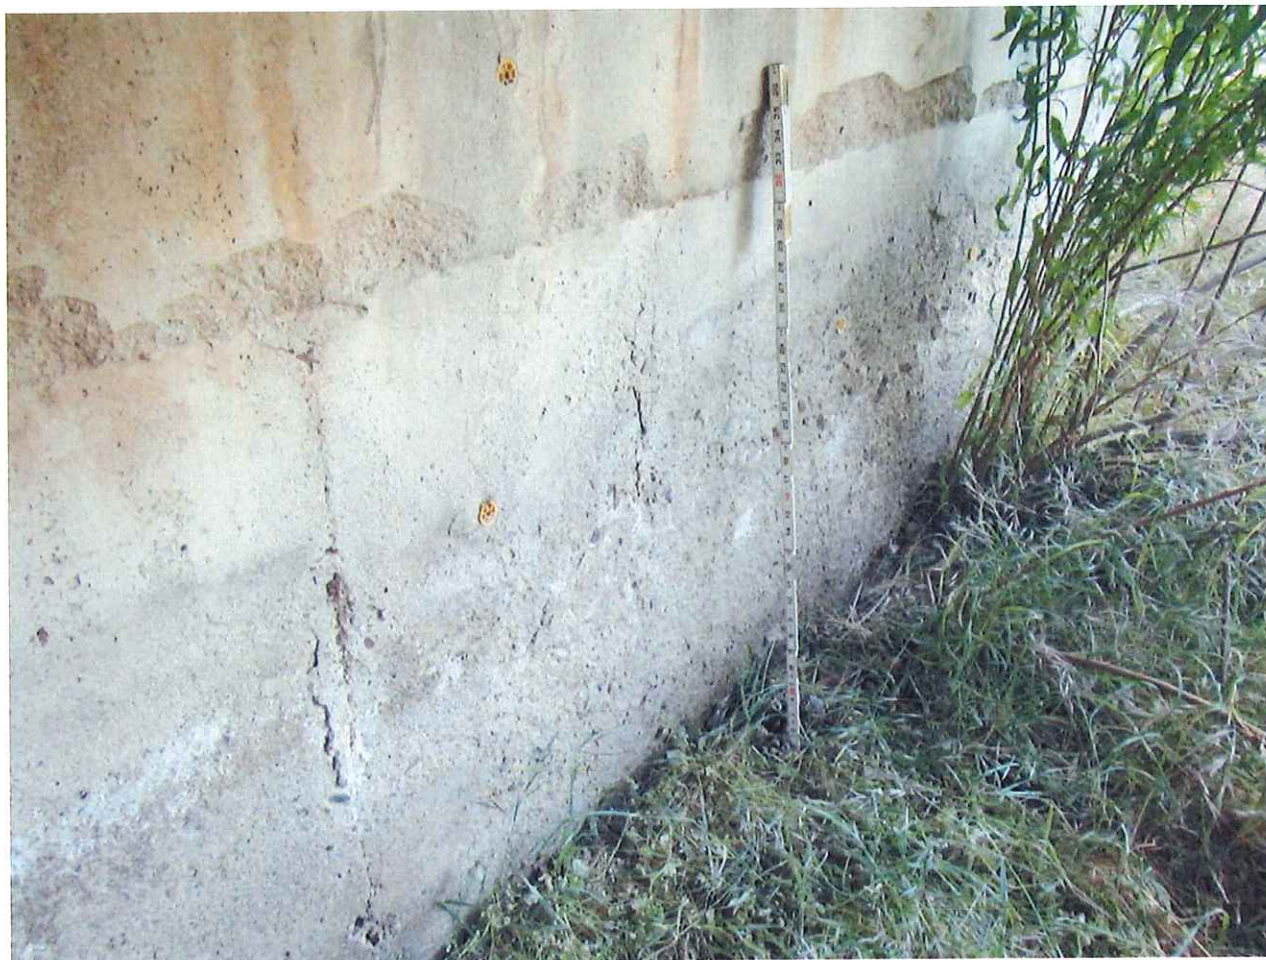
File Name : 10839-2020-05-29-Photo-i.JPG

1. West half of Abutment 1 and east half of Abutment 2 exhibit light stream abrasion.								
(Full quantity of CS2=36 not represented in condition states to eliminate double counting).								
4000	Settlement	18.00	ft	2.00	0	0	18	0

Description : Stream abrasion in Abutment 1

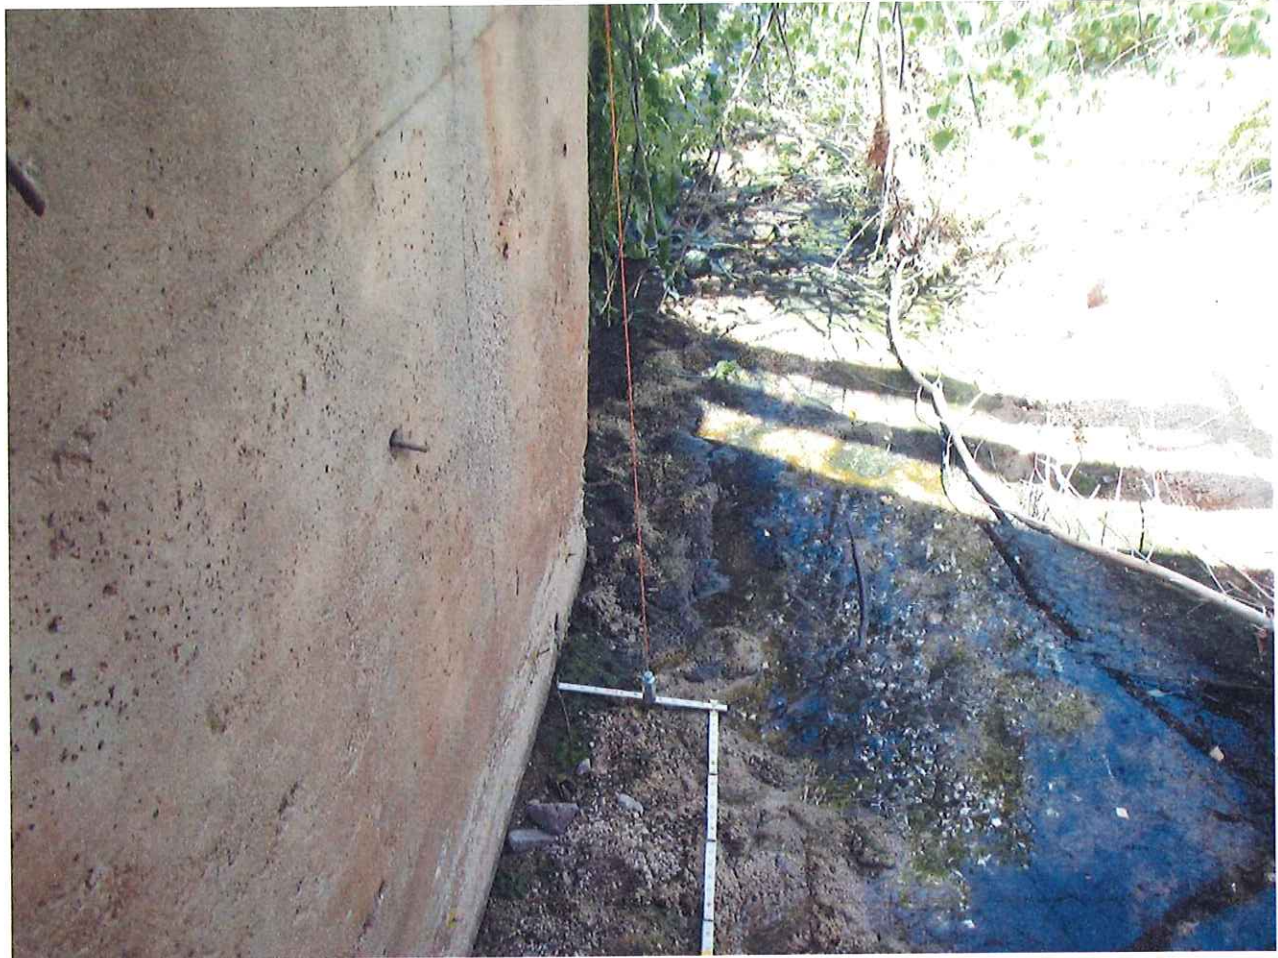
File Name : 10839-2020-05-29-Photo-j.JPG

1. East half of Abutment 1 has settled and is pushing towards channel up to 7" at top (See Repair Report and Photos J and K).								
a. Settlement has caused the (2) halves of Abutment 2 to separate, up to 1", at construction joint at centerline (Photo L).								
NOTE: Due to settlement of Abutment 2, N60 was lowered from 6 to 5.								
330	Metal Bridge Railing	68.00	ft	2.00	58	10	0	0
38" high rail consisting of (2) aluminum I-beam rails on 2" diameter steel tube posts. Rails are inadequate for vehicular traffic.

Description : East half of Abutment 2 leaning at top, overview

<b>Work Candidate ID:</b>	508C6CE-6D3D-061920-62A9A752FD	<b>A216 - Actual Completion Cost</b>	\$ <input type="text"/>
<b>Action:</b>	1071 Substructure-Rehab	<b>A215 - Completion Date:</b>	<input type="text"/>
<b>Estimated Quantity:</b>			
<b>Estimated Cost:</b>	\$0.00		
<b>A212 - Repair Priority:</b>	2-Priority over routine		
<b>Repair settlement affecting east half of Abutment 2 (Photos J, K, and L).</b>

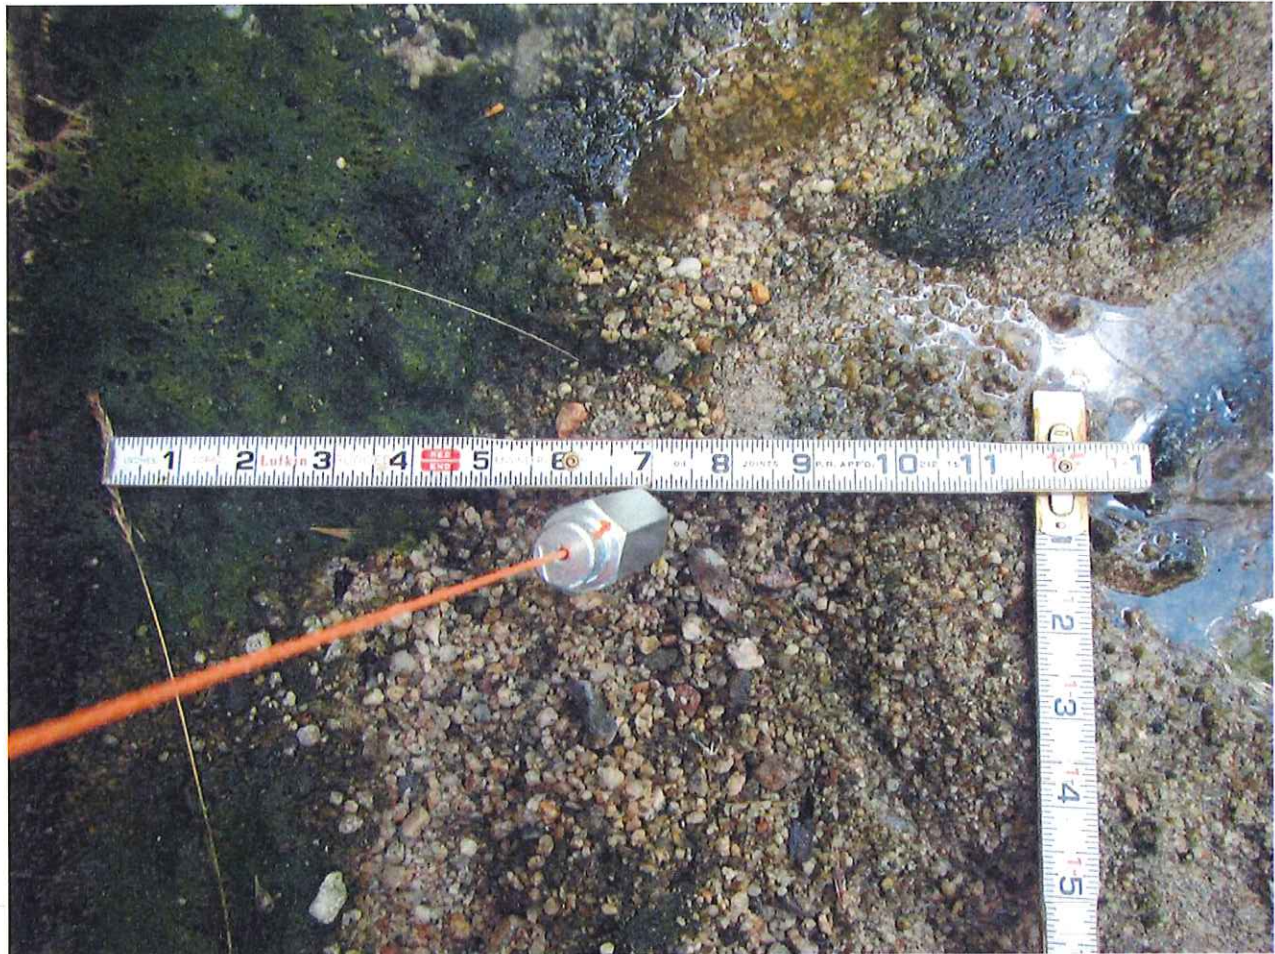
File Name : 10839-2020-05-29-Photo-k.JPG

Description : East half of Abutment 2 leaning at top, close up

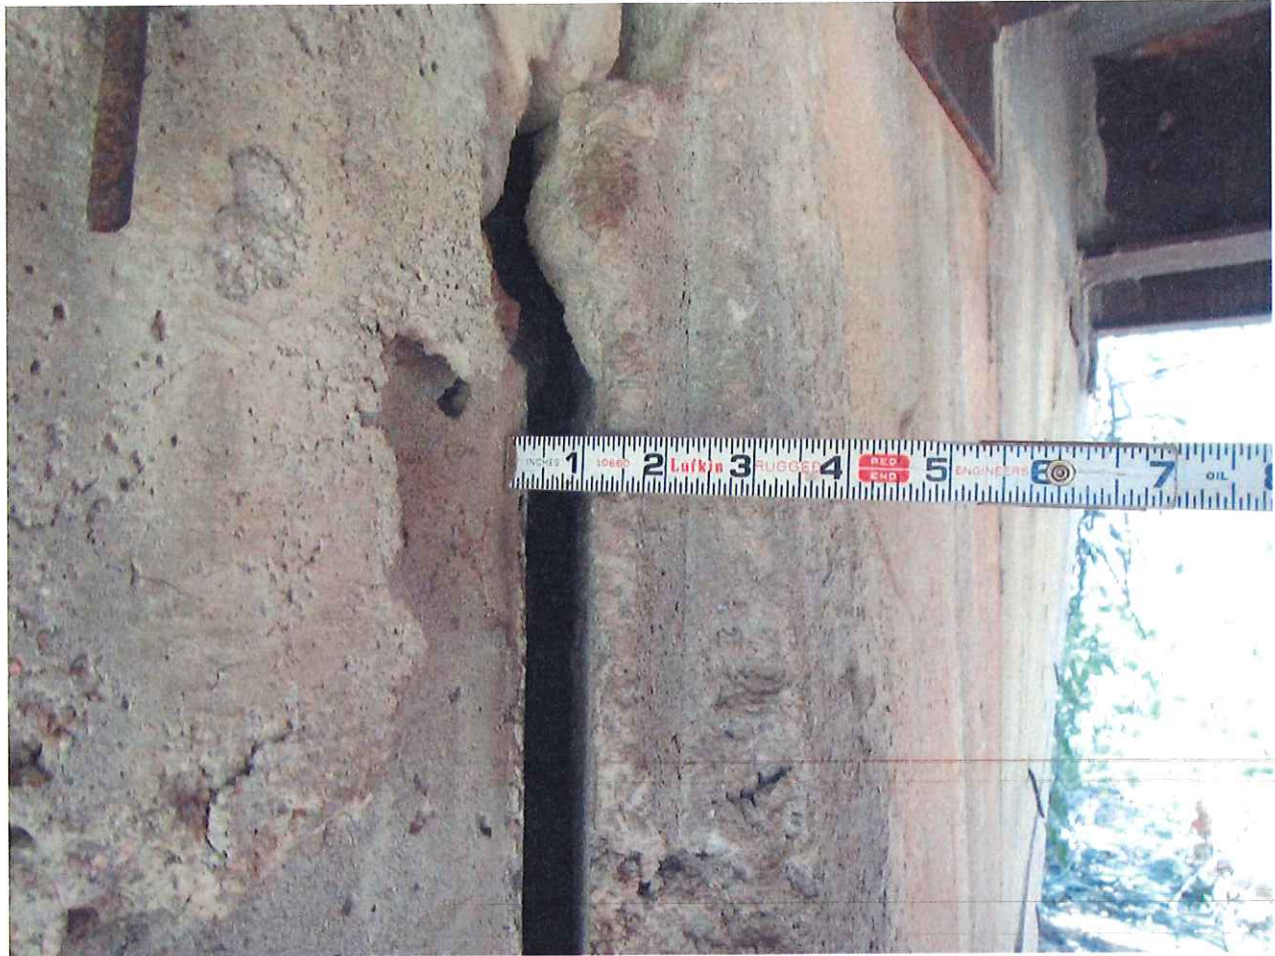
File Name : 10839-2020-05-29-Photo-1.JPG

Description : View showing no change in gap at construction joint in Abutment 2
