**BRIDGE GROUP**

Bridge Inspection Photographs

Structure Number :	<b>08197</b>	Structure Name :	<b>Icehouse Canyon Br 2</b>	Inspected by :	<b>ADOT-Zapata/Kazmi</b>
Route :	<b>0</b>	Road Name :	<b>Pinal View Drive</b>	Inspection Type:	<b>Routine</b>
MP :	<b>0</b>	Agency :	<b>Gila Co</b>	Inspection Date :	<b>Monday, May 4, 2020</b>
ADOT District:	<b>Southeast</b>			Next Insp. Due By :	<b>05/04/2022</b>

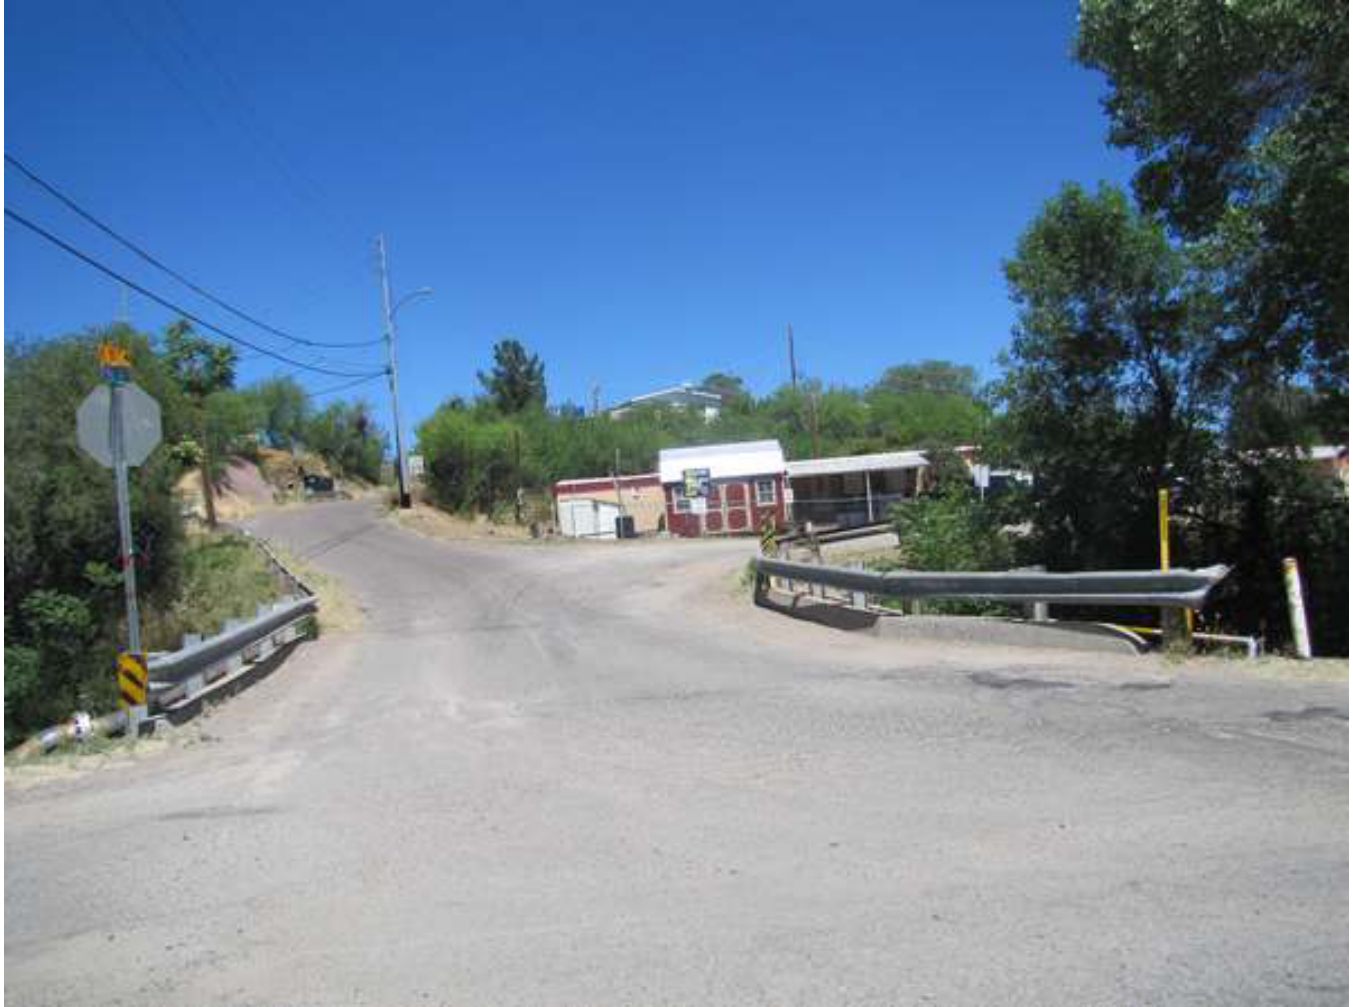
File Name : 08197-2020-05-06-Photo-1.jpg

Description : Roadway ID looking West

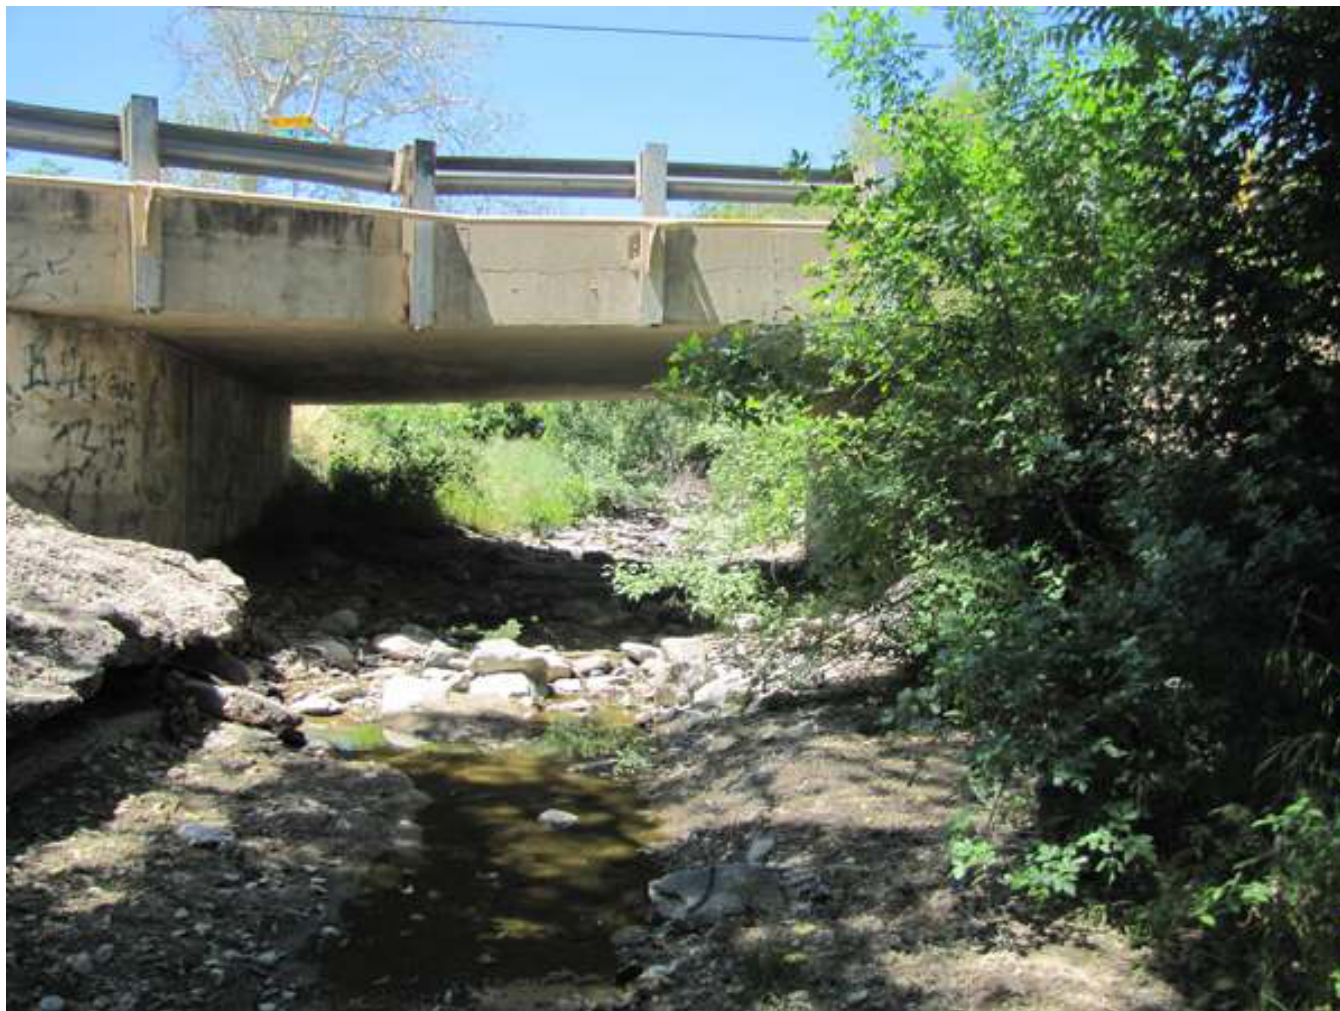
File Name : 08197-2020-05-06-Photo-2.jpg

Description : Elevation ID looking U/S (S)

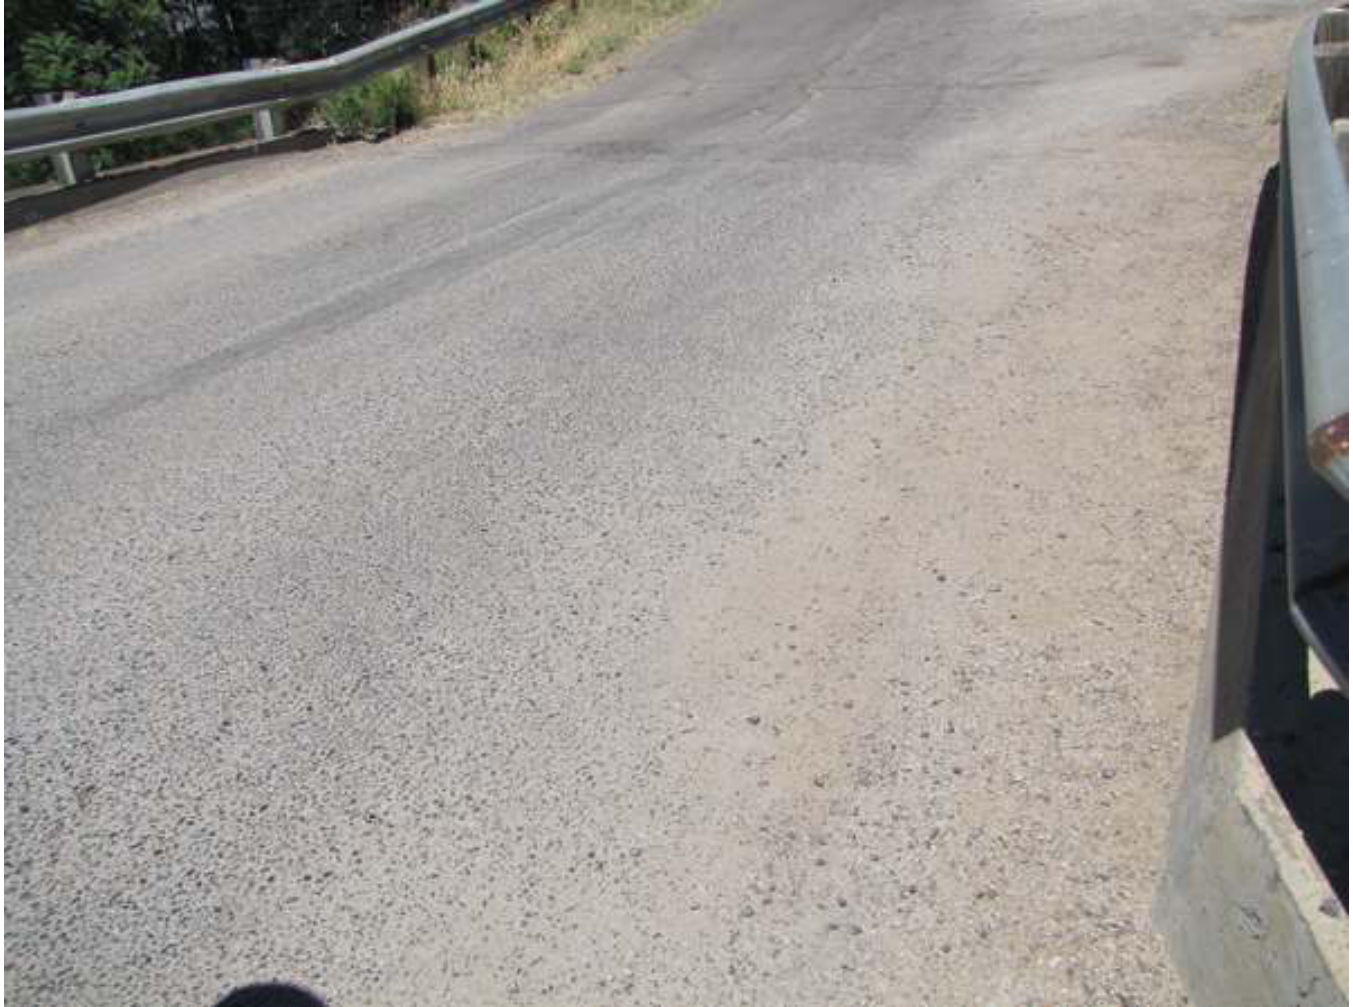
File Name : 08197-2020-05-06-Photo-3.jpg

Description : Deck Top

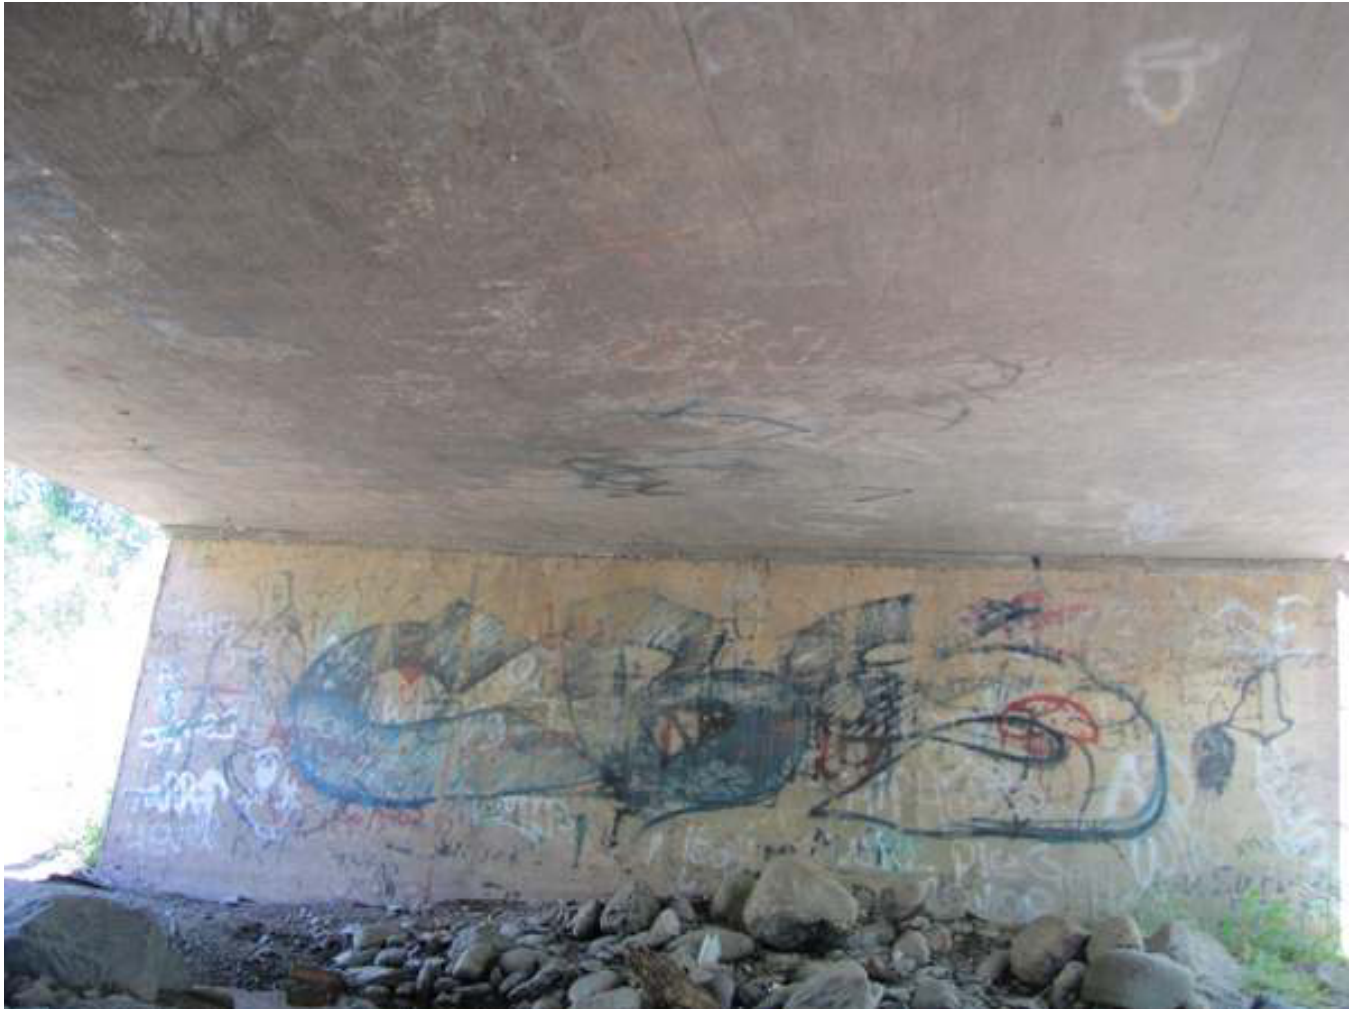
File Name : 08197-2020-05-06-Photo-4.jpg

Description : Soffit

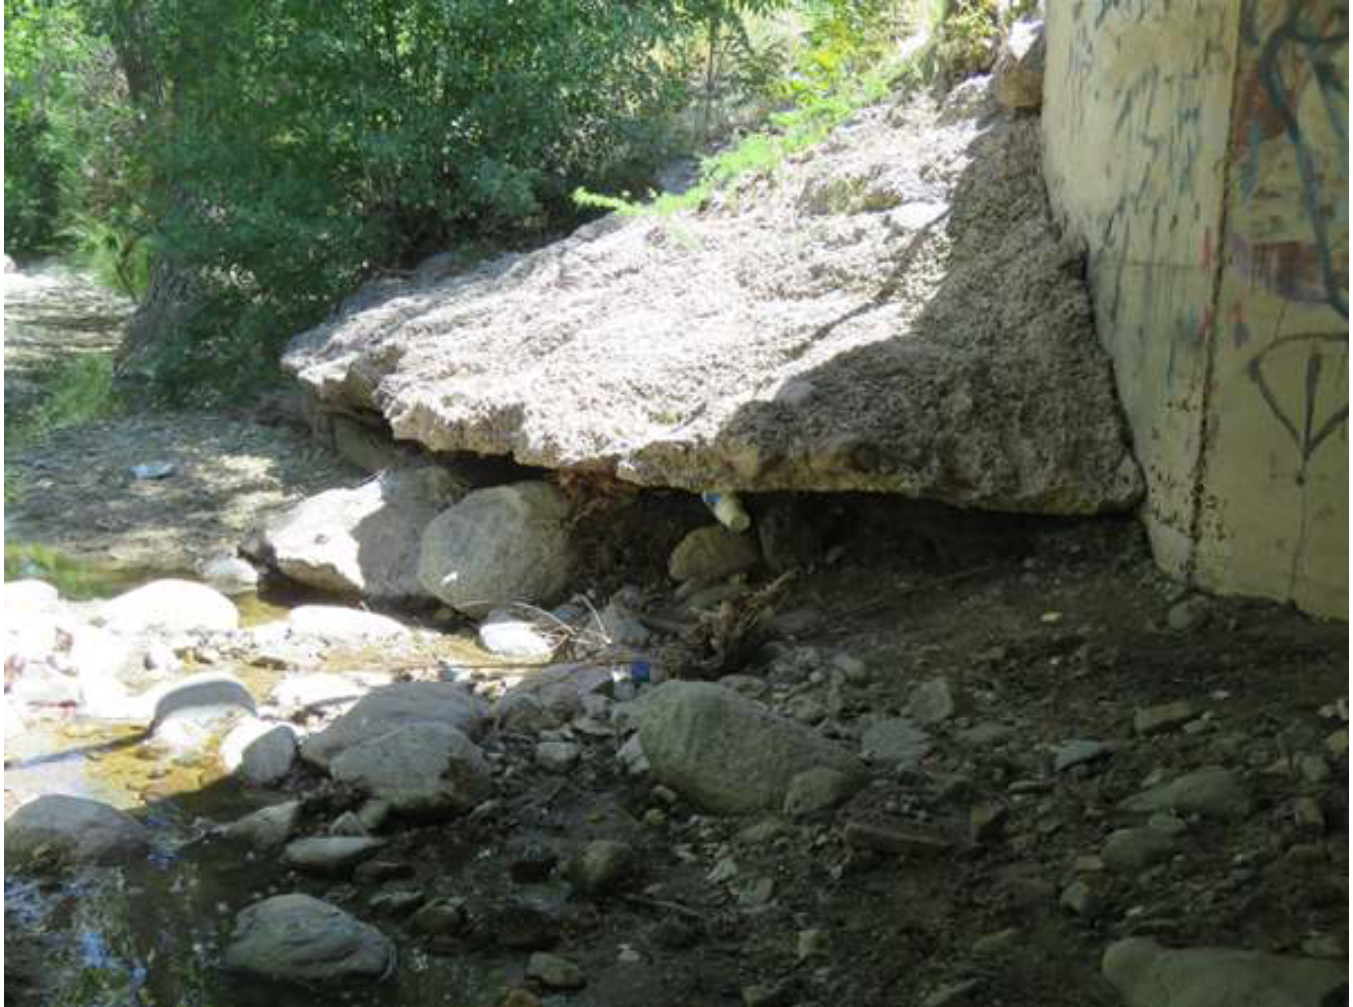
File Name : 08197-2020-05-06-Photo-5.jpg

Description : Northeast slope protection undermined

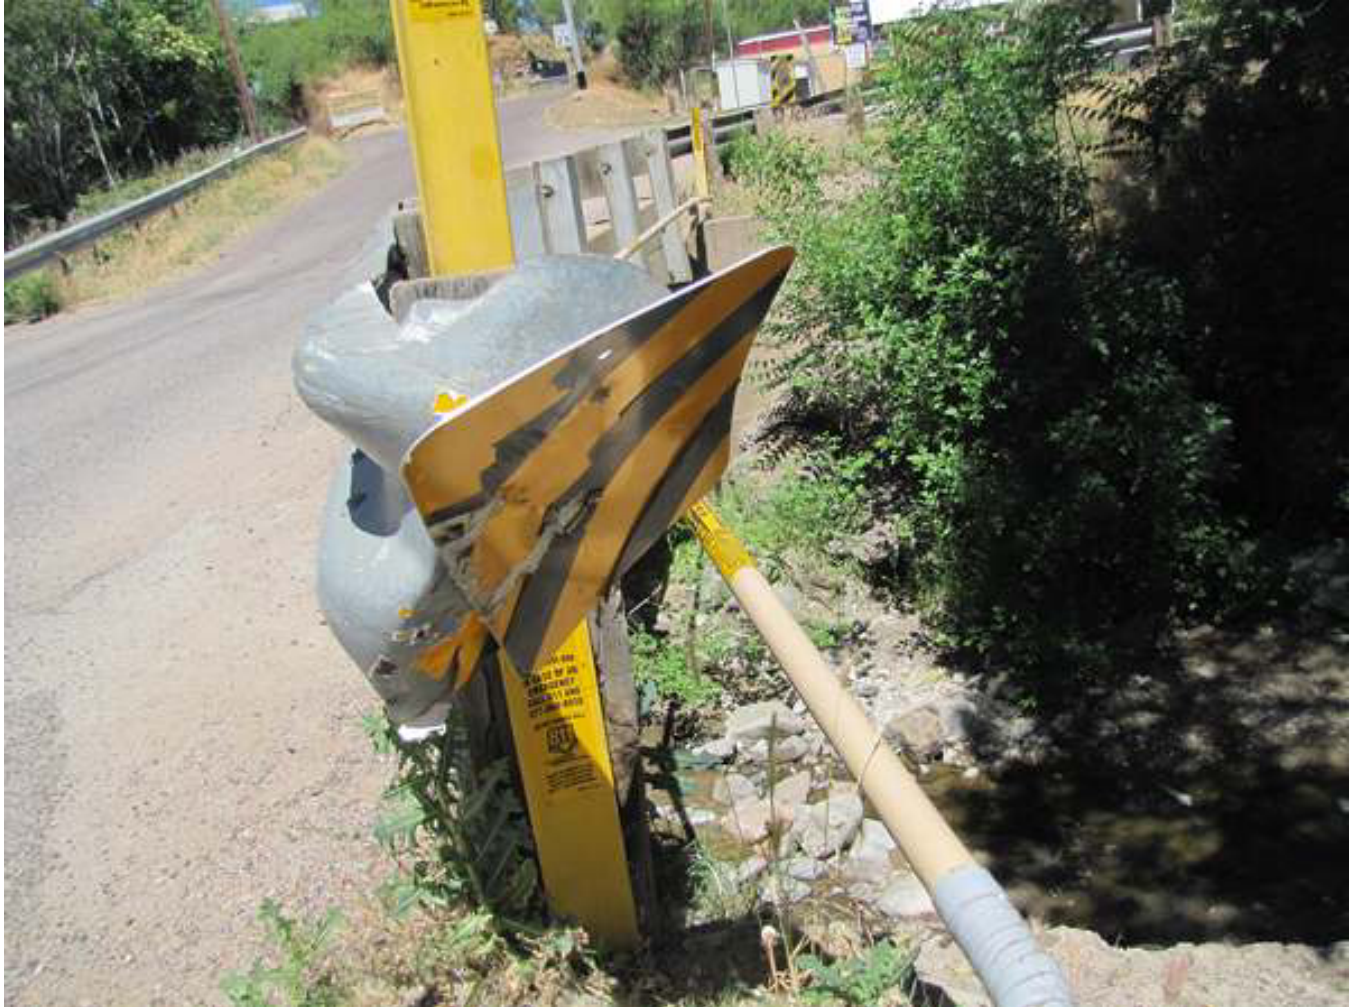
File Name : 08197-2020-05-06-Photo-6.jpg

Description : B/Y marker on northeast corner damaged
