Level II HAER Documentation of the Historic Control Road (FR 64) and its Associated Features, Payson Ranger District, East of Payson, Gila County, Arizona

December 2011

LSD Technical Report No. 115042a

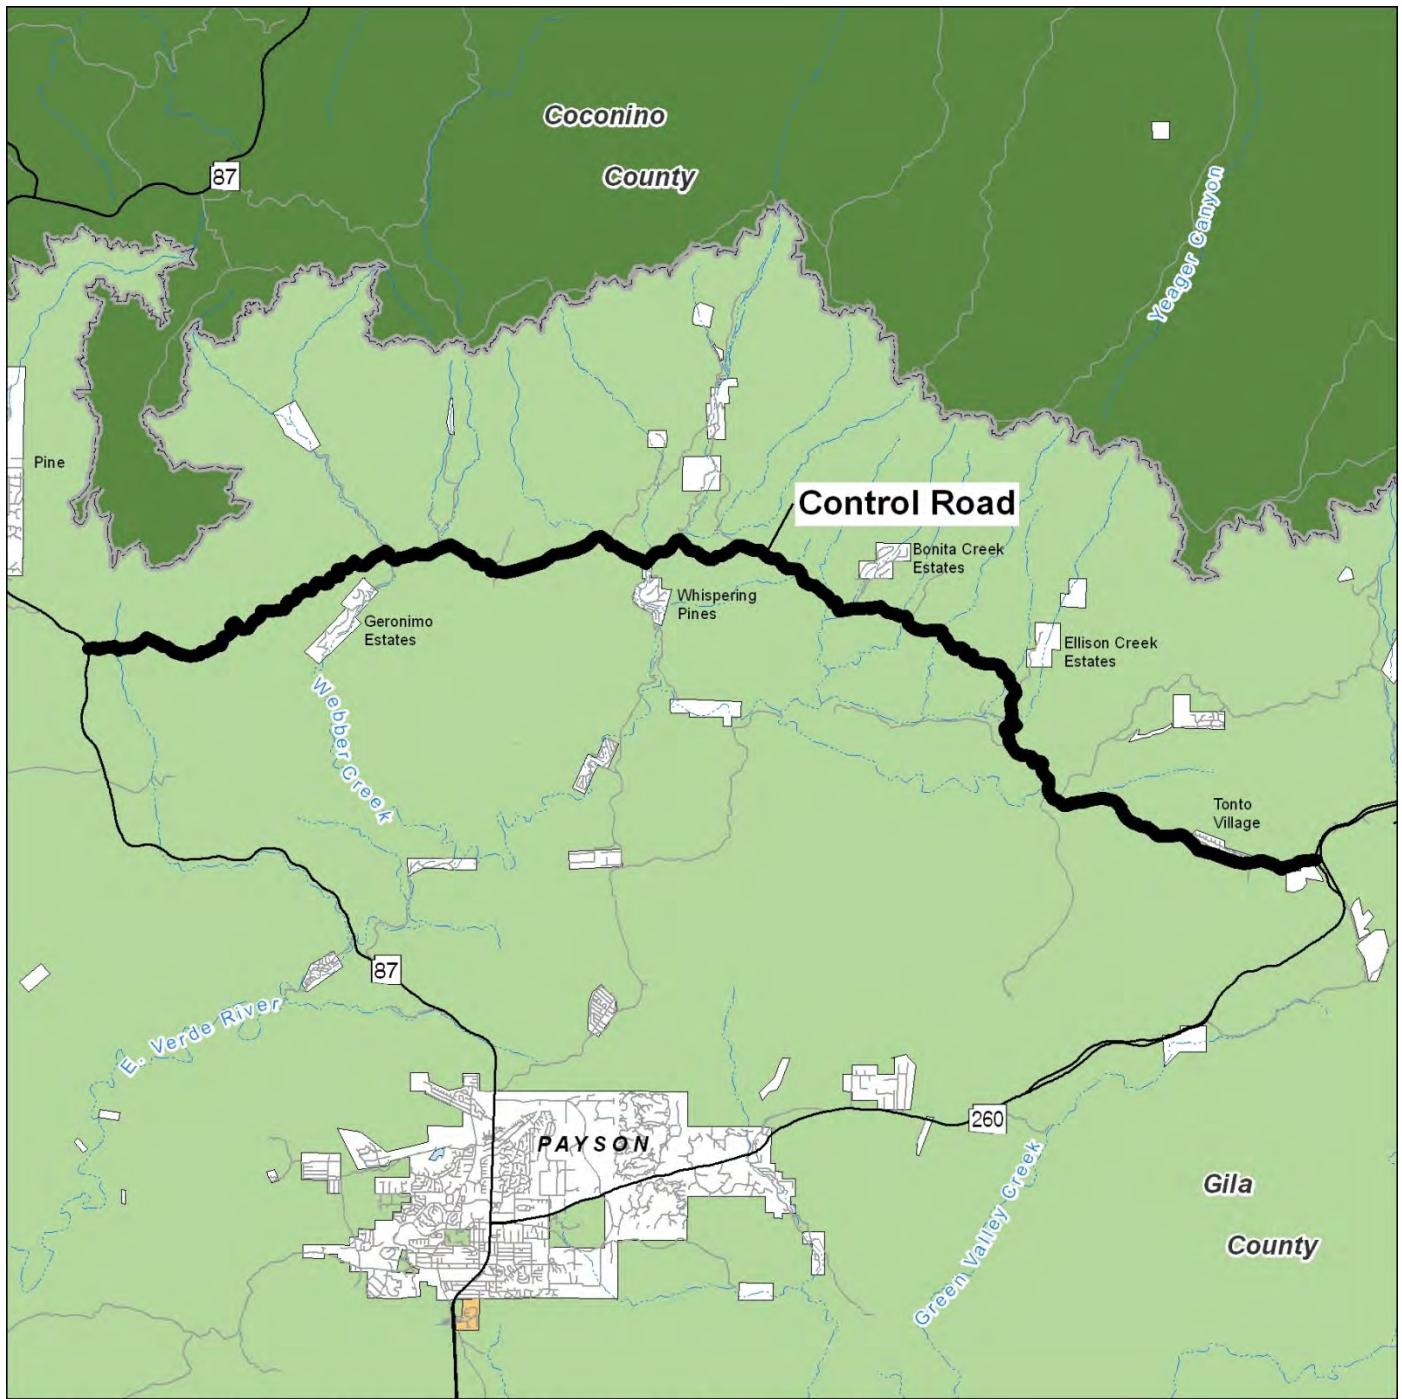
Figure 2. Land jurisdiction of project area.

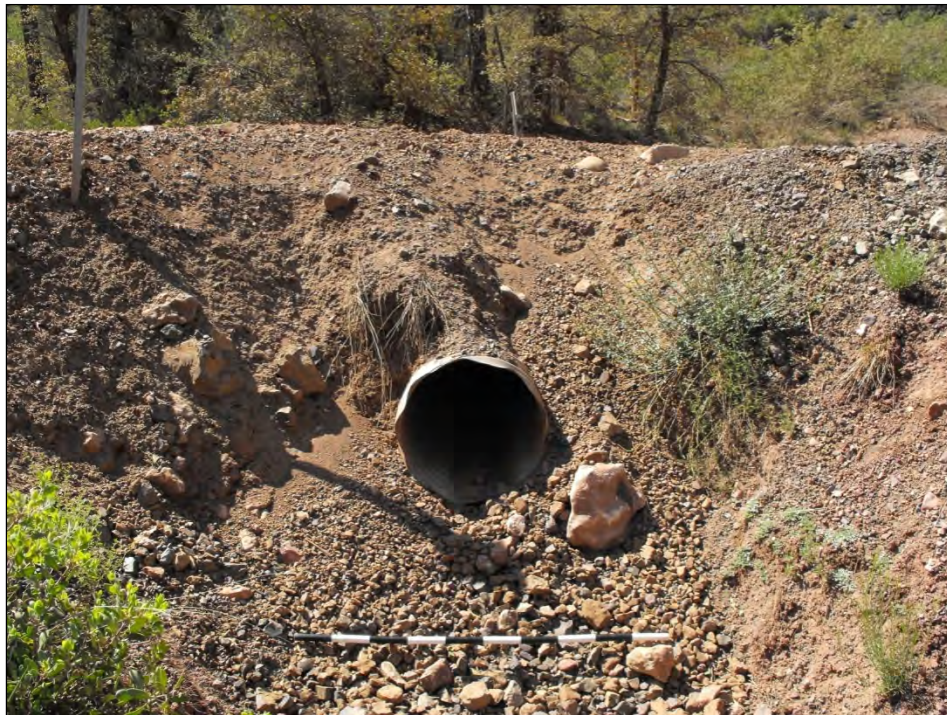
The 29 historic Type 1A features documented along the Control Road consist of a CMP culvert with no accompanying headwall or wing wall (Photograph 1). With the exception of 3 of the features (Features 1, 2, and 265), all of the Type 1A culverts were constructed by the CCC between 1934 and 1942. Features 1 and 2 are associated with a modern alignment of the roadway at the east end of the project area and Feature 265 is situated parallel to Control Road beneath a modern access road leading to a small parking area for TNF Trailhead 294 (Photograph C.1).

Photograph 1. Feature 235, an example of a Type 1A culvert, facing northwest.

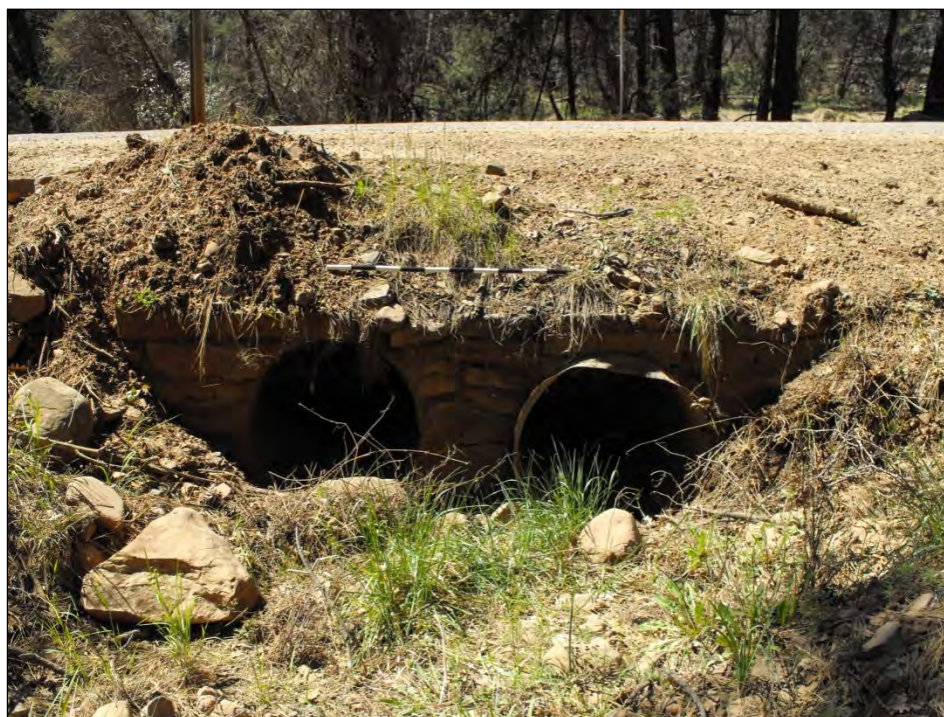
Photograph 3. Feature 149, a mortared Type 1B feature with a double CMP, facing northwest.

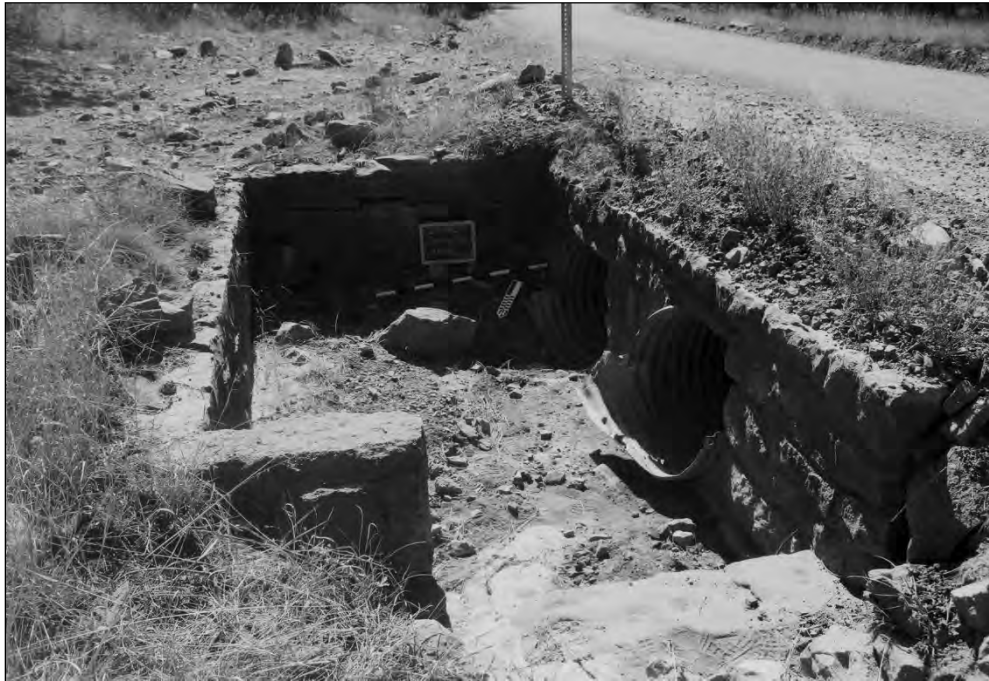
Two types of catchments are present along Control Road: vertical-walled boxes and partially sloped boxes. Vertical-walled boxes are defined as those with the top courses at or nearly level with the surrounding ground surface (Photograph 4); 102 of the Type 1C features are of this design. Partially sloped basins are

Photograph 4. Feature 51, an example of a Type 1C feature with vertical walls, facing southeast.

All Type 1C features have stepped openings that slow down water as it drains into the CMP (see Photograph 4). One feature (Feature 73) has three stepped openings at its northern, southern, and western ends (Photograph C.16); the remaining Type 1C features have one stepped opening perpendicular to the headwall. Nearly all of the Type 1C features are partially or mostly silted in; however, visible floors in some of the features are finished with carefully laid masonry flagstone or with poured concrete (Photograph 6). Unprepared dirt floors are also common. The majority of the features are in poor condition and many of the headwalls and/or catchment basin walls have been partially or fully dismantled (Photograph 7).

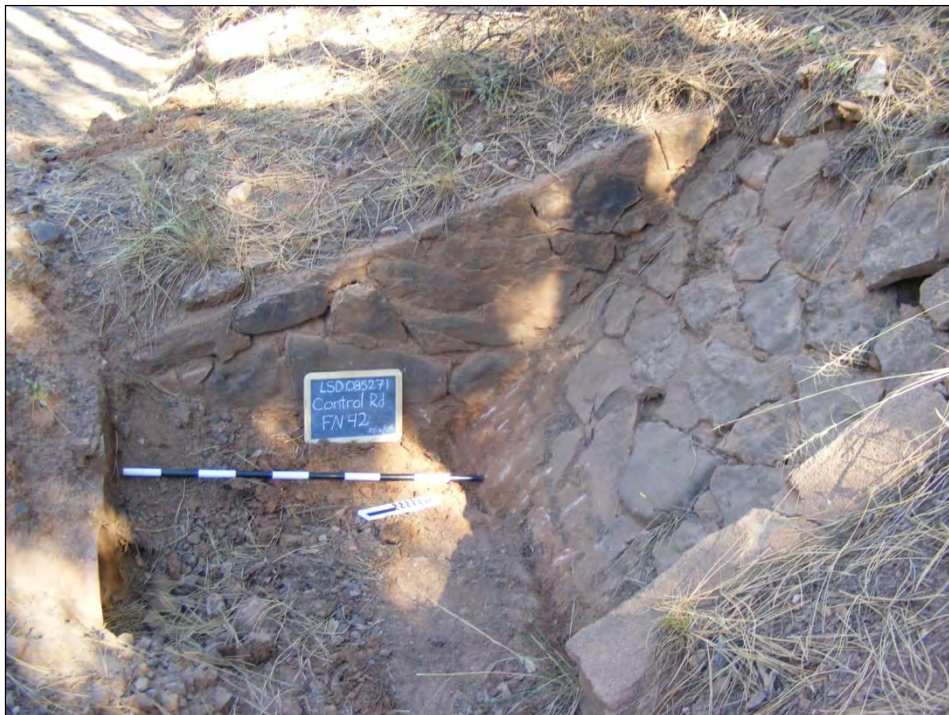
defined as those with a sloping sidewall that extends up the slope and above the tops of the other catchment walls (Photograph 5). Six sloped basins were identified (Features 33, 38, 40, 43, 44, and 115); with the exception of Feature 115, which is located within Walk Moore Canyon, all of the sloped basin features are situated along a 0.5 mile stretch of road in the vicinity of Thompson and Pyeatt Draws (see Figure A.1).

Photograph 5. Feature 33, an example of a Type 1C feature with a partially sloping catchment wall, facing west.

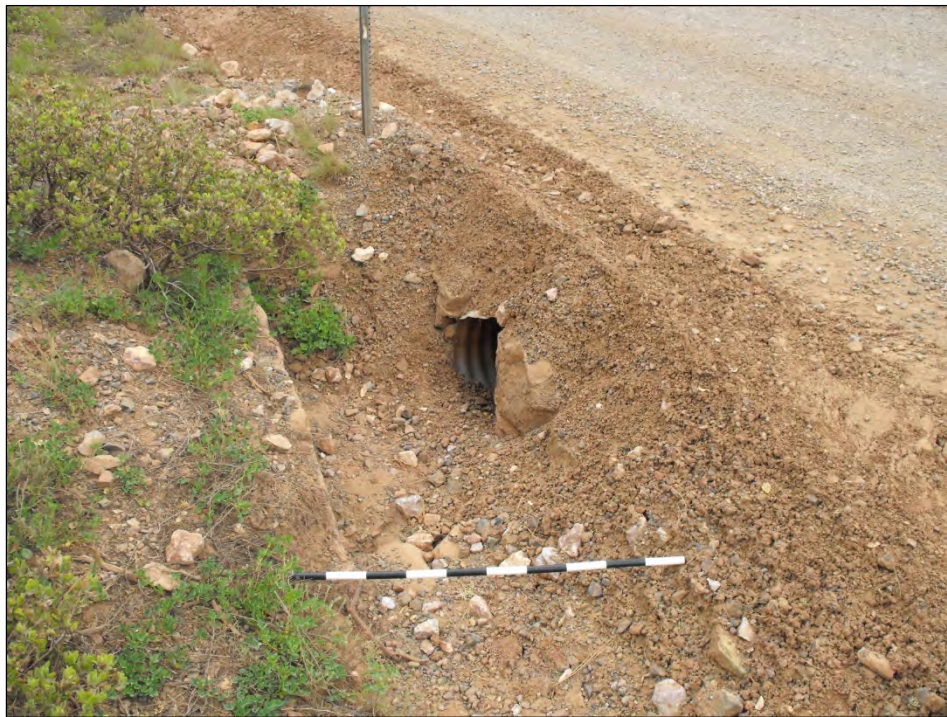
Photograph 7. Feature 297, an example of a Type 1C feature with a partially destroyed headwall, facing southeast.

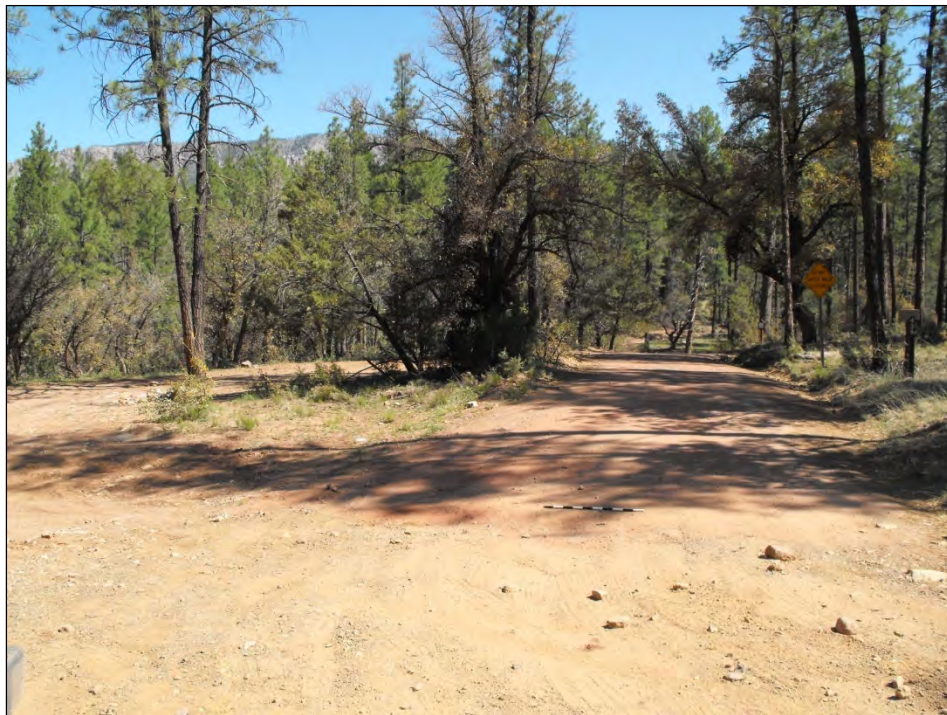
Pull-outs are located at numerous locations along the Control Road. In most cases, the pull-outs are located in areas where the roadway intersects with jeep trails or forest roads (Photograph 8). These pull-outs range in size from 35 ft to 100 ft long by 20 ft to 50 ft wide, and often serve as informal parking areas for recreationists (Photograph 9). Pull-outs are also located along steep and narrow sections of the roadway where additional shoulder space is needed for vehicular safety. These pull-outs parallel the shoulder of the in-use roadway and are much smaller in size than those located near popular recreation areas (Photograph 10).

Photograph 8. Pull-out 5, an example of a pull-out adjacent to a jeep trail or forest road, facing north. FR 432 is visible at the right of the photograph.

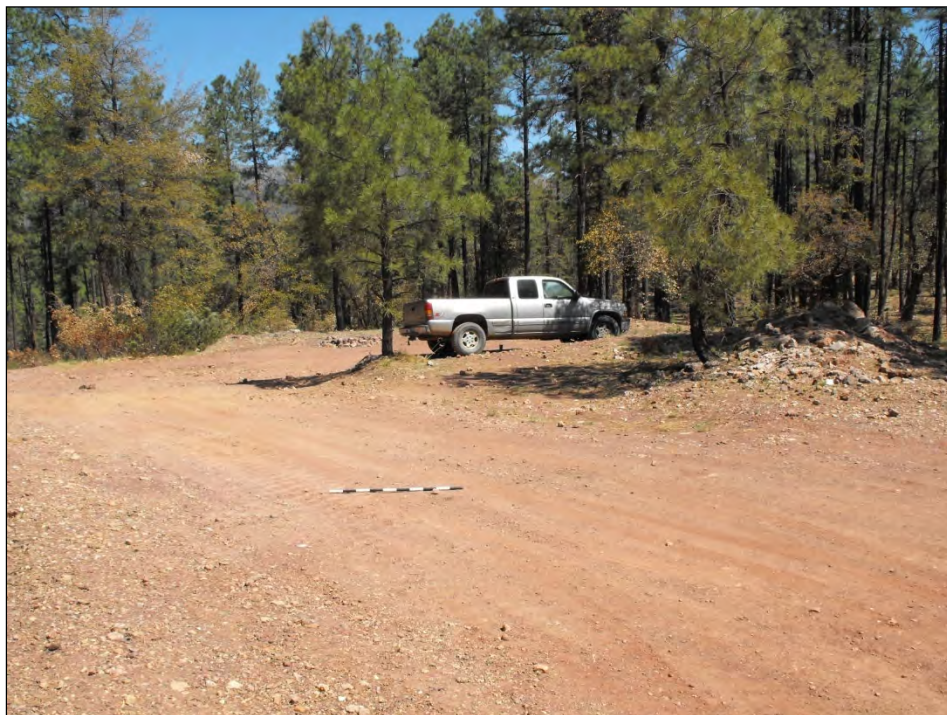
Photograph 9. Pull-out 2, an example of a pull-out that serves as an informal parking area for recreationists, facing north.

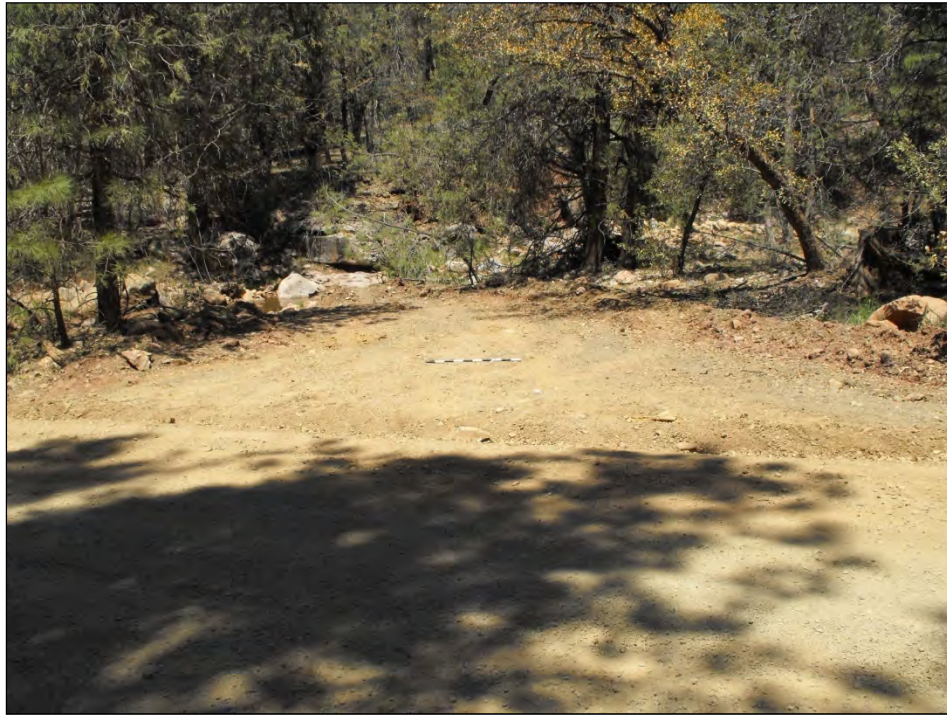
Photograph 10. Pull-out 6, an example of a pull-out along the north shoulder of the roadway, facing northwest.

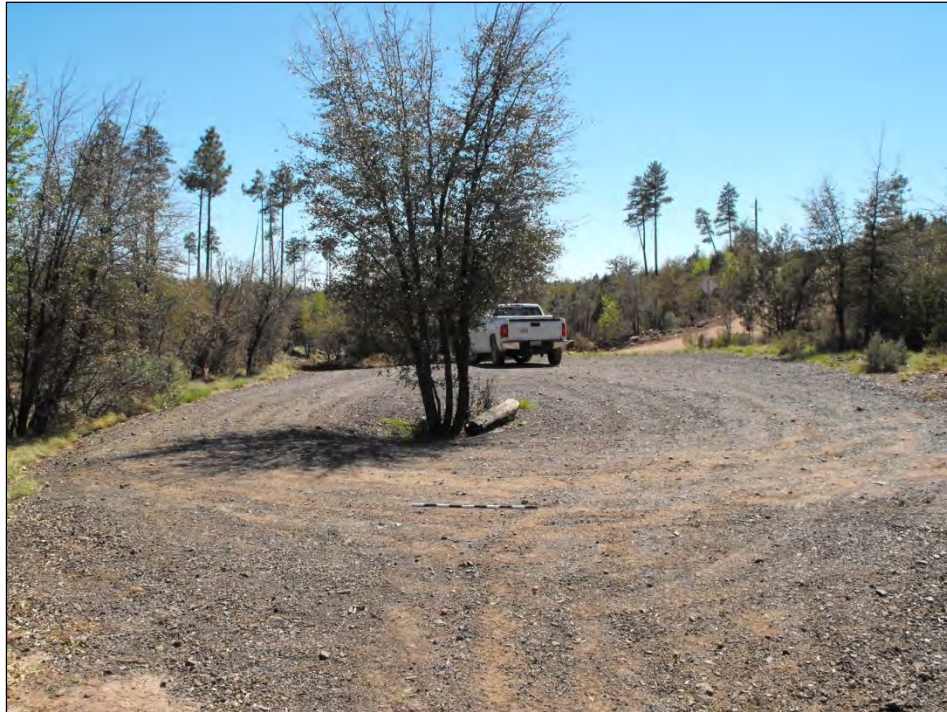
In addition to pull-outs, three parking areas are located along the Control Road. The parking areas are located adjacent to trailheads or in popular recreational areas, such as Verde Glen along the East Verde River, and most are designed to accommodate parking for more than one vehicle (Photographs 11 and 12). One parking area with space for a single vehicle is present at a campsite along the East Verde River approximately 0.2 mile west of the East Verde Glen parking area (Photograph 13). Additionally, a trailhead associated with one of the parking areas was documented in the project area. The trailhead for the Stand 1

Photograph 11. Parking area 2 for the Dude Fire trailhead, facing southeast. Control Road is visible near the top right of the photograph.

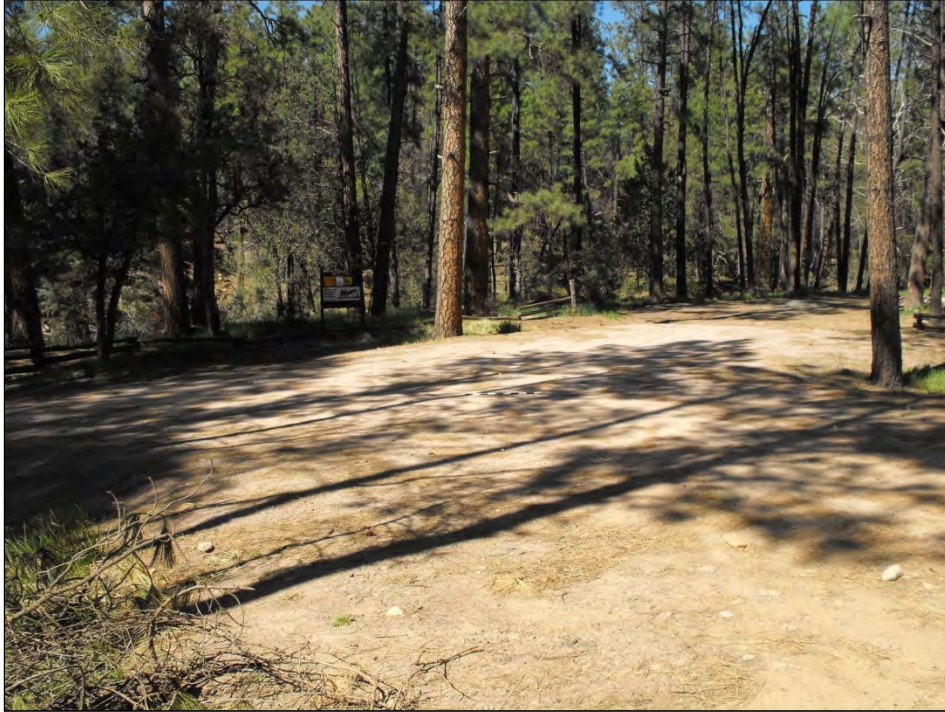
Photograph 12. Parking area 3, East Verde Glen parking area, facing northeast.

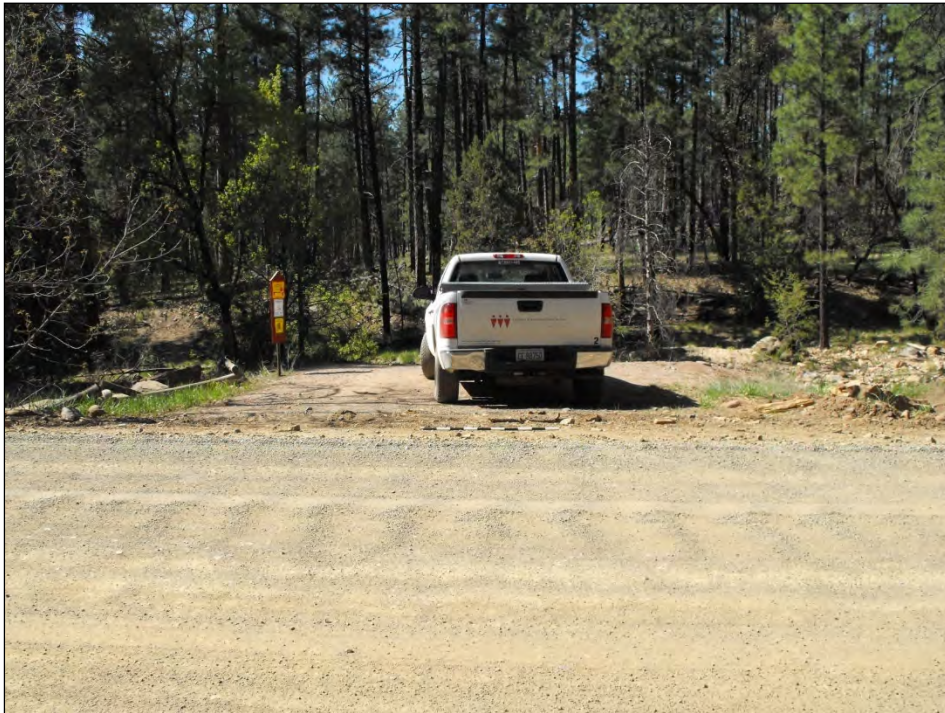
Photograph 13. Parking area 4, parking area for a campsite along the East Verde River, facing northwest and across Control Road.

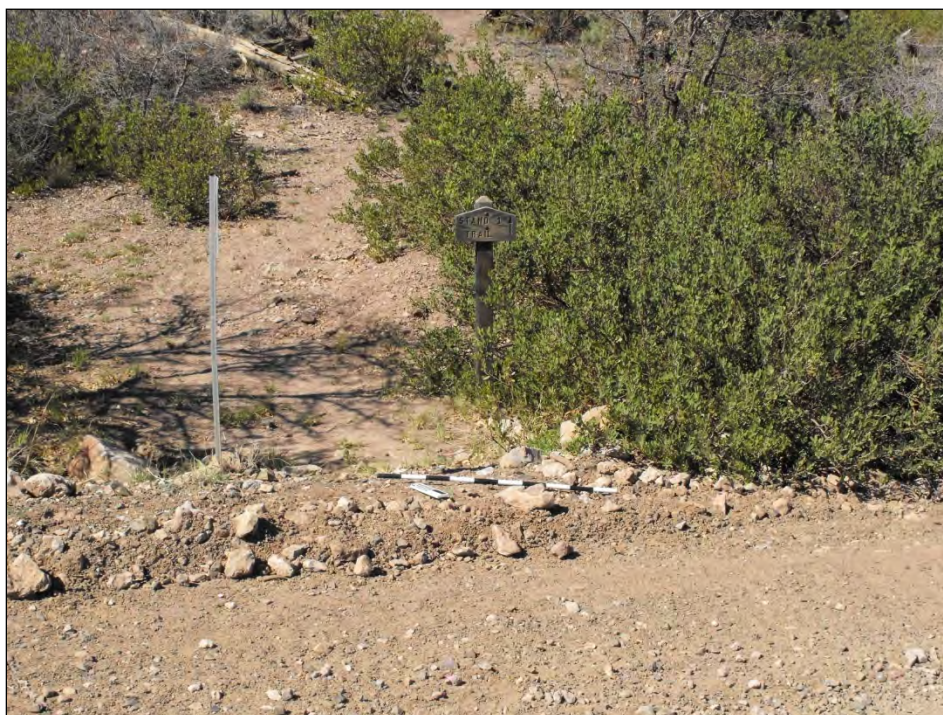
Trail is located near a wooden sign for the trailhead on the north side of the road (Photograph 14). Other trailheads located along the road, such as Trailhead 294 and the Dude Fire Trail, are accessible from parking areas and are not located immediately adjacent to the road.

Photograph 14. Photograph of the Stand 1 trailhead marker from Control Road, facing northeast.

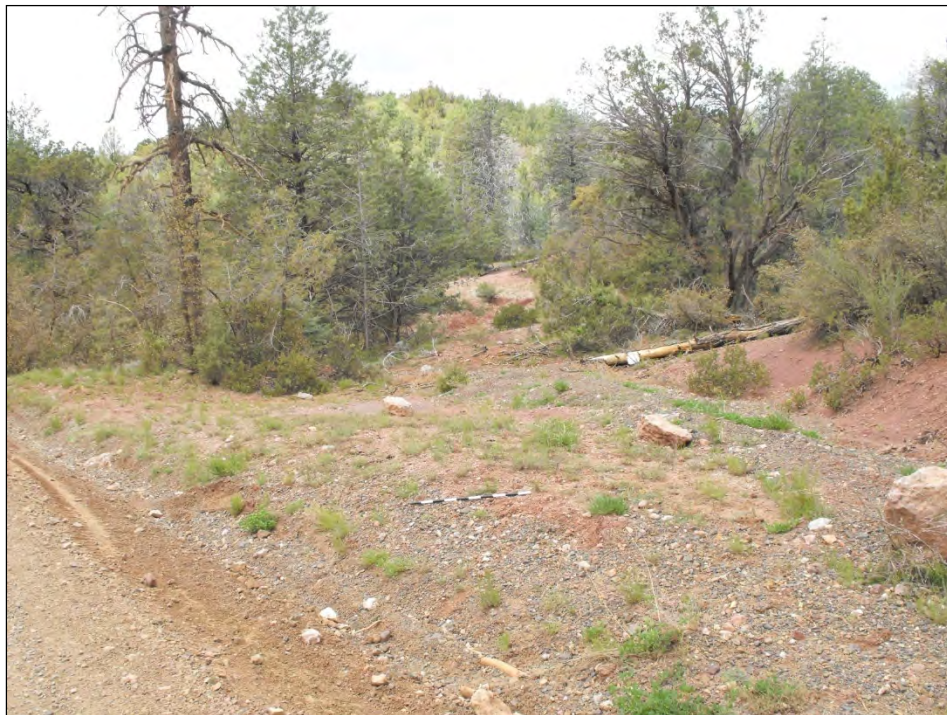
The majority of the abandoned road segments are adjacent to drainage systems where the roadway originally followed the hill contours around drainage heads or was deviated to unimproved low-water crossings at larger tributaries or creeks (Photograph 15). Abandoned segments also follow the hill slopes and ridge systems above the existing roadway (Photograph 16). The road segments vary in length, with the longest segment (RS 6) spanning approximately 1.2 miles between Ellison and Perley Creeks in Hells Gate Canyon. The shortest segment, RS 13, measures 0.2 mile long and parallels the hill slope along the south side of the current Control Road alignment. In some areas where the road segments intersect the in-use alignment of the Control Road, earthen berms or barricades of large boulders or logs have been placed in the center of the abandoned segments to discourage continued use of the routes (Photograph 17). Other segments appear to remain in use as primitive trails for off-road vehicles.

Photograph 15. RS 10, an abandoned road segment that follows the hill contours around Webber Creek, facing northwest. The in-use alignment of the Control Road is visible at the bottom left of the photograph.

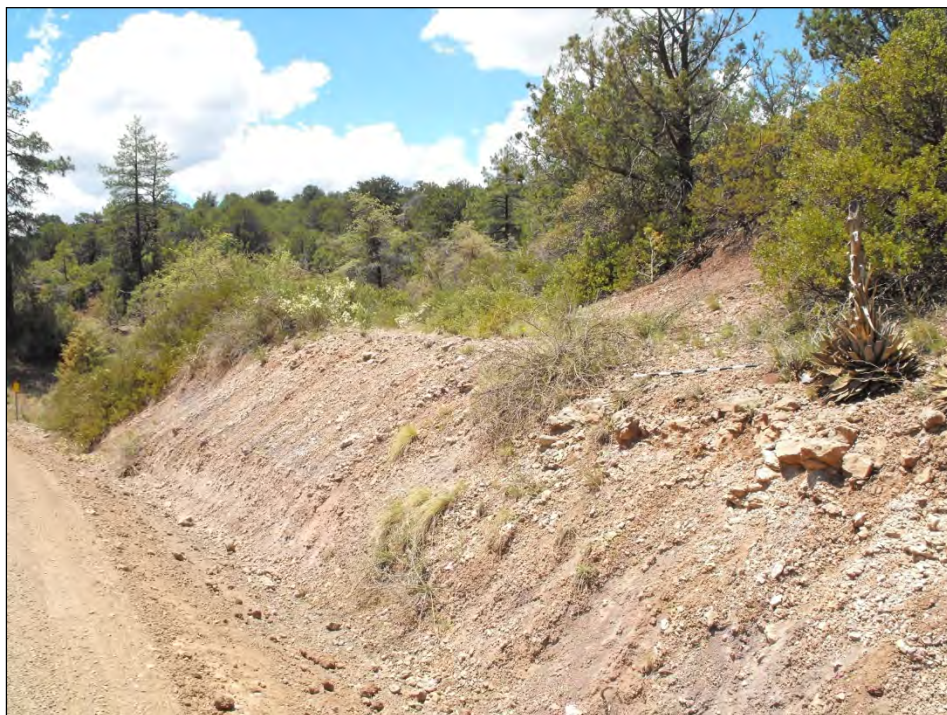
Photograph 16. RS 15, an abandoned road segment that follows the hill contours above the in-use alignment of Control Road near Shannon Gulch, facing northeast.

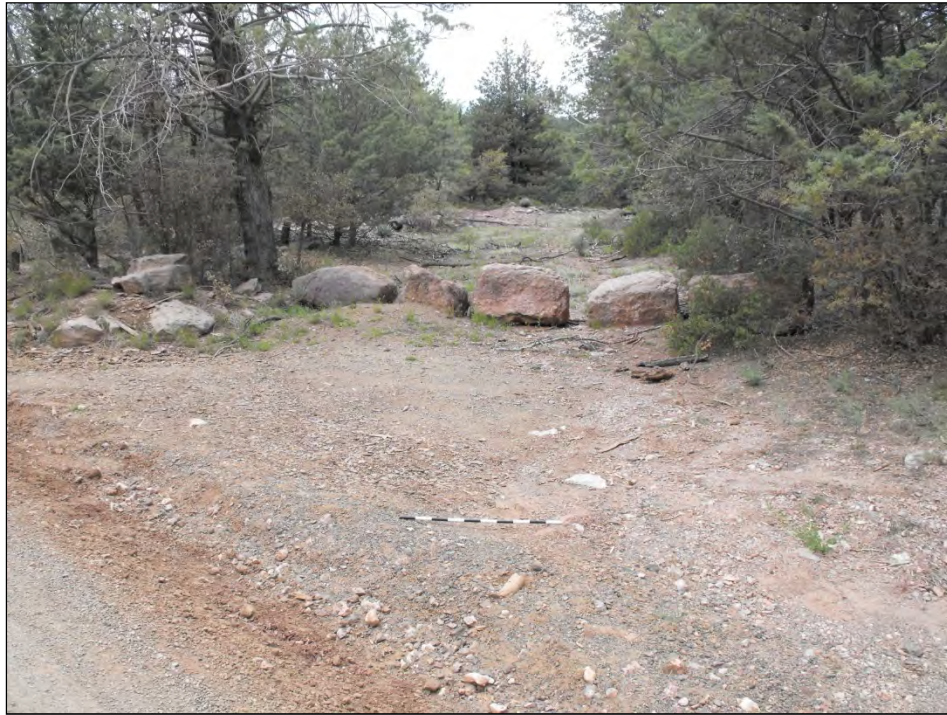
Photograph 17. RS 16, showing a rock barricade visible from the in-use alignment of the Control Road, facing northwest.

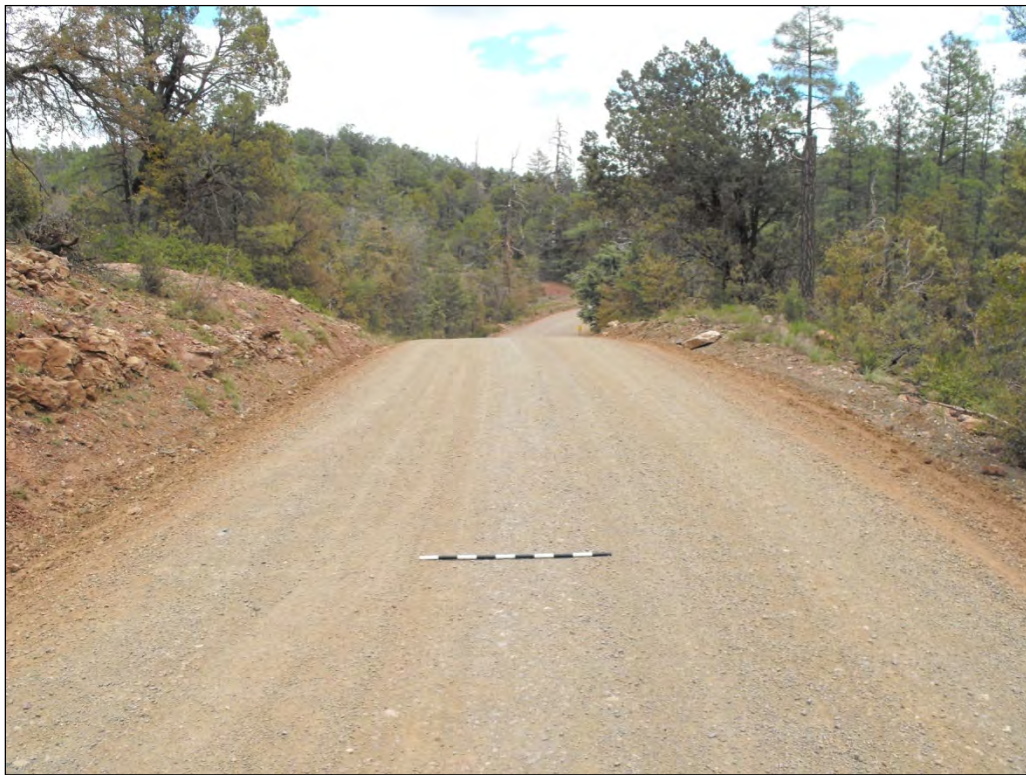
- A.21. Photograph of the Control Road in the vicinity of Feature 295 (UTM Zone 12, NAD 1983 CONUS: 462077 mE, 3802231 mN), photographer Leigh Davidson, May 2011, facing northeast (*Source*: Logan Simpson Design Inc., 51 West Third Street, Tempe AZ 85281).

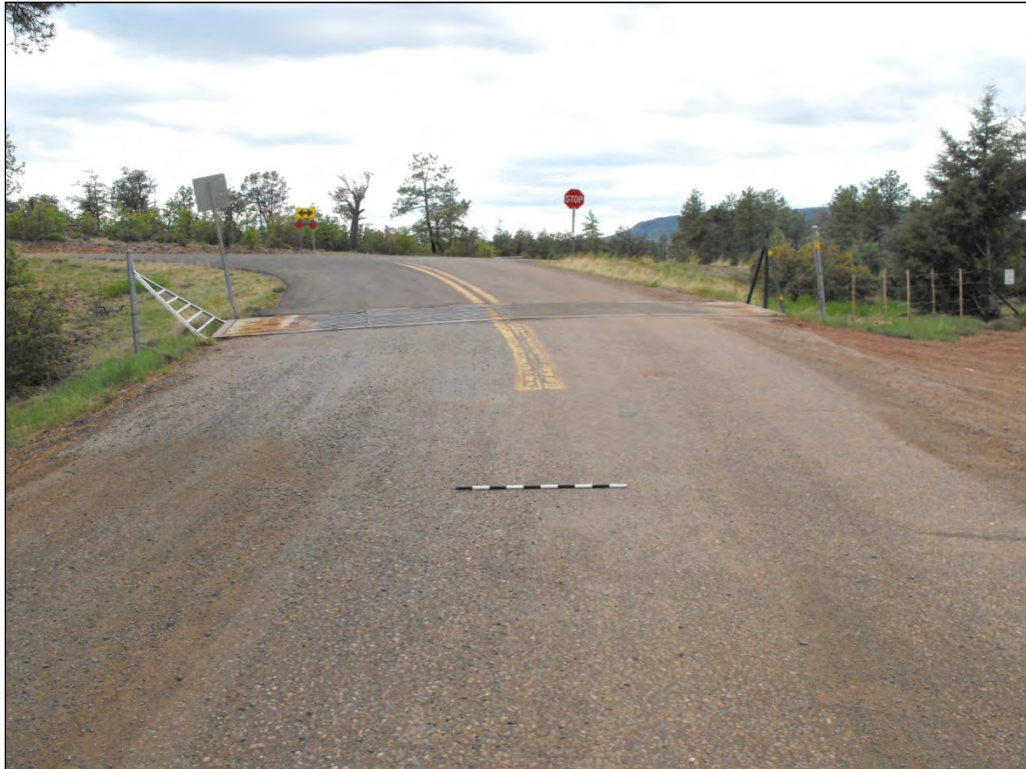
- A.22. Photograph of a modern paved section of the Control Road just east of SR 87 (UTM Zone 12, NAD 1983 CONUS: 406963 mE, 3802170 mN), photographer Leigh Davidson, May 2011, facing east (*Source*: Logan Simpson Design Inc., 51 West Third Street, Tempe AZ 85281).

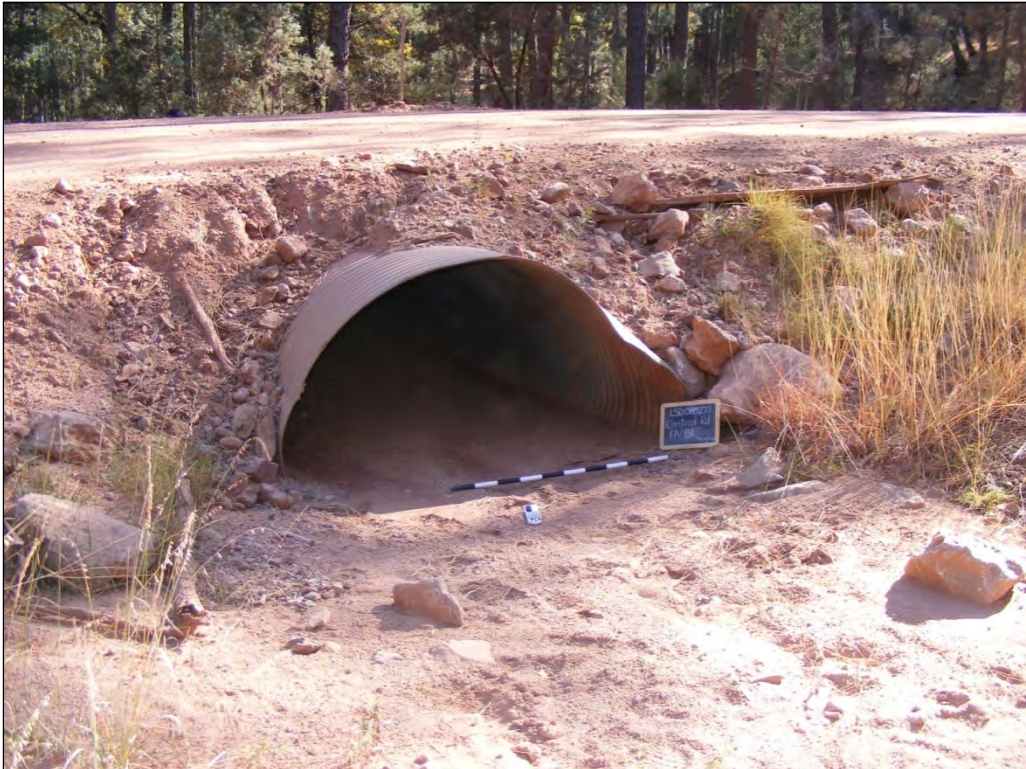
C.2.

Twenty-eight of the Type 1A features are constructed of a single pipe, although two of the features (Features 65 and 263) have two pipes. The culverts have a variety of different pipe diameters which are related to the size of the drainage: 12 are 18 inches; two are 20 inches; six are 24 inches; one is 30 inches; two are 32 inches; three are 36 inches; one is 62 inches; and one is 72 inches. One Type 1A culvert (Feature 46) was completely silted in and the pipe diameter could not be determined. The largest of the Type 1A features (Feature 65) is located approximately 4.5 miles west of SR 260 in an area where Pyeatt Draw crosses the roadway (Photograph C.2).

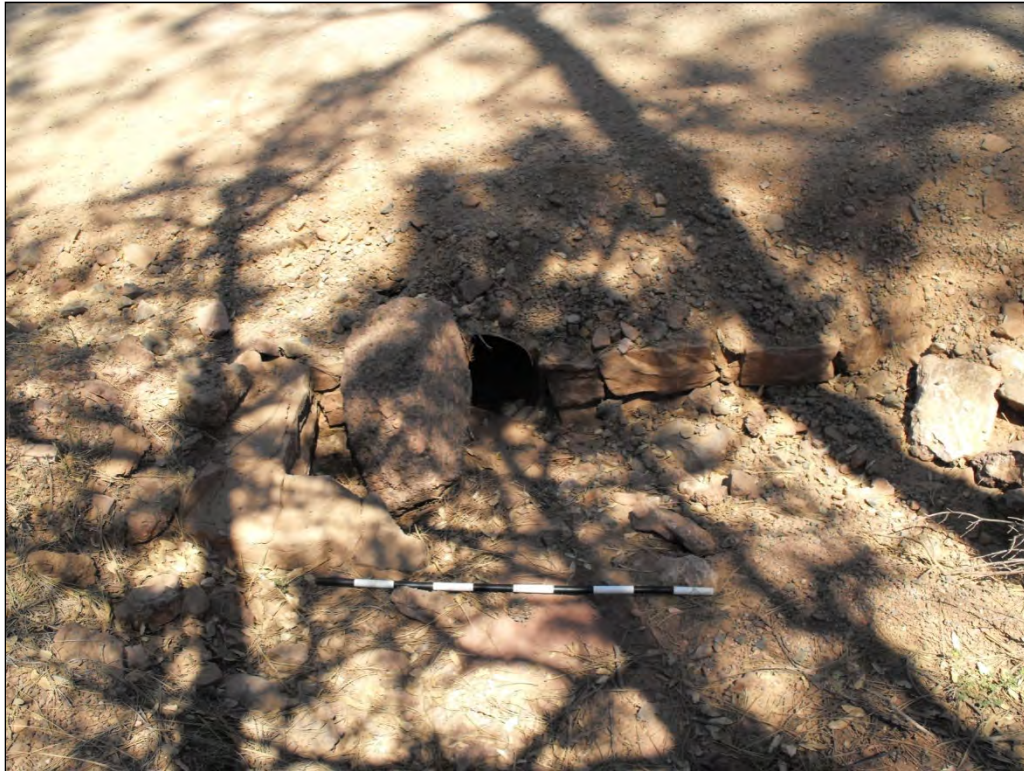
C.7.

Features 183 and 288 have L-shaped headwalls (Photograph C.7), and the headwall at Feature 202 is J-shaped (Photograph C.8). All of the features are in poor condition and it is probable that portions of the original headwalls have been destroyed by erosion. The only V-shaped headwall, Feature 278, is located 1.5 miles east of SR 87 near the western terminus of the roadway. The feature is composed of a single 32-inch-diameter CMP with an 11-ft-long by 3-ft-high headwall. At the center of the CMP, the headwall angles slightly to the east and west forming the shape of a wide “V” (Photograph C.9).

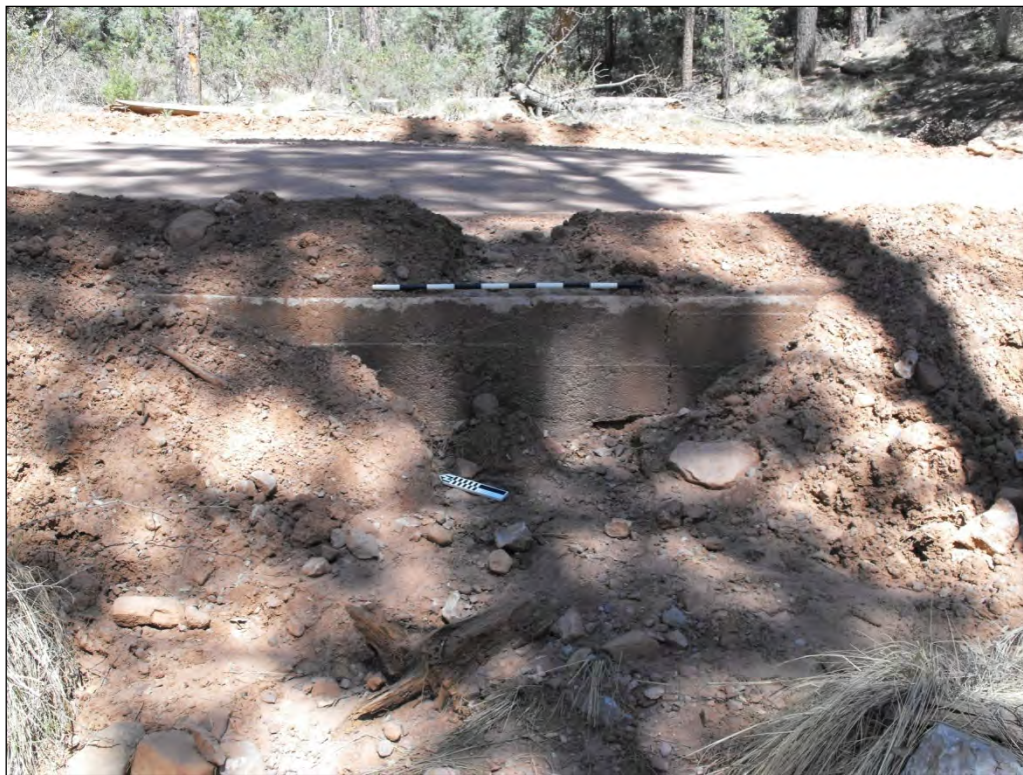
C.25.

The remaining low-water crossings are located within tributaries of Ellison Creek (Feature 86), Moore Creek (Feature 93), Fuller Creek (Feature 116), the East Verde River (Feature 173), Webber Creek (Feature 207), and Shannon Gulch (Feature 277). These crossings are generally in poor condition and each was mostly obscured by sediment. Additionally, the drop structures at three of the crossings (Features 86, 173, and 207) are partially or almost completely destroyed due to flooding and erosion (see Photographs C.25, C.28, and C.29).

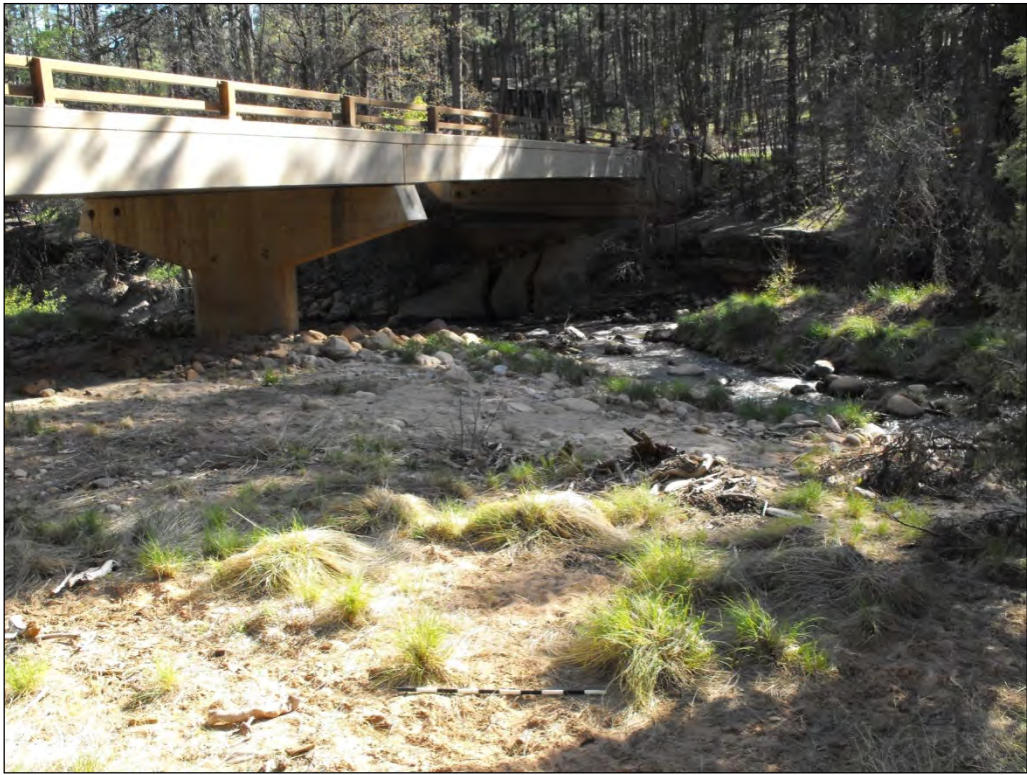
C.36.

Feature 154 is the most substantial bridge along Control Road. The bridge spans the East Verde River within the community of Whispering Pines and was constructed by the TNF in 1995 (see Photograph C.36). The bridge replaced an earlier Steel Pratt through truss bridge that was constructed by the Works Projects Administration (WPA) in 1939 (Ryan 2000). According to Frazier (1995), the steel truss of the 1939 bridge was originally part of the San Carlos Bridge that spanned the Gila River during the early 20th century. In 1934, the San Carlos Bridge was dismantled by the Bureau of Indian Affairs, and portions of the bridge were distributed to the Forest Service at this time (Frazier 1995).
