Level II HAER Documentation of the Historic Colcord Road (Forest Road 291) and its Associated Features, Payson and Pleasant Valley Ranger Districts, East of Payson, Gila County, Arizona

December 2011

LSD Technical Report No. 115042b

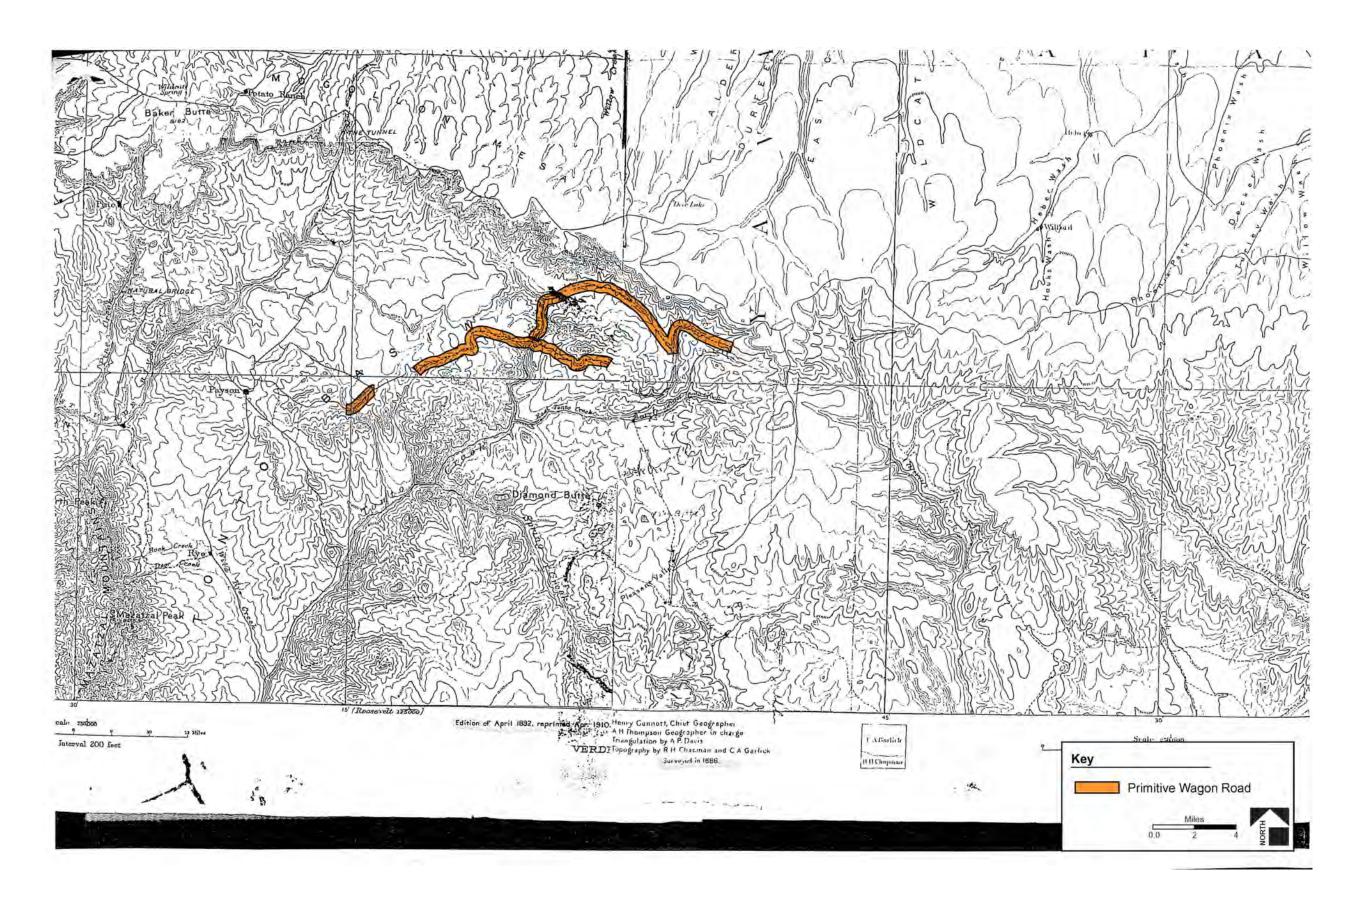
Figure 3. Excerpt from an 1886 USGS map showing primitive wagon roads in the Payson Basin and western Mogollon Rim area.

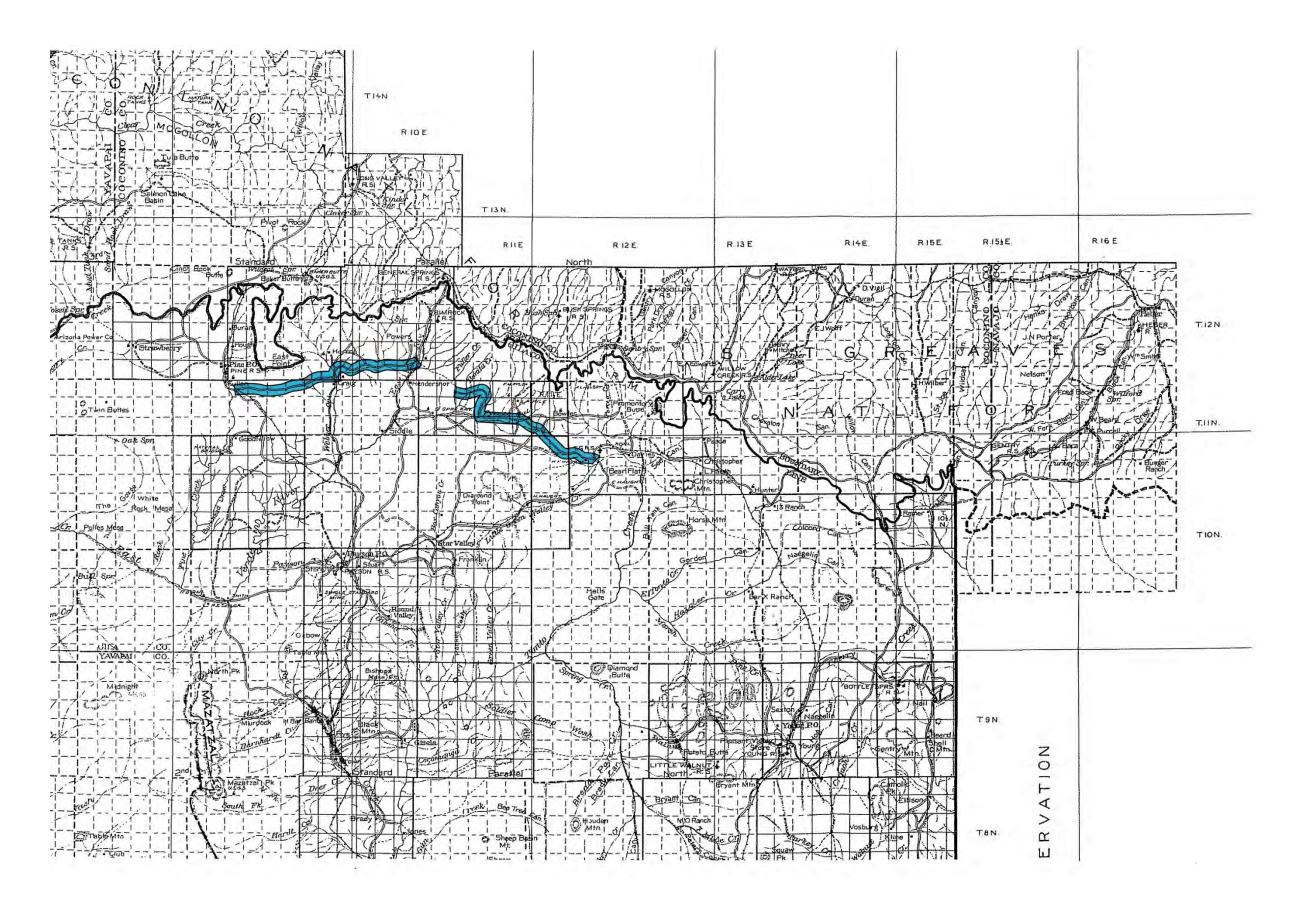
Figure 4. Excerpt from a 1924 TNF map showing the two main roads in the western Mogollon Rim area.

road is depicted as a dashed line on the map and is presumably little more than a trail (see Figure 4). The second road is depicted as more formalized; this route began east of the river, to the south of Fuller and Bonita creeks, and extended west where it connected with numerous roads and continued in a generally southeast direction to its terminus with the Payson to 13 Ranch Wagon Road near the Indian Garden Ranger station (later known as Guard Station).

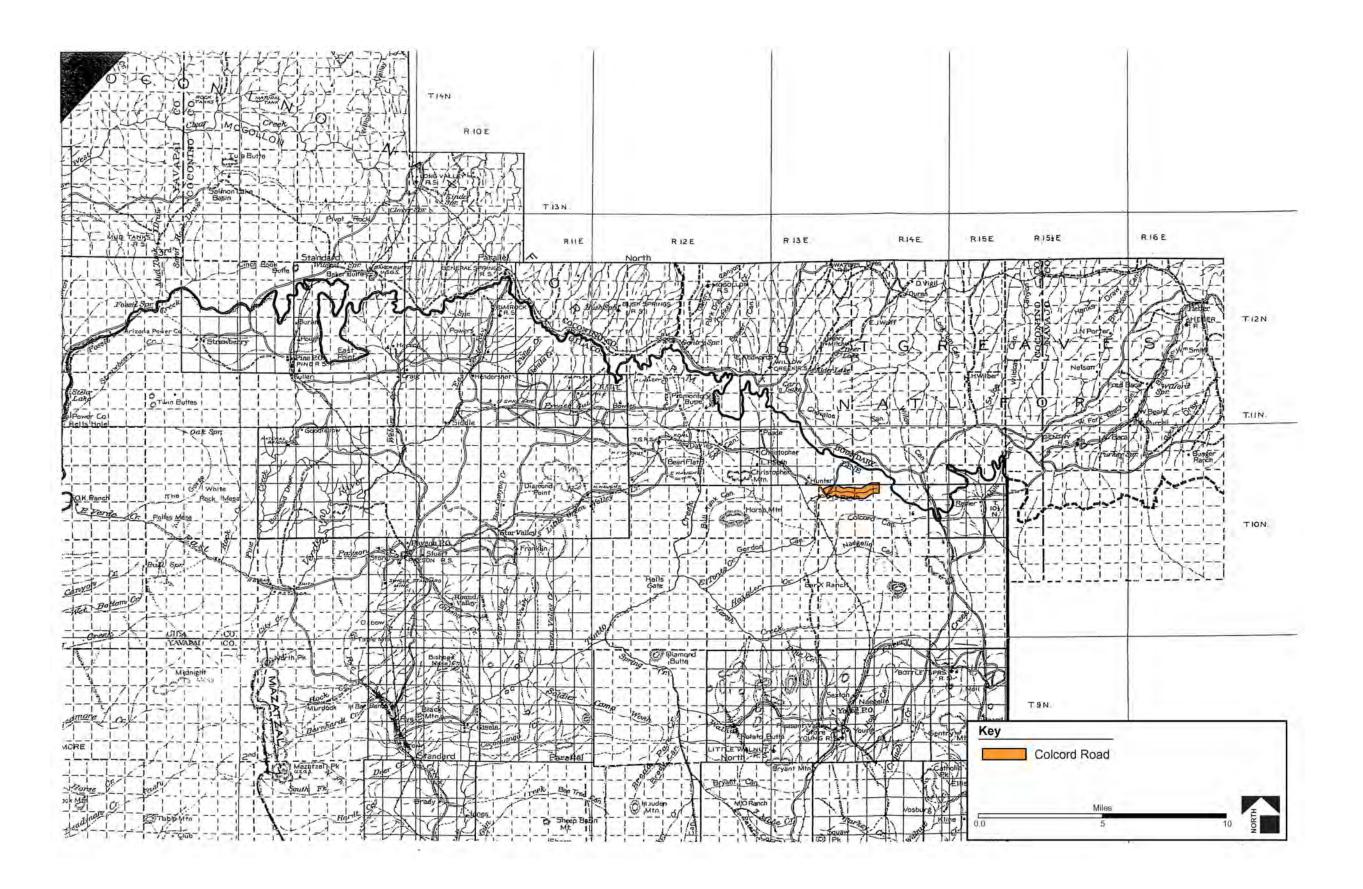
Figure 5. Excerpt from a 1924 TNF map showing the western end of the Colcord Road.

A TNF map indicates that by 1924, the majority of the route is in "good" to "fair" condition; only a 2-mile-long segment of the road to the south of Promontory Butte is characterized as "minor" or "very poor" condition. The road generally follows the 1886 alignment, although in some areas, it meanders around topographic features to connect various ranches and homesteads established along the roadway (see Figure 4; Figure 5). Additionally, the western end of the Colcord Road alignment is shown turning north at 13 Ranch and ascending the Mogollon Rim.

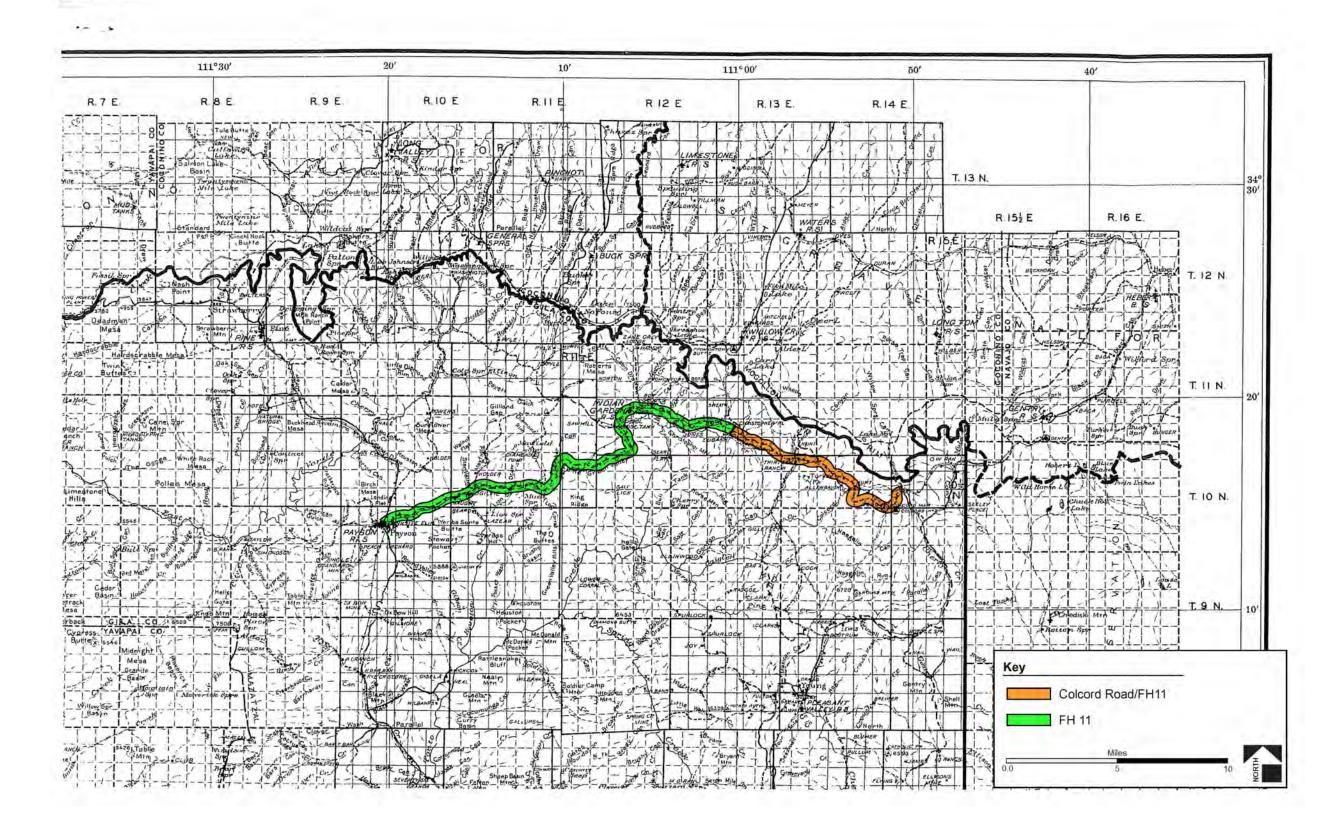
Figure 6. Excerpt from a 1933 TNF map showing the early alignment of the FH 11 and the Colcord Road.

After 1930, the wagon road was improved and re-designated as FH 11. The road comprised 11.6 miles of the overall FH 11 route, which spanned 40 miles between Payson and FH 12. A series of TNF and Bureau of Public Roads maps show the Colcord Road along its present-day alignment between the 13 Ranch and FH 12. However, a TNF map indicates that the road had deteriorated to "minor" or "very poor" condition by the time the CCC arrived at the TNF in 1933 (Figure 6).

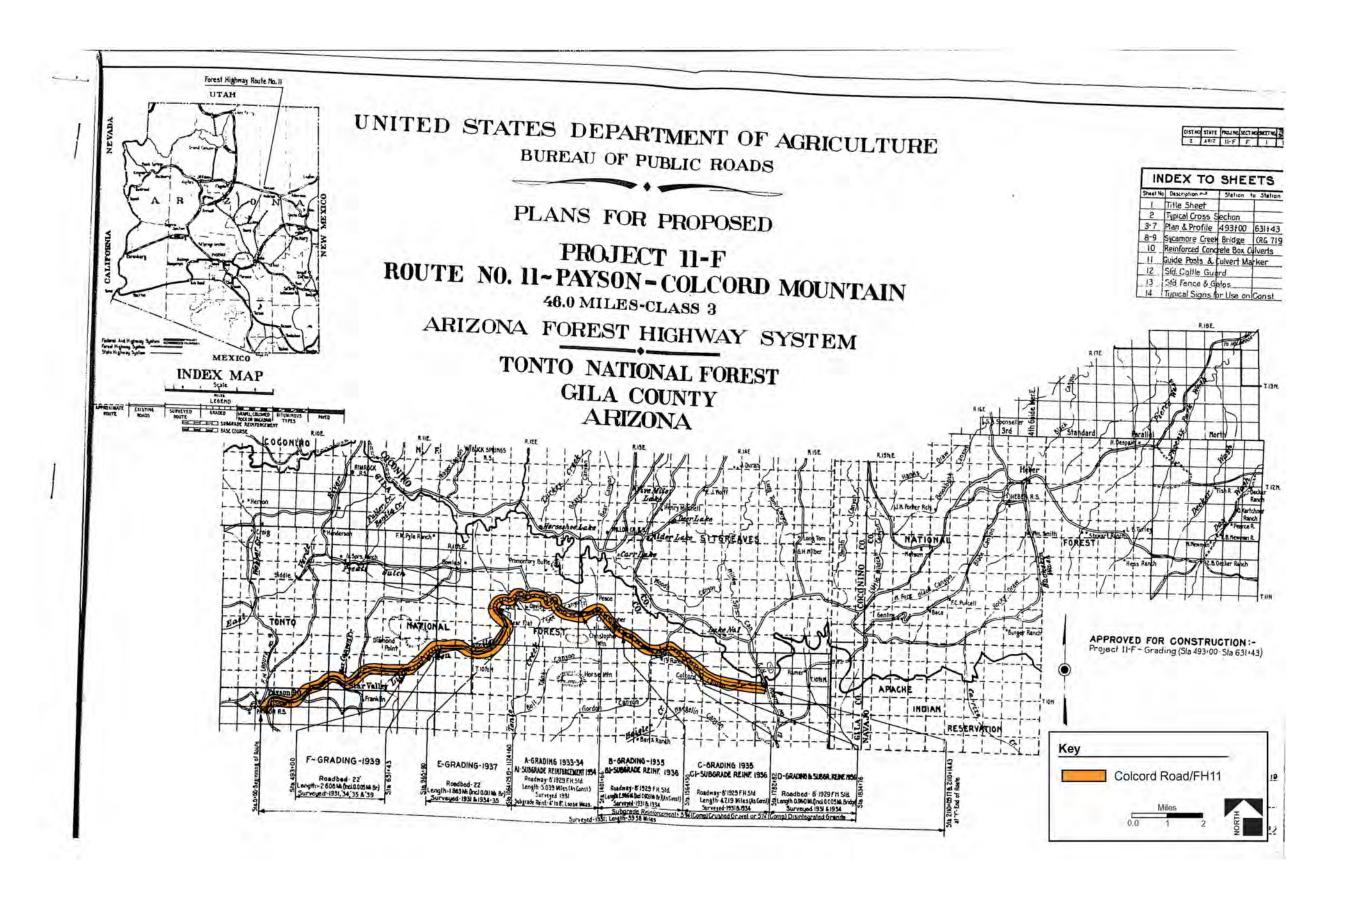
Figure 7. 1939 Bureau of Public Roads as-built plan showing CCC improvements to the early alignment of FH 11.

A 1939 Bureau of Public Roads as-built drawing of FH 11 indicates that CCC improvements to Colcord Road included grading sections of the existing roadway, sub-grade reinforcement, and the construction of road features including culverts and bridges (Figure 7). The map indicates that portions of the eastern end of the roadway were graded between 1935 and 1936. Additionally, the drawings suggest that the sub-grade of the road to the west of Ponderosa Estates was reinforced with crushed gravel or disintegrated granite in 1936. At this time, the road bed measured 8 ft wide and consisted predominantly of existing roadway and routes surveyed between 1931 and 1934. Two sections of FH 11 to the west—in Little Green Valley and northwest of Bear Flat—were graded while segments east of Tonto Creek near See Canyon had crushed rock or macadam applied to the road surface.

A 1946 TNF map suggests that the western end of the route between 13 Ranch and FH 12 was realigned between 1939 and 1946 (see Figure 7; Figure 8). Additionally, a 1952 Bureau of Public Roads as-built plan for the Colcord Road suggest that portions of the route were widened from 8 ft to 14 ft after 1952 (Figure 9).

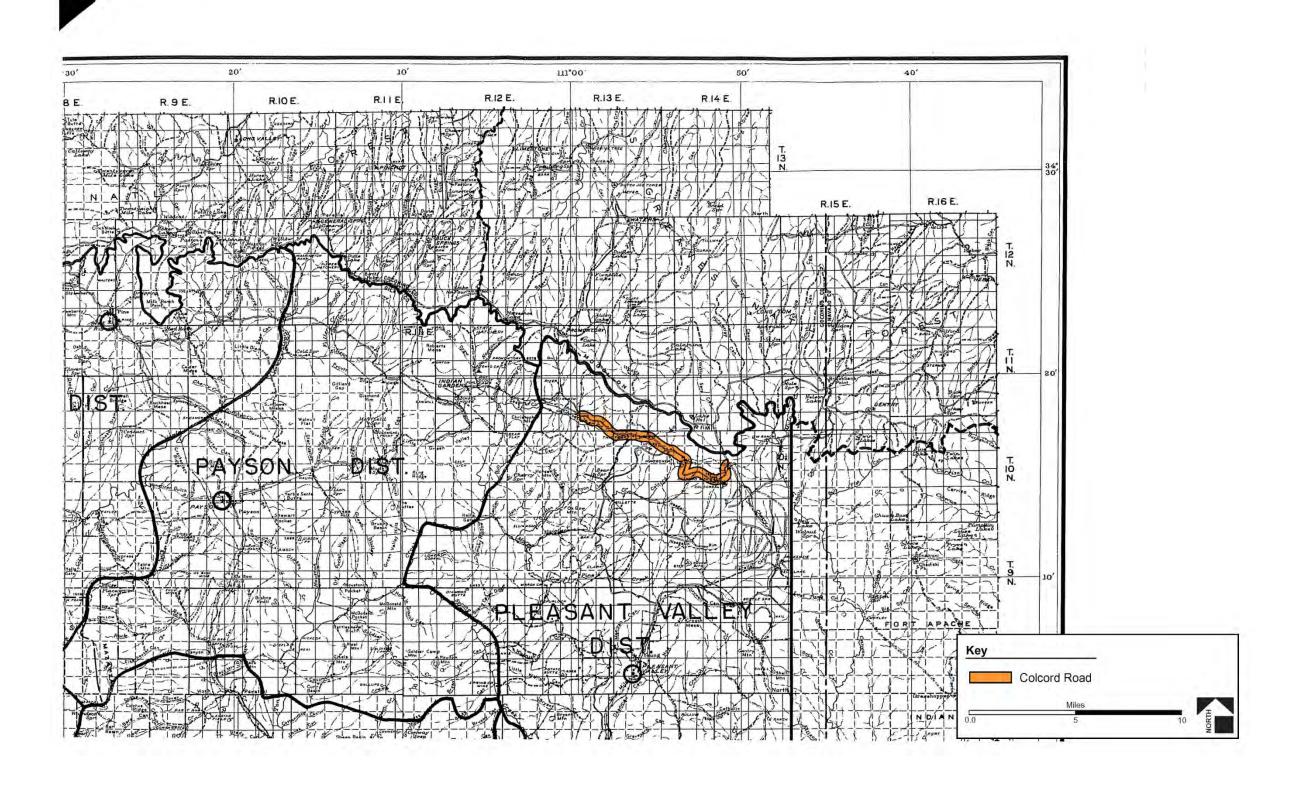
Figure 8. Excerpt from a 1946 TNF map showing the CCC-era alignment of the Colcord Road.

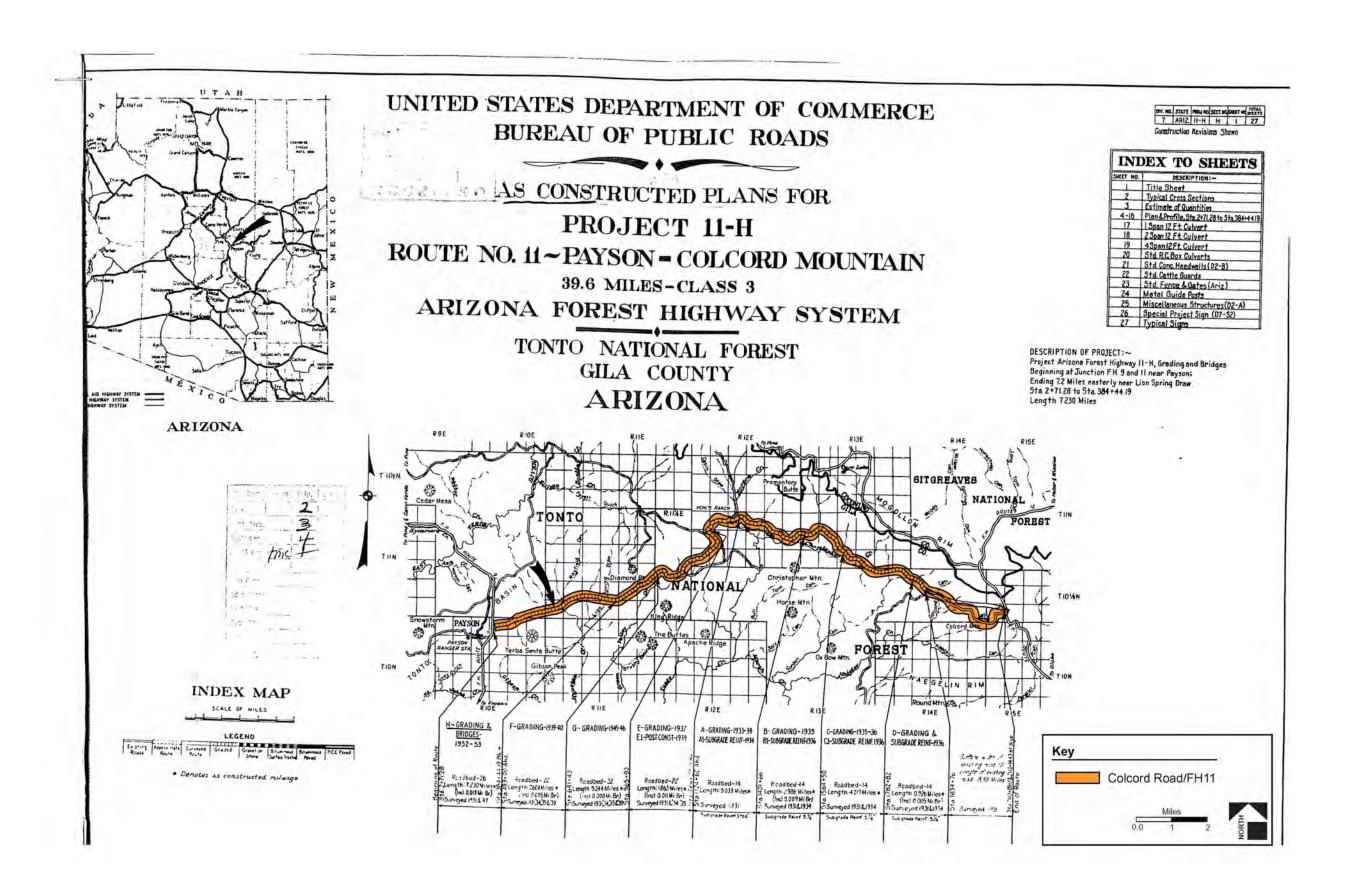
Figure 9. 1952 Bureau of Public Roads as-built plan showing the current, in-use alignment of the Colcord Road.

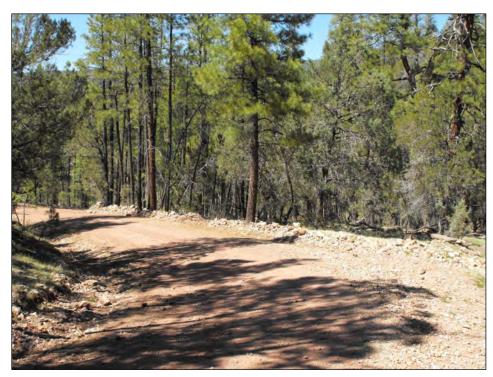
Photograph 1. Photograph of the historic Colcord Road showing cobble and earthen berms along the northern shoulder of the roadway, facing north.

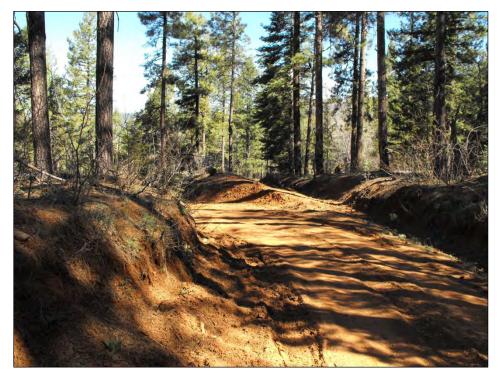
Photograph 2. Photograph of the historic Colcord Road showing evidence of plowing along the flanks of Colcord Mountain, facing northwest.

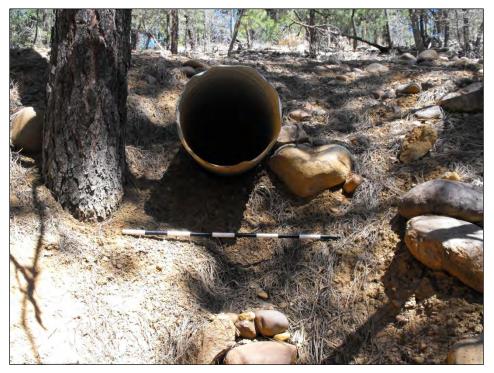
The 30 historic Type 1A culverts documented along Colcord Road consist of a single CMP with no accompanying headwall or wing wall (Photographs 3 and 4). The Type 1A culverts have a variety of different pipe diameters: one is 16 inches; 14 are 18 inches; six are 20 inches; six are 24 inches; one is 30 inches; and two are 54 inches.

Photograph 3. Feature 58, an example of Type 1A CMP, facing north.

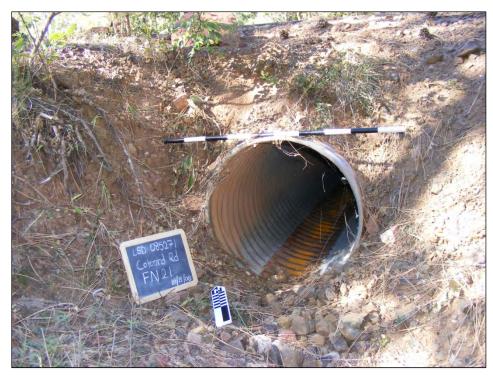
Photograph 4. Feature 9, an example of Type 1A CMP, facing south.

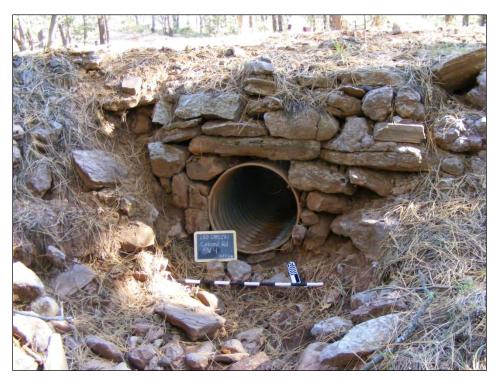
Thirty-six Type 1B culverts with one or more associated dry-laid masonry headwalls were documented within the project corridor (Table 5). One Type 1B culvert with a 24-inch-diameter double CMP (Feature 42) was recorded (Photograph C.2); all others are constructed of a single pipe (Photographs 5 and 6). The diameters of the pipes are as follows: one is 16 inches; 15 are 18 inches; three are 20 inches; seven are 24 inches; four are 36 inches; two are 48 inches; one is 54 inches; and three are 60 inches. Masonry materials include sandstone and limestone slabs and conglomerate boulders. Most rocks are of a size that could have been moved by one or more men, but several of the larger culverts have large boulders that would have required machinery and/or draft animals to place. The most substantial Type 1B culvert (Feature 1) is 24-ft long and 8-ft high, with five courses of sandstone slabs (Photograph C.3)

Photograph 5. Feature 2, an example of Type 1B CMP with a dry laid masonry headwall, facing north.

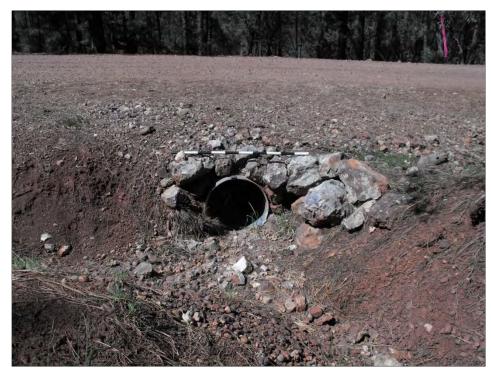
Photograph 6. Feature 49, an example of Type 1B CMP with a dry laid masonry headwall, facing north.

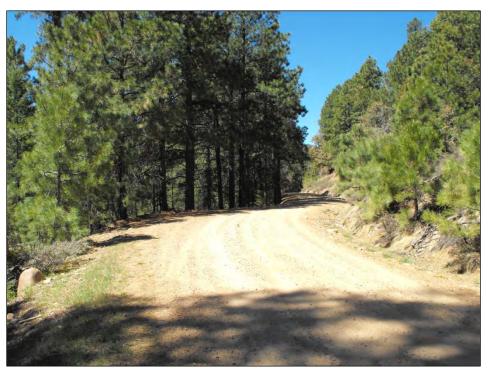
Pull-outs are located at numerous locations along the Colcord Road. In most cases, the pull-outs are located along steep and narrow sections of the roadway where additional shoulder space is needed for vehicular safety. These pull-outs parallel the roadway and range in size from 18 ft to 92 ft long by 13 ft to 18 ft wide (Photograph 7). Pull-outs are also located in developed areas and where the roadway intersects with private driveways and/or access roads. These pullouts are much larger in size and often serve as informal parking areas for recreationists (Photograph 8). Additionally, one of the pull-outs (Pull-out 9) is located along Valentine Ridge and serves as an informal scenic overlook for the Naegelin Canyon (Photograph 9).

Photograph 7. Pull-out 6, an example of a pull-out located along a narrow section of roadway for vehicular safety purposes, facing southwest.

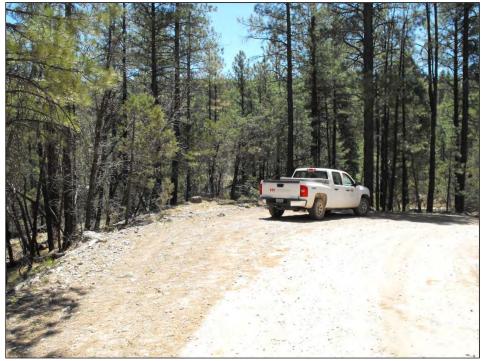
Photograph 8. Pull-out 1, an example of a pull-out that serves as an informal parking area for recreationists, facing southwest.

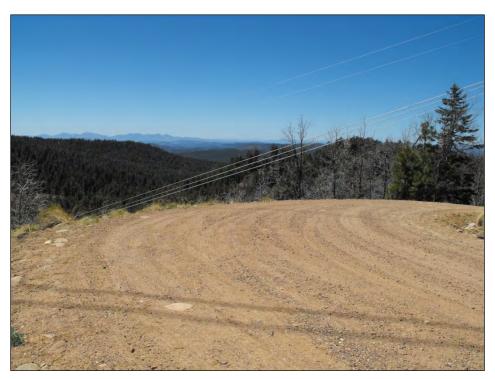
Photograph 9. Pull-out 8, overlooking Naegelin Canyon from Valentine Ridge, facing west.

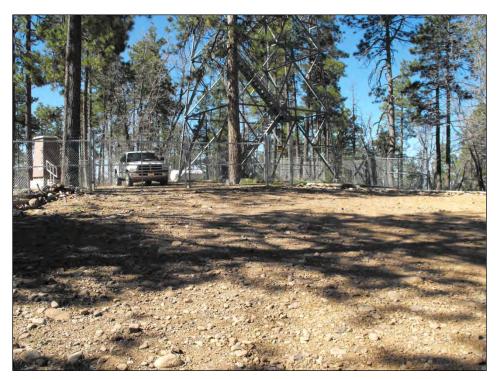
In addition to the pull-outs and barricades, one parking area was documented along the Control Road alignment. The parking area is located at Colcord Lookout at the top of Colcord Mountain, and the scenic overlook is situated along Valentine Ridge to the east of Naegelin Canyon. The parking area is irregular-shaped and graveled and is designed to accommodate parking for more than one vehicle. At its maximum dimensions, the parking area measures 62 ft long by 59 ft wide. A fenced enclosure surrounds the lookout tower and abuts the south side of the parking area; the east and west sides of the parking area are bounded by barricades that consist of large wooden logs placed on top of 1.5-ft-high cobble and earthen berms.

Photograph 10. Photograph of the Colcord Lookout parking area at the top of Colcord Mountain, facing south.

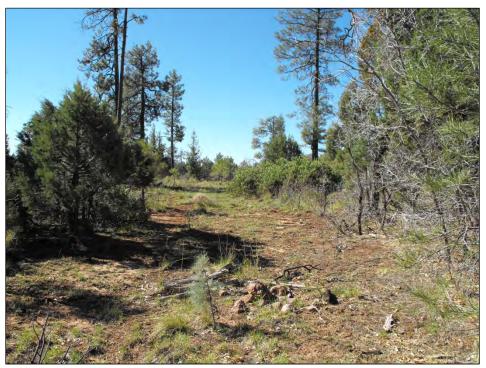
In addition to the features identified along Colcord Road, one abandoned road segment (RS) was documented (see Appendix D). The RS is approximately 411 ft long by 10 ft wide and follows the contours of a small hill on the north side of the roadway. A log has been placed in the center of the roadbed at the east end of the RS where it intersects the in-use alignment of the Colcord Road to discourage further use of the route (Photograph 12). The age of the RS is not known. The route is not depicted on historic maps of the region and information pertaining to its construction was not available.

Photograph 11. Photograph of the abandoned road segment, facing south.

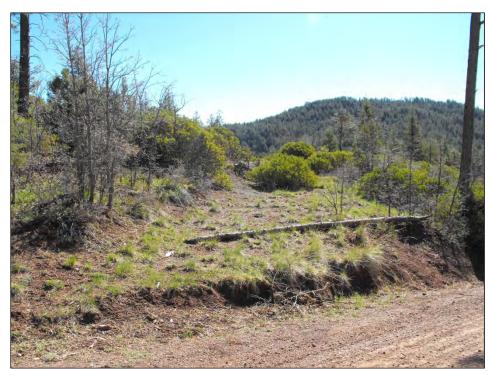
Photograph 12. Photograph showing the abandoned road segment where it intersects with the in-use alignment of the Colcord Road, facing northeast. Colcord Road is visible at the bottom of the photograph.

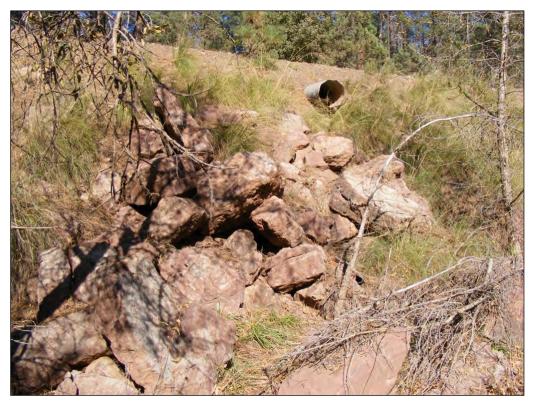
C.1.

One Type 1A culvert (Feature 31) that spills into Gordon Canyon Creek has three associated embankments (Photograph C.1). The embankments consist of dry-laid sandstone and conglomerate slabs

and boulders placed on the downslope side of the feature. The nearest embankment is immediately west of the CMP and consists of 23-ft-long and 8-ft-high mound of large conglomerate boulders that were likely placed with the aid of machinery. The remaining embankments are located further downstream on the north and south sides of the creek bank. The northern embankment measures 80 ft long and 9 ft high and almost completely covers the creek bank. The embankment on the south side is slightly smaller, measuring60 ft long and approximately 4 ft high, and covers only the lower third of the creek bank. Feature 31 is the only road feature in the current project area that has associated embankments.

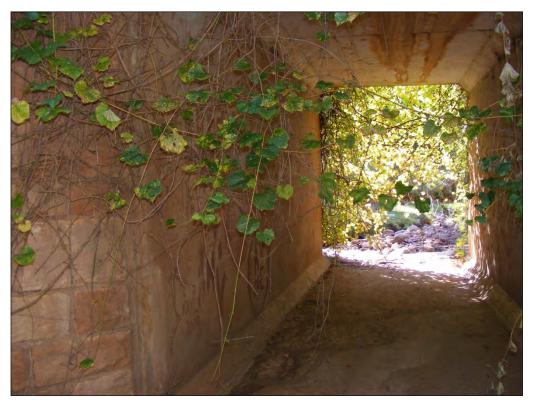
C.9.

Two Type 2 MBCs were identified along the Colcord Road alignment. Both of the Type 2 features (Features 16 and 30) span north-south tributaries to Gordon Canyon Creek. The features are similarly constructed of form-poured concrete with masonry wing walls extending from each side. The wing walls are constructed of sandstone blocks in a rusticated Ashlar design. Ashlar is dressed stone work of any type of stone; the blocks are large rectangular rocks sculpted to have square edges and even faces.

- C.9 Photograph of Feature 16, a Type 4 feature showing rusticated Ashlar construction technique, photographer Jackie Orcholl, October 2008, facing south (*Source:* Logan Simpson Design Inc., 51 West Third Street, Tempe AZ 85281).

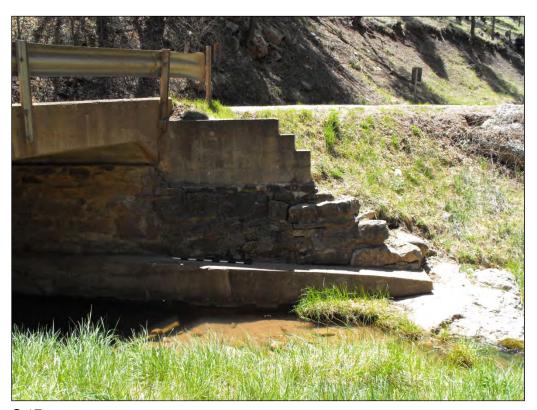
- C.17. Photograph of Feature 47, a Type 4 feature, showing the concrete block added to the southwest wing wall, photographer Leigh Davidson, April 2011, facing south (*Source:* Logan Simpson Design Inc., 51 West Third Street, Tempe AZ 85281).
